ALA8 - Re-Screwing All-Wheel Final Drive and Replacing All-Wheel Final Drive if Necessary (Stop Delivery/Recall Campaign)

Vehicle Type: **911 Carrera 4S (992)**
911 Carrera 4S Cabriolet (992)

Model Year: **2020**

Subject: **All-wheel final drive on the front axle**

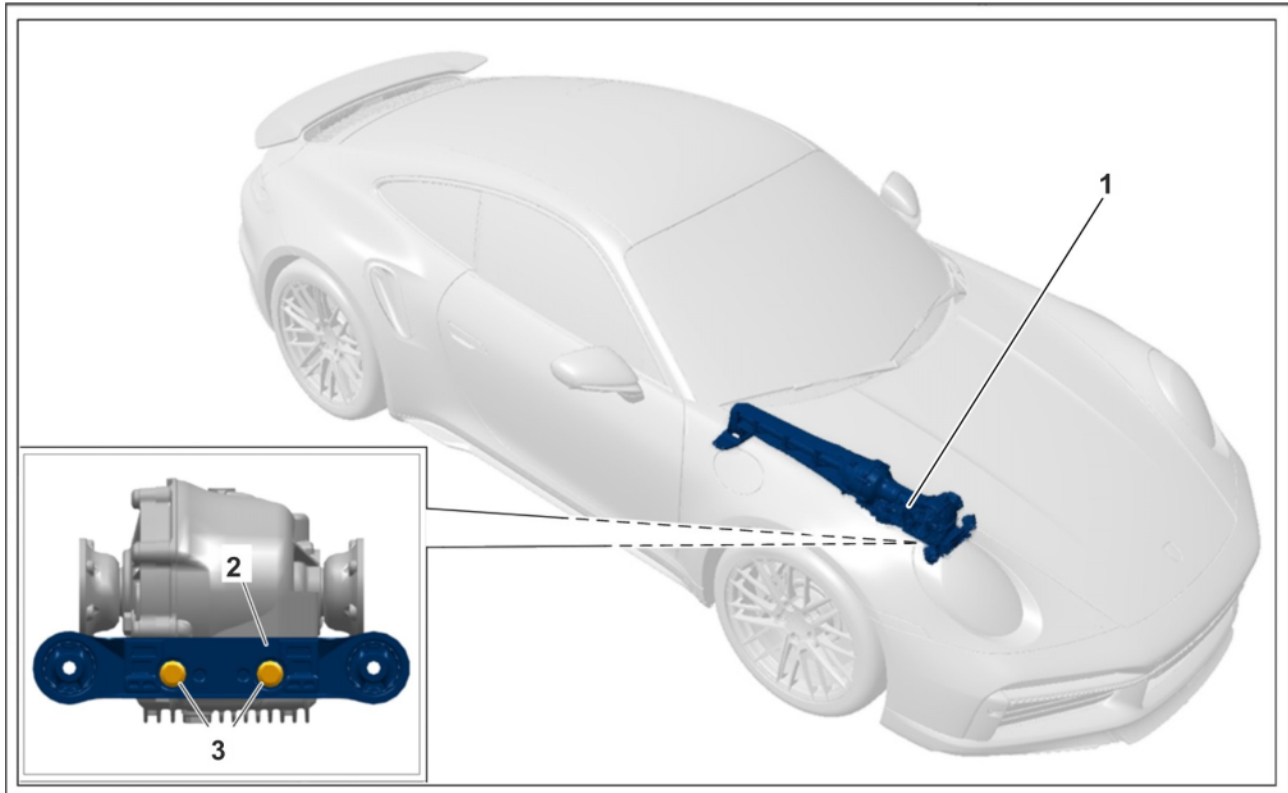
Installation position overview

- 1 – All-wheel final drive (**replace if necessary**)
- 2 – Bracket for final drive
- 3 – Fastening screws (**replace**)

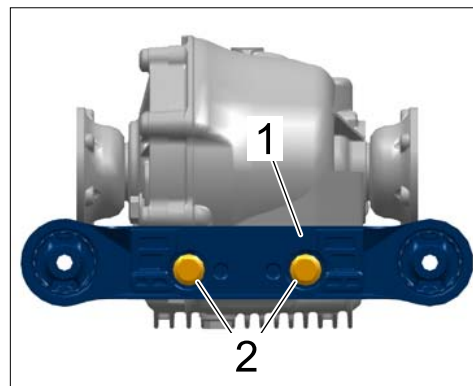
Threaded joint for final drive bracket

6.2 **Check threaded joint on front bracket** for final drive and then loosen the bracket ⇒ *Threaded joint for final drive bracket -1-* at the all-wheel final drive.

To do this, **measure the loosening torque** of the fastening screws ⇒ *Threaded joint for final drive bracket -2-* using **9768 - electronic torque wrench, 2 - 100 Nm (1.5 - 74 ftlb.)** or a similar torque wrench.

- The **loosening torque of both screws is at least 3 Nm (2 ftlb.)**: The fastening screws have **not loosened**. Continue with **Step 6.3**.

- If the **loosening torque of one of the two screws is less than 3 Nm (2 ftlb.)**, the **all-wheel final drive must be replaced**. To do this, continue with ⇒ *Technical Information '398819 Replacing all-wheel final drive and checking vehicle for damage'*.

- 6.4 Secure bracket ⇒ *Threaded joint for final drive bracket -1-* with **new fastening screws** on the all-wheel final drive.

Tightening torque 65 Nm (48 ftlb.)

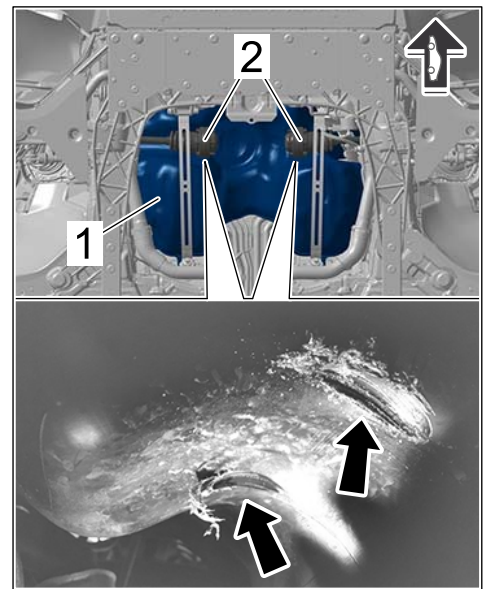
Checking fuel tank for damage

1.1 **Check the fuel tank** ⇒ *Checking fuel tank for damage -1-* for grinding and chafing marks caused by contact with the drive shaft flanges ⇒ *Checking fuel tank for damage -2-* and/or the final drive.

If **grinding or chafing marks** ⇒ *Checking fuel tank for damage -Arrows-* are visible, the **fuel tank must be replaced.**

For instructions, see ⇒ *Workshop Manual '201019 Removing and installing fuel tank'.*

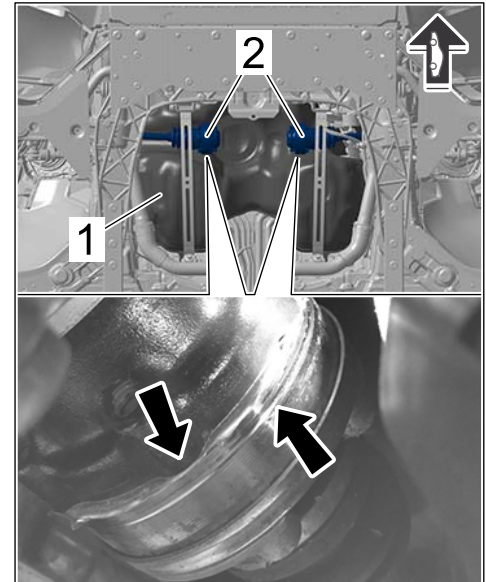
Checking drive shafts for damage

1.2 **Check drive shafts** ⇒ *Checking drive shafts for damage -2-* for grinding and chafing marks caused by contact with the fastening points on the body side of the final drive and/or the fuel tank ⇒ *Checking drive shafts for damage -1-*.

If **grinding or chafing marks** ⇒ *Checking drive shafts for damage -Arrows-* are visible, the relevant **drive shaft must be replaced.**

For instructions, see ⇒ *Workshop Manual '404119 Removing and installing front drive shaft'*.
