SAFETY RECALL N476 AND REVISED N335 REPAIR PROCESS OVERVIEW AND CARE POINTS

05 November 2020

Safety Recall N476

Door Will Not Latch

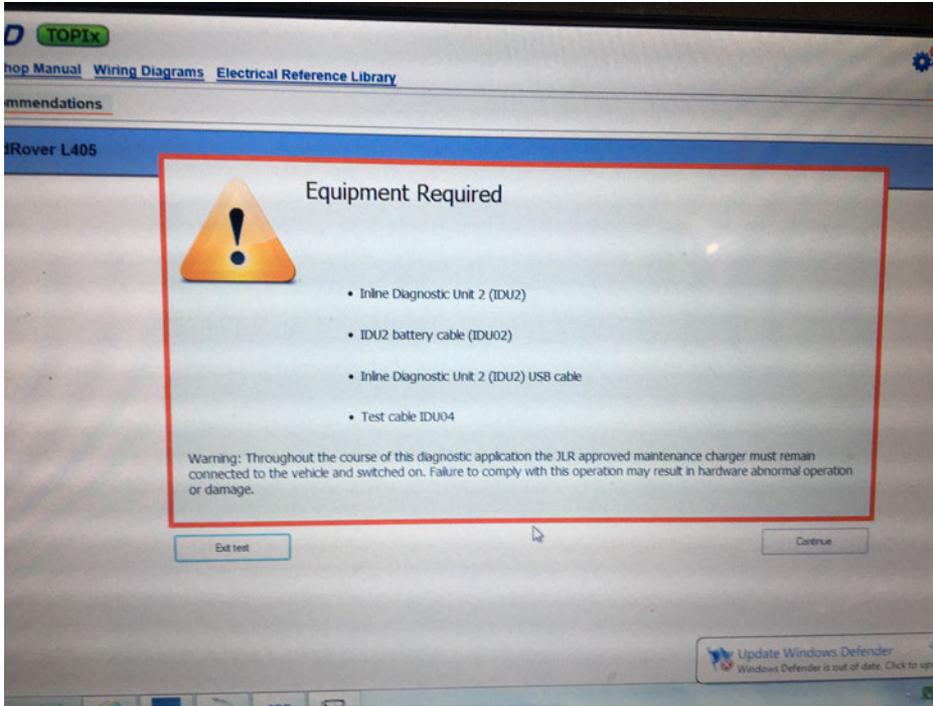
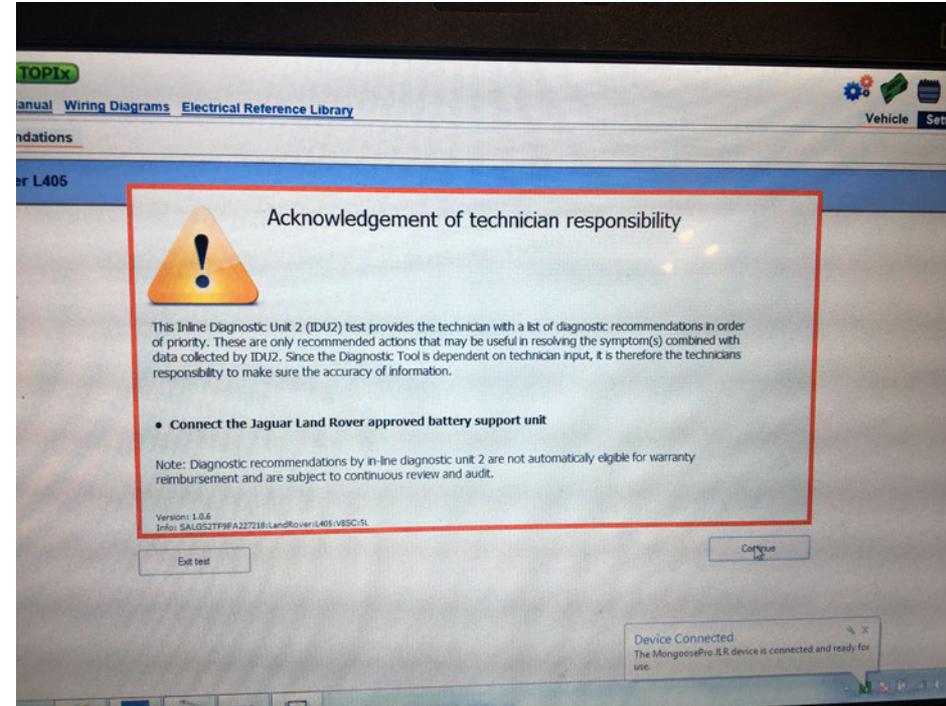
The power door locks must be operational before attempting to perform this test procedure.

Ensure that an approved battery maintainer is connected to the vehicle and that the battery voltage is within range.

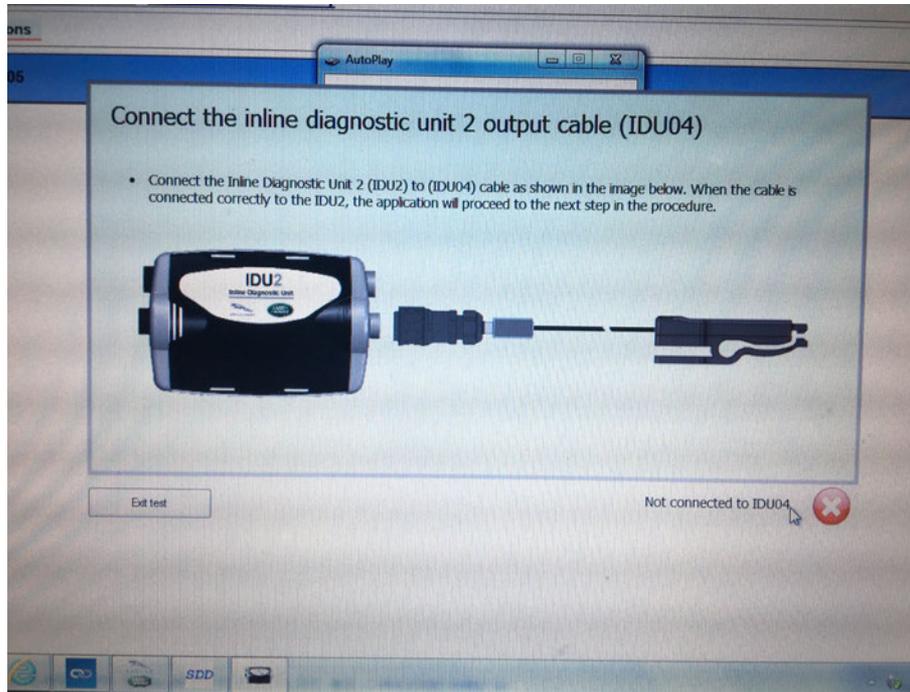
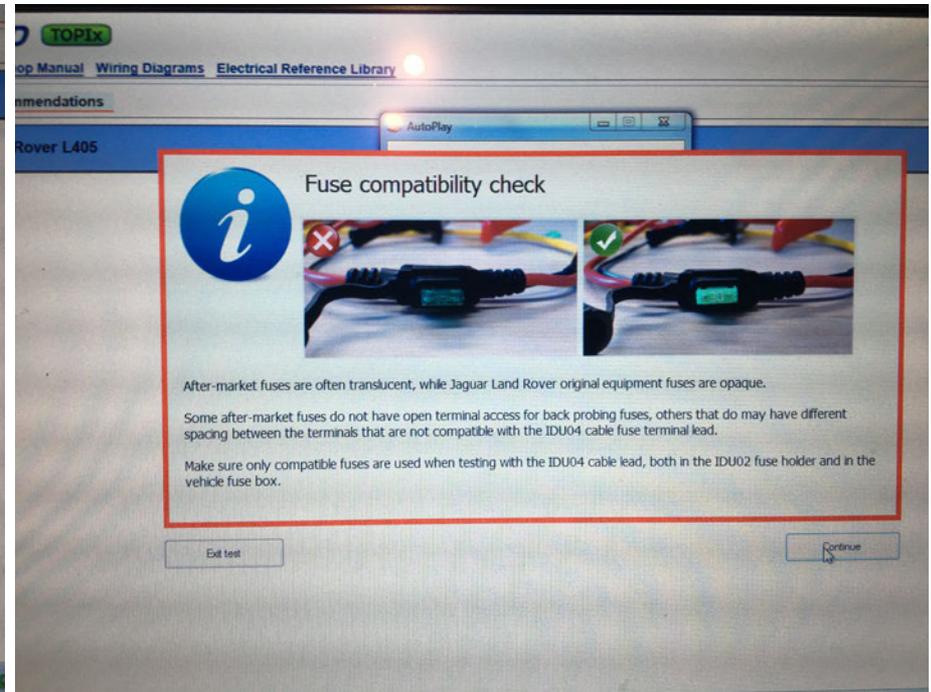
Ensure that the IDU04 cable is connected to the correct fuse.

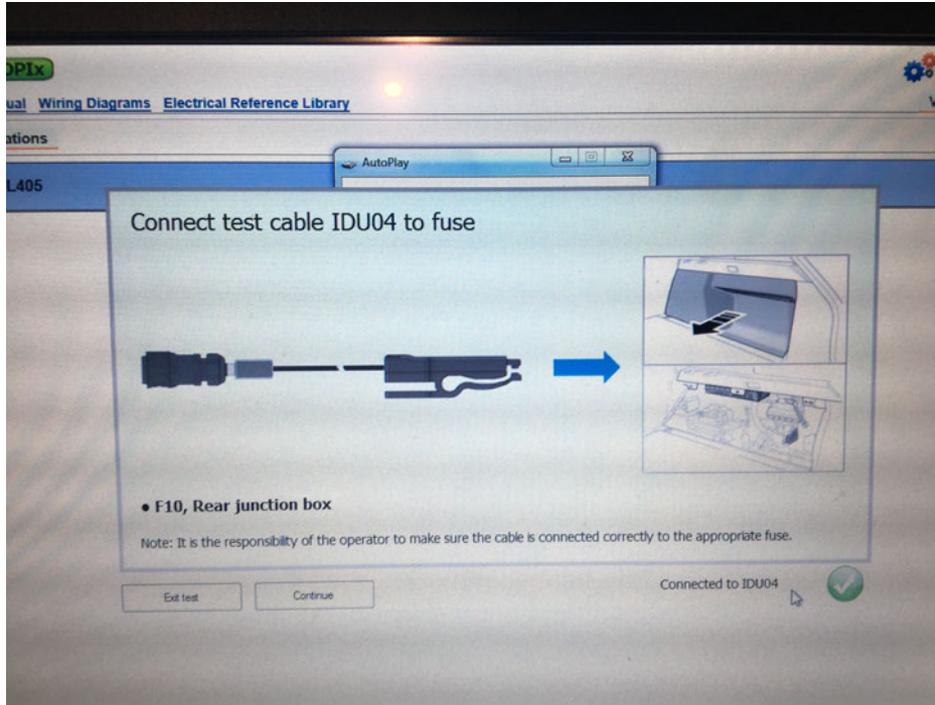
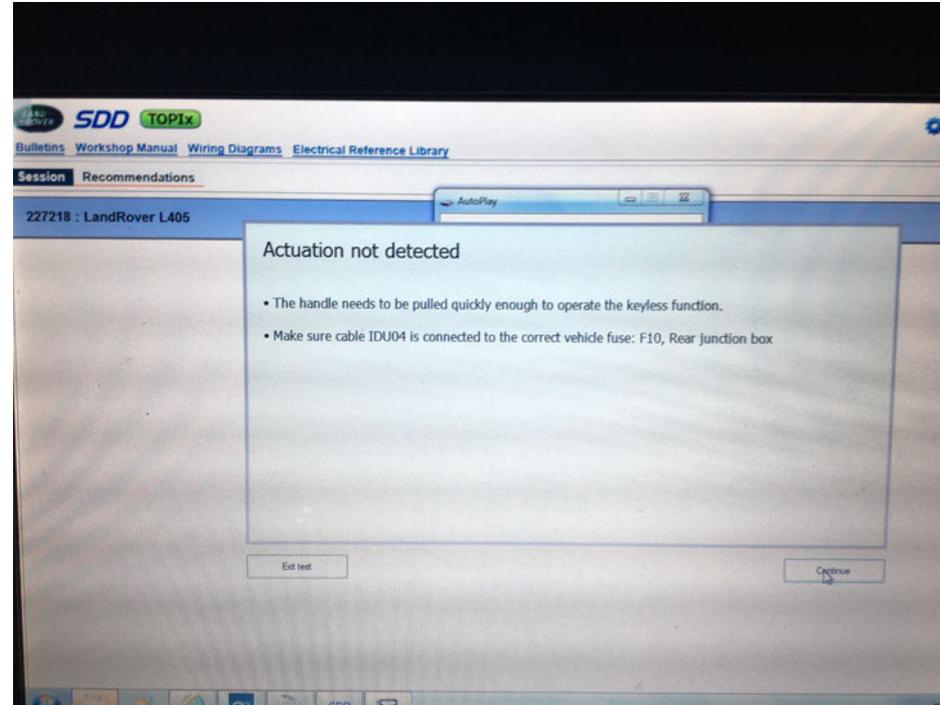
The door handle must be pulled quickly enough from when reaching for the door handle to test the Fast Unlock/Open Actuator properly.

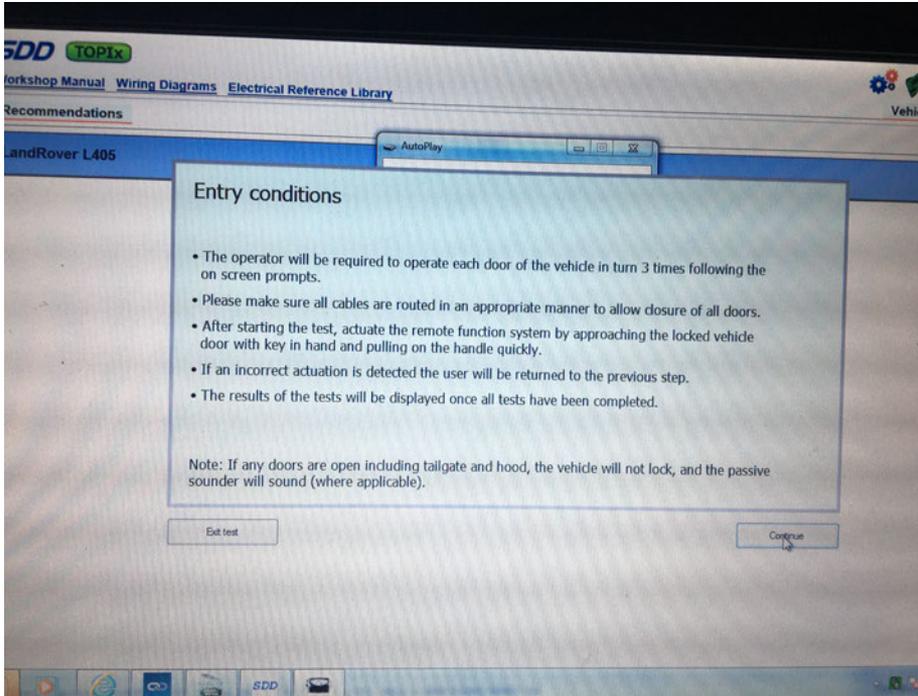
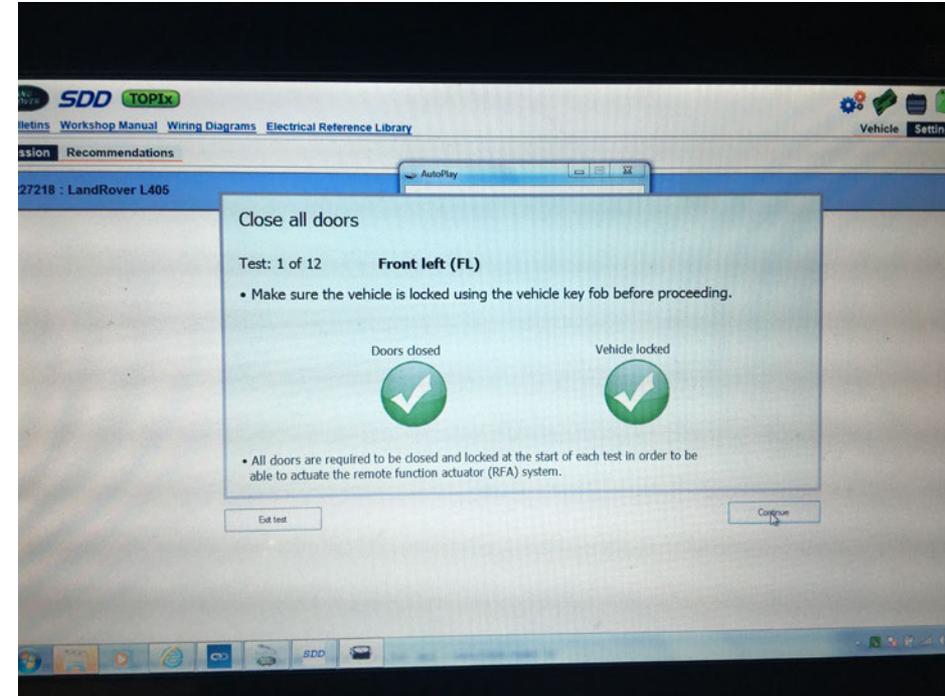
During N335 IDU2 testing, each door latch was tested 3 times. With the new IDU2 test procedure, each door latch is tested up to 5 times to ensure results.

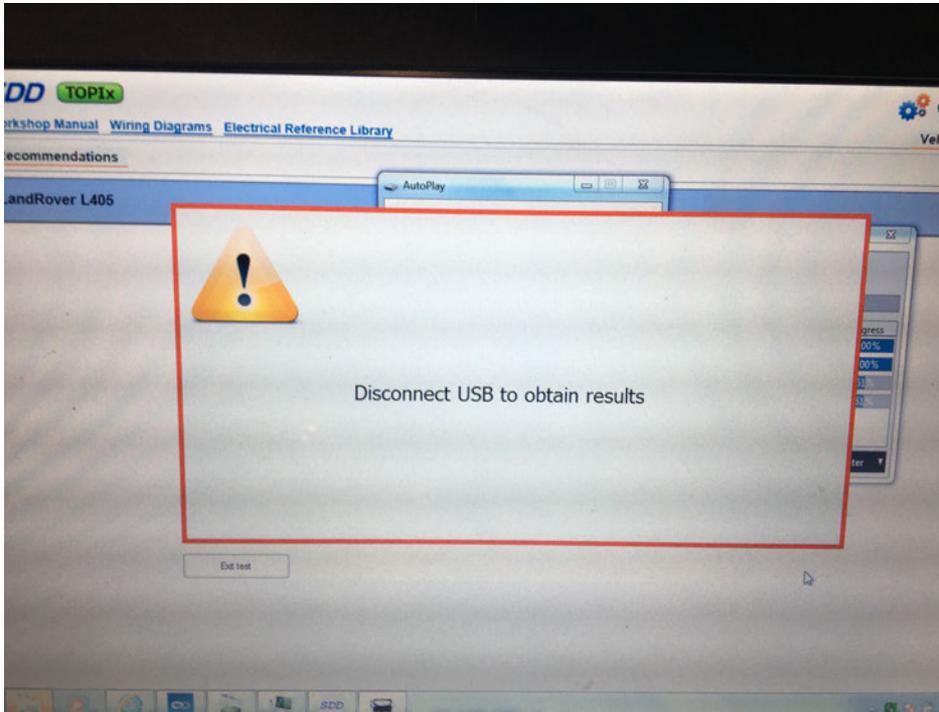
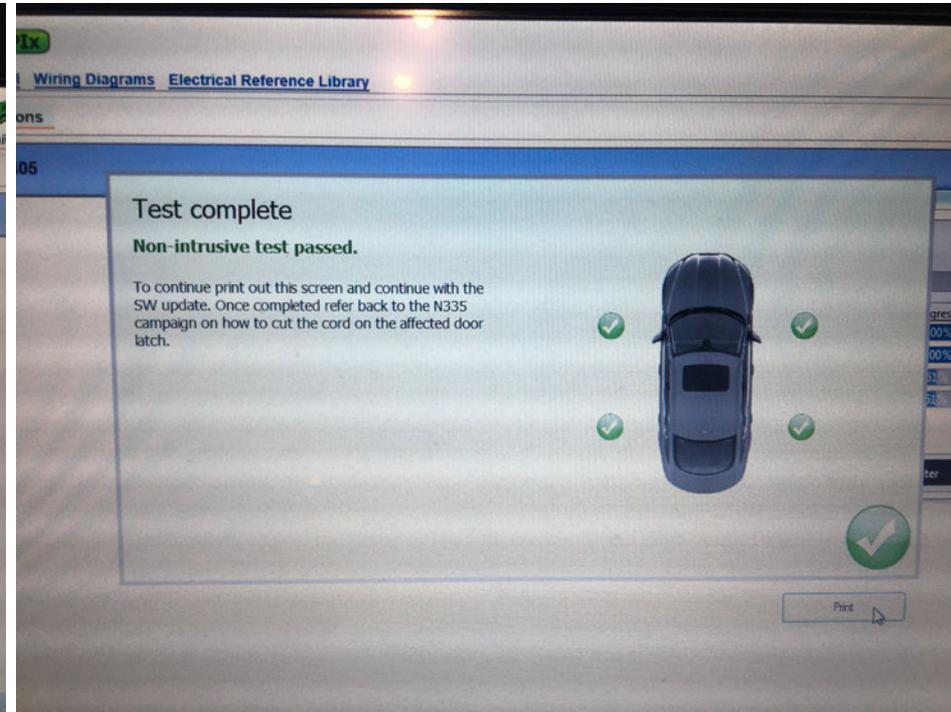
Upon completion of all SDD steps if any door latch fails the test, refer to the bulletin for service instruction on cutting the door latch fast unlock/ open actuator cord.
