Revision (1) February 2021

Dealer Service Instructions for:

# Safety Recall W09 / NHTSA 20V-396 Driver Air Bag Emblem

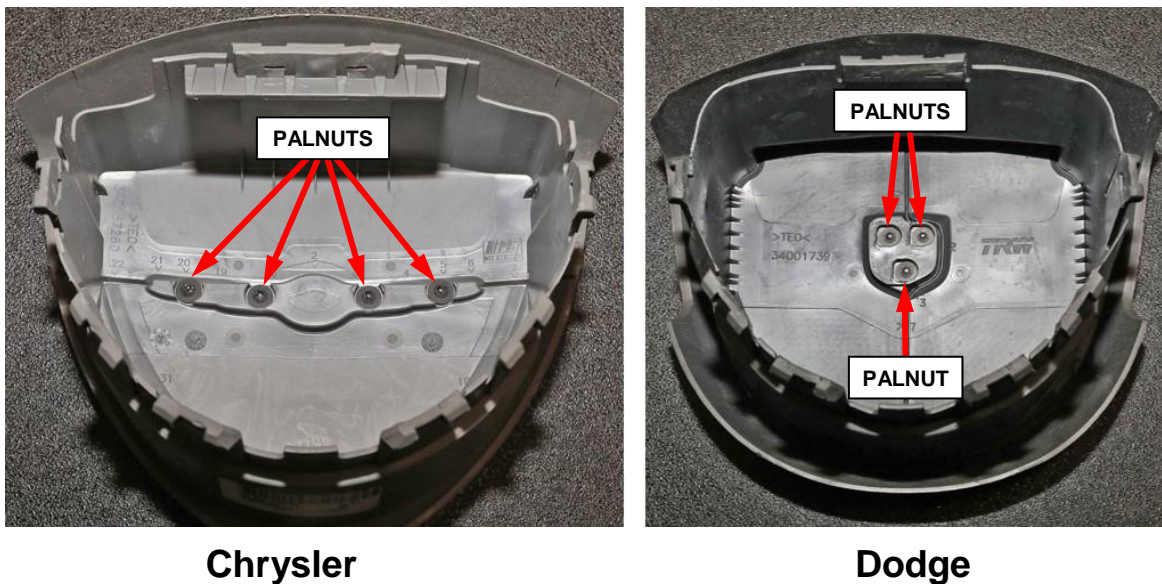
**Chrysler****Dodge****Figure 14 – Emblem Palnut Retainers**

9. Verify that all palnut retainers and emblem pieces are accounted for (Figure 14).
  - Chrysler emblems have four palnut retainers.
  - Dodge emblems have three palnut retainers.

If necessary, carefully inspect the air bag cushion folds for any trapped palnut retainers or emblem post pieces. Be careful to not unfold the air bag too far because it needs to be folded back exactly as it was prior to inspecting.

10. After all palnut retainers and emblem pieces are accounted for. Place the air bag and inflator assembly in a clean safe place **away** from the DAB cover work area to prevent any air bag contamination from debris.
11. Are all palnut retainers securely attached to emblem or are any palnut retainers loose not securely attached to the emblem?
  - If **ALL** palnut retainers are securely attached to the emblem. Proceed to **Section C. Tape Installation, page 15.**
  - If one or more palnut retainers are loose or detached from the emblem. Proceed to **Section D. Emblem Removal, page 16.**

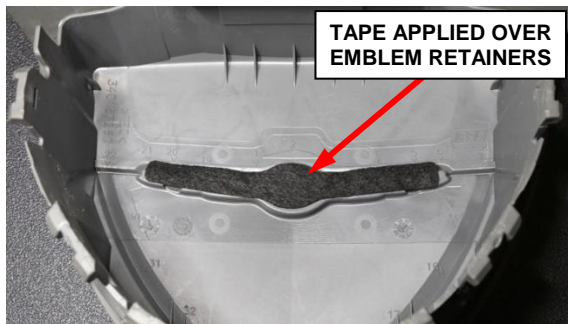
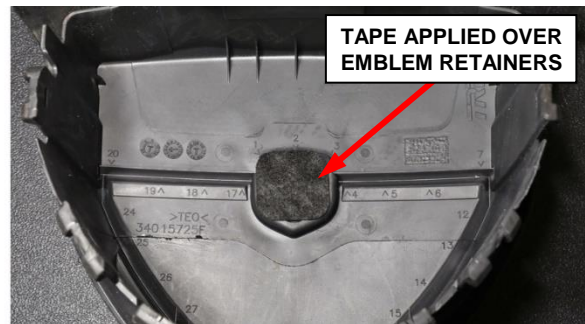
**Figure 16 – Center the Tape Over the Palnuts Then Firmly Press to Adhere**

**NOTE: This repair is ONLY for DAB emblems which are securely attached with ALL palnut retainers.**

2. Select the proper shape tape for Chrysler or Dodge. Remove the paper backing from the tape. Carefully center the tape over the emblem palnuts. Firmly press the tape to ensure good adhesion to the inside of the DAB cover (Figure 16).

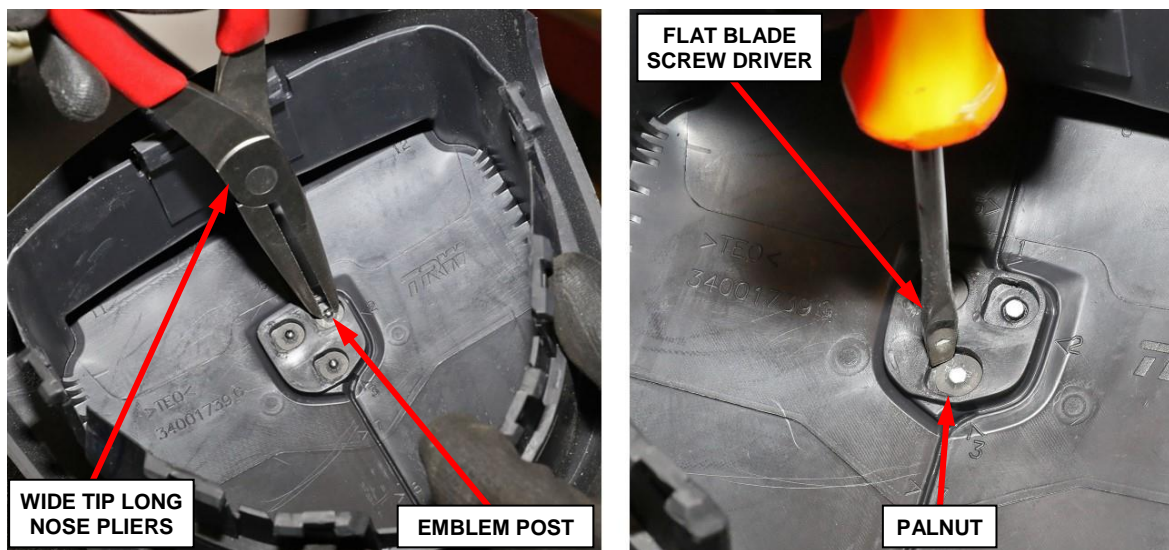
**Figure 17 – Emblem Palnut Retainer Removal**

**NOTE: This repair is for DAB emblems which are partly or fully detached due to one or more loose or missing palnut retainers.**

1. Using wide-tip long-nose pliers, break off any emblem posts protruding beyond the palnut retainers (Figure 17).
2. Using a flat blade screwdriver, pry the palnut retainers off of the emblem posts (Figure 17).

3. Remove the emblem from the cover.
4. Verify that all palnuts retainers and emblem pieces are accounted for and disposed of so as to not contaminate the air bag cushion during reassembly.
5. Proceed to **Section E. DAB Reassembly.**
