Dealer Service Instructions for:

Safety Recall W09 / NHTSA 20V-396 Driver Air Bag Emblem (Interim Repair)

2008-2010 (RT) Chrysler Town and Country

2007-2011 (KA) Dodge Nitro

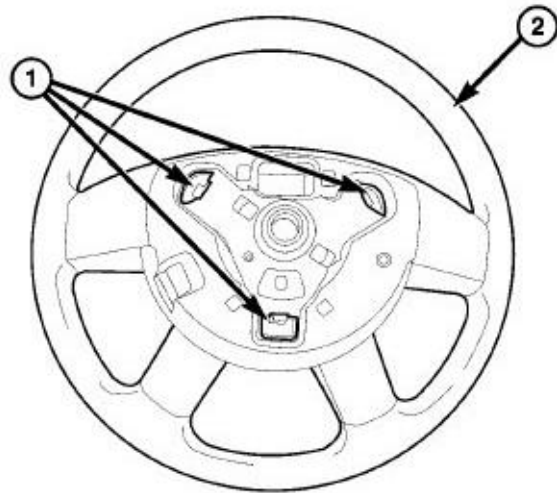
Figure 1 – DAB Retainer Locations

7. There are three DAB retainer access holes (1) on the instrument panel side of the hub of the steering wheel (2), located at the two o'clock, six o'clock and ten o'clock positions. The steering wheel must be rotated to bring each of these access holes up to the twelve o'clock position of the steering column one at a time for removal access (Figure 1).
