GROUP  
**Safety Recall**

MODEL  
**2020MY  
Sedona (YP)**

NUMBER  
**SC192 (Rev 1, 08/14/2020)**

**ALTERNATOR B+ TERMINAL NUT  
INSPECTION AND TIGHTENING (SC192)**

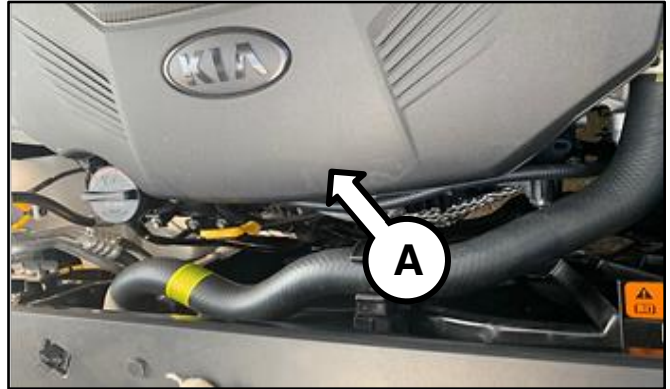
1. Open the hood and remove the engine cover (A).

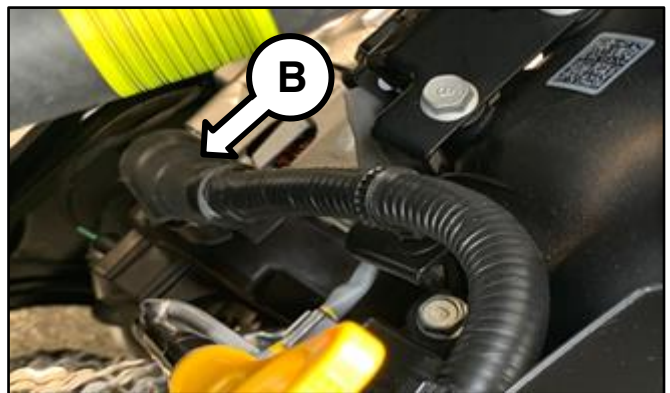
2. Pull back the alternator B+ terminal cover (B).

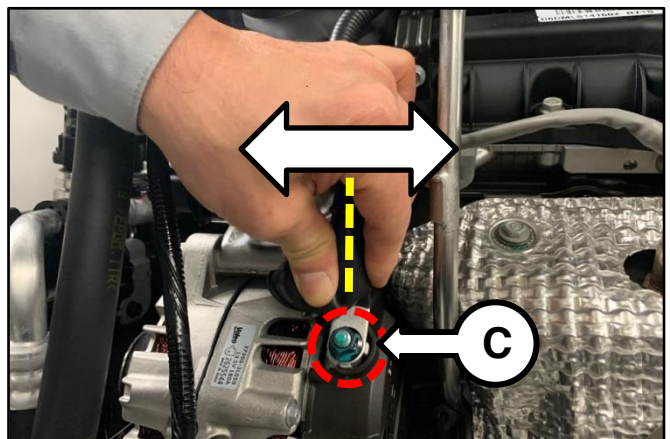
3. Inspect the B+ terminal and confirm the nut (C) is properly secured by attempting to move the terminal end left to right.

**Note:** The alternator B+ terminal cable should be connected vertically (refer to the yellow dashed line).

If the cable end/nut is loose (FAIL), refer to 'Repair Procedure' on page 3.

If the cable end/nut is properly secured (PASS), the campaign is complete.

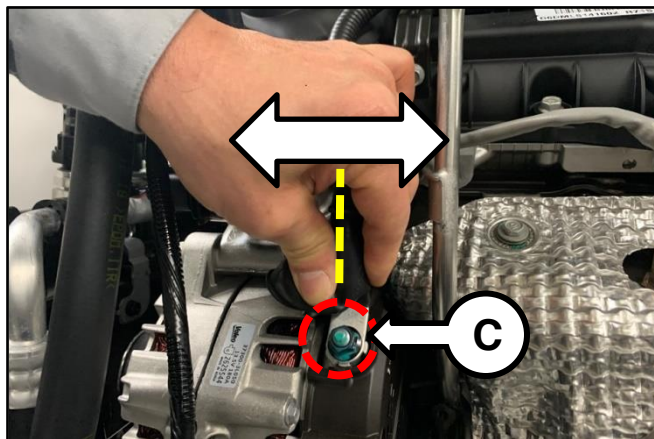
Confirm the nut (C) is properly secured by attempting to move the terminal end left to right.

1. Save radio presets.
2. Disconnect the battery Negative (-) terminal.
3. Torque the alternator B+ nut (C) to specification.

**Torque Specification for nut (C):  
8.7 lb.ft (11.8 N.m., 1.2 kgf.m)**
