# SAFETY RECALL BULLETIN

SUBJECT:		No: <b>SR-20-004</b>	
<b>SEAT BELT BUCKLE - SAFETY RECALL CAMPAIGN</b>		DATE: <b>September 2020</b>	
		MODEL: <b>SEE BELOW</b>	
<b>CIRCULATE TO:</b>	<input checked="" type="checkbox"/> GENERAL MANAGER	<input checked="" type="checkbox"/> PARTS MANAGER	<input checked="" type="checkbox"/> TECHNICIAN
<input checked="" type="checkbox"/> SERVICE ADVISOR	<input checked="" type="checkbox"/> SERVICE MANAGER	<input checked="" type="checkbox"/> WARRANTY PROCESSOR	<input checked="" type="checkbox"/> SALES MANAGER

Certain 2014 - 2019 Outlander vehicles  
 Certain 2018 - 2019 Outlander PHEV vehicles

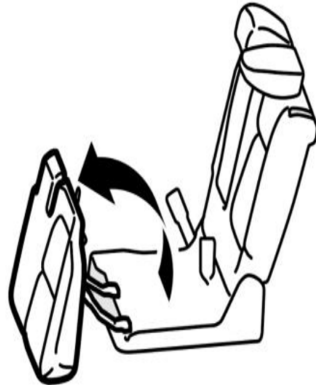
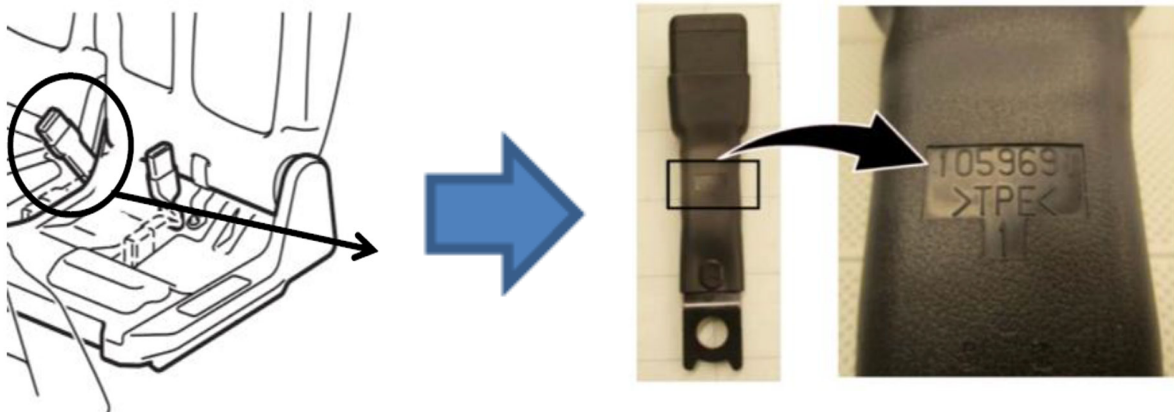
Step 2. Confirm the buckle number:

- A. If part number is 1084145; countermeasure part has been used. No repair necessary. Proceed to Step 11, label attachment procedure.
- B. If part number is 1059691, proceed with repair in Step 3.

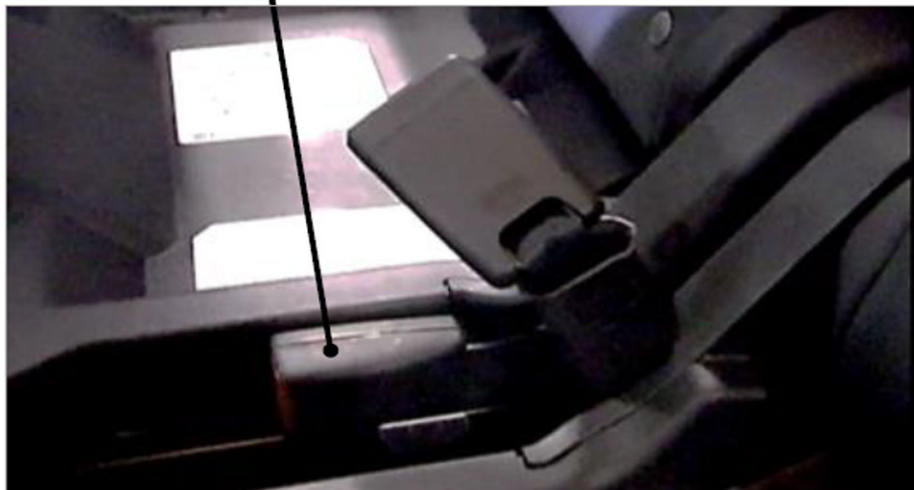
Inner right hand side seat belt

Step 10: Make sure the right hand side seat belt buckle is not broken. If it is broken, replacement is necessary (Part #7000D555XA). For detailed replacement instructions, refer to TSB-19-52A-005 and if needed, the Service Manual -> Group 52A-Interior -> Seat Belt -> Rear Seat Belt -> Removal and Installation.
