Recall Campaign Bulletin

Campaign No. 2020070013, August 2020

SUBJECT: Model A-Class vehicles (177 platform)

Installation of AC Drain Hose

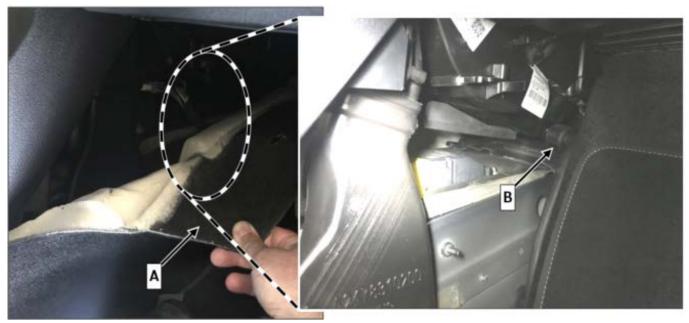
Figure 1

1. Lift floor covering (A, figure 1) at right front center console so that the condensation drain hose of air conditioning system (B, figure 1) becomes visible.

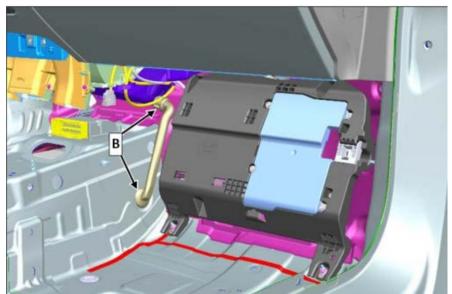
Figure 2

- 2. Check condensation drain hose of air conditioning system (B, figure 2) at top and bottom for correct seating, *correctly* attach if necessary.
 - i If the drain hose is **not** correctly attached, the arising condensation can get into the footwell (driver and/or front passenger side).

- **a.** Condensation drain hose of air conditioning system *not correctly* attached and water ingress in footwell: Perform **work procedure**.
- **b.** Condensation drain hose of air conditioning system *not correctly* attached and *no* water ingress in footwell: *Correctly* attach condensation drain hose.
- c. Condensation drain hose of air conditioning system correctly inserted: End measure.
