# Thor Motor Coach Recall Repair Instructions

| Recall # | <b>20V-419<br/>2020-332</b> | | |
| Description/Title: | <b>Battery Cable Routing</b> | | |
| Affected Product Line(s): | Certain model year 2021 Daybreak, Four Winds, Quantum, Chateau, and Freedom Elite motorhomes built on the 2020 Ford E-Series chassis | | |

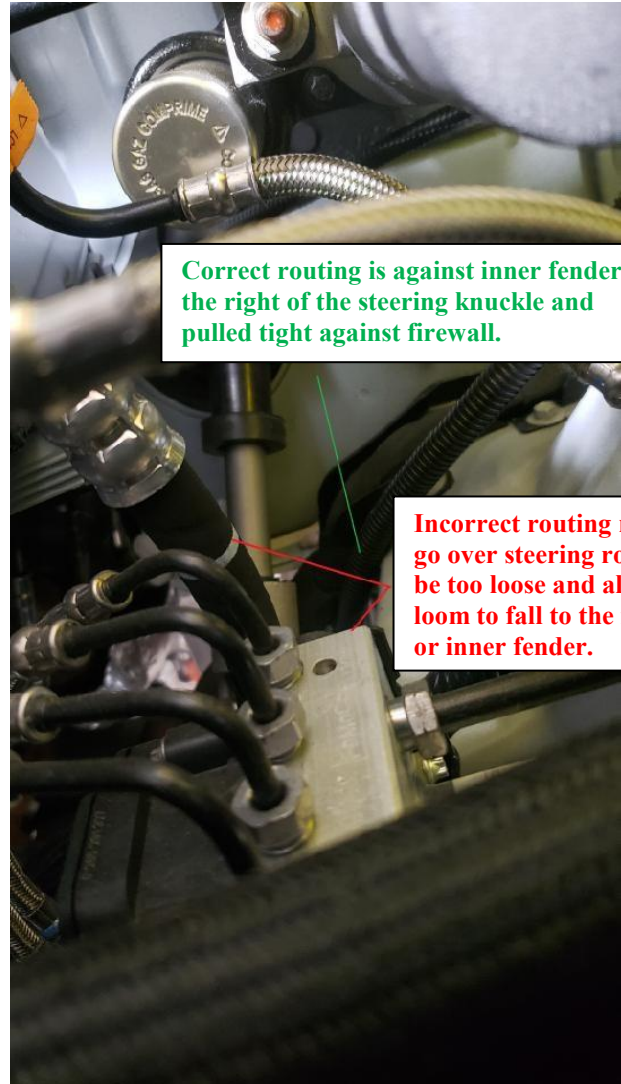
1. Open hood and remove windshield washer reservoir using the 5/16" nut and socket.
2. Locate battery cable and inspect routing and to determine if cable is tightly secured.

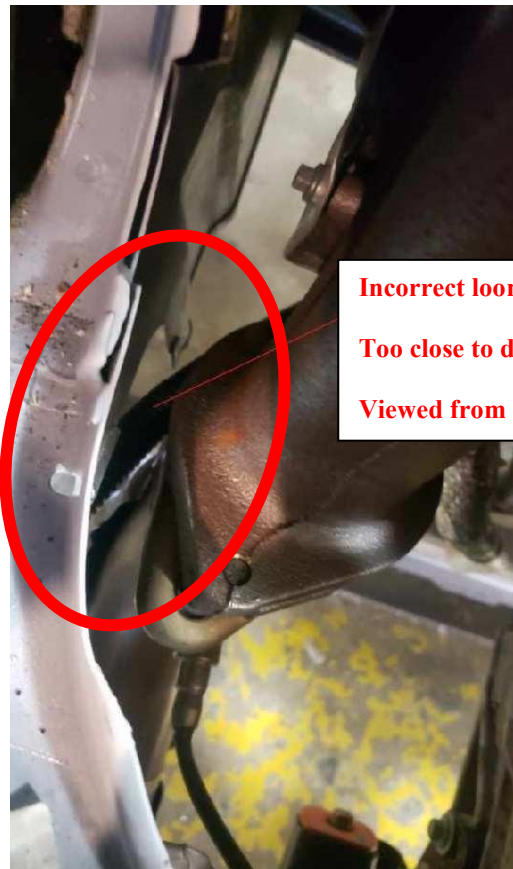
(Additional examples of correct and incorrect routing)

If battery cable is too loose or routed too close to manifold, continue to Step 4.

4. If needing to secure cable, use UV rated zip ties to properly secure cable to frame rail and away from manifold.
5. If cable will need to be re-routed:
  - a. Remove ½ in. nut off battery solenoid to remove cable.
  - b. Re-route as needed along frame rail to ensure cable is away from heat shield and conduit is visible on top of frame rail from driver's side front wheel well. Be sure to properly secure once re-routed.
  - c. Re-install cable to solenoid.
