Thor Motor Coach Recall Repair Instructions

Recall #	20V-419 2020-332		
Description/Title:	Battery Cable Routing		
Affected Product Line(s):	Certain model year 2021 Daybreak, Four Winds, Quantum, Chateau, and Freedom Elite motorhomes built on the 2020 Ford E-Series chassis		
Service Campaign # :	RC000197	Released Date:	09/04/2020
Repair Code:	Inspect Only: TMCRC80492Y Inspect with Repair: TMCRC80492V	Document Date:	09/04/2020
Time Allowed:	Inspect Only: 0.2 Inspect with Repair: 0.4	Document Revision:	A

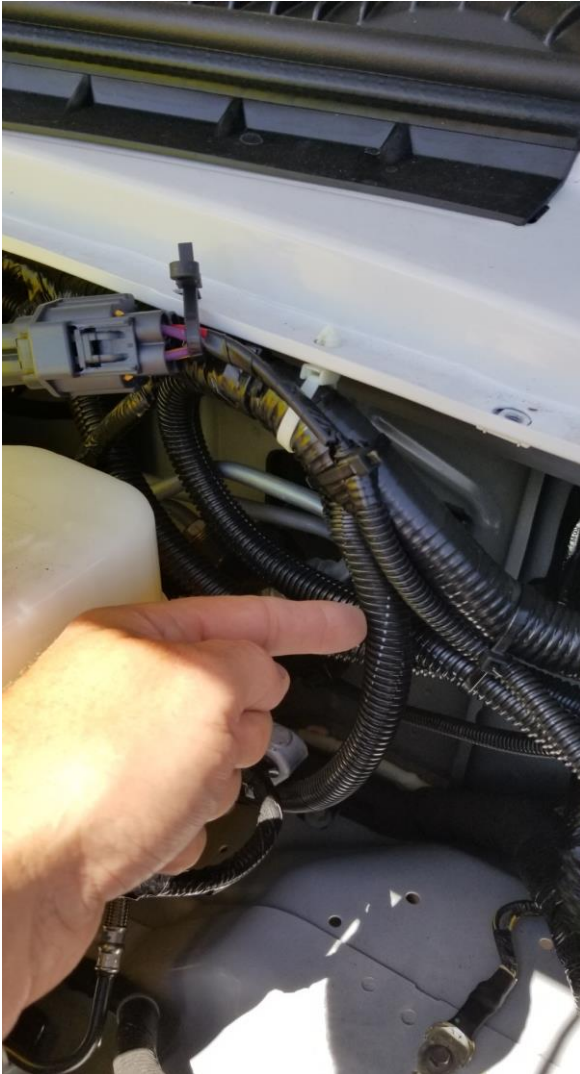
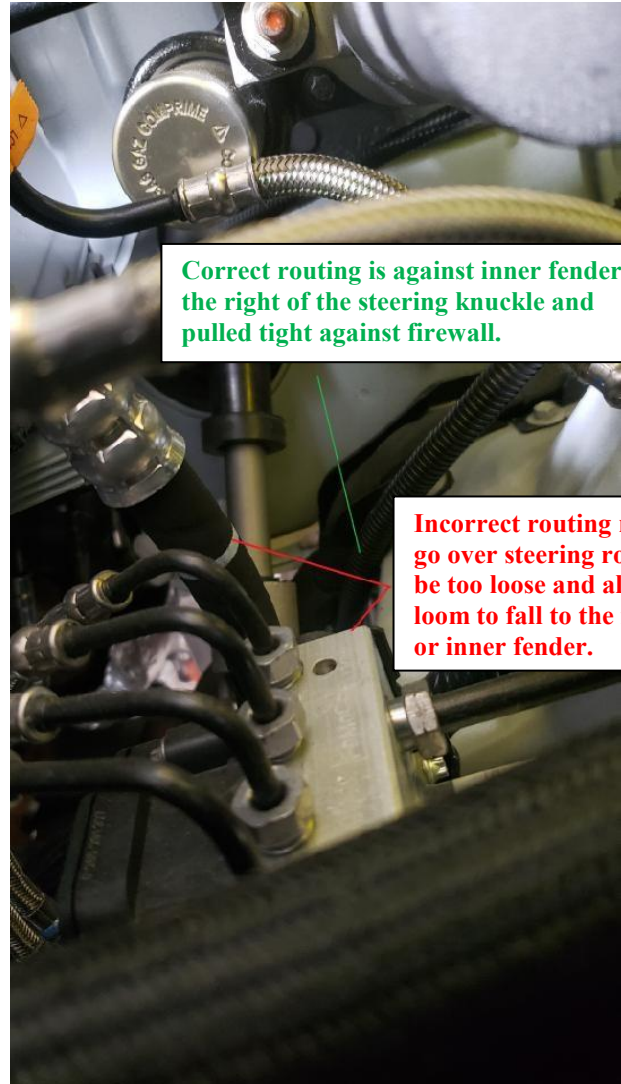
1. Open hood and remove windshield washer reservoir using the 5/16" nut and socket.
2. Locate battery cable and inspect routing and to determine if cable is tightly secured.

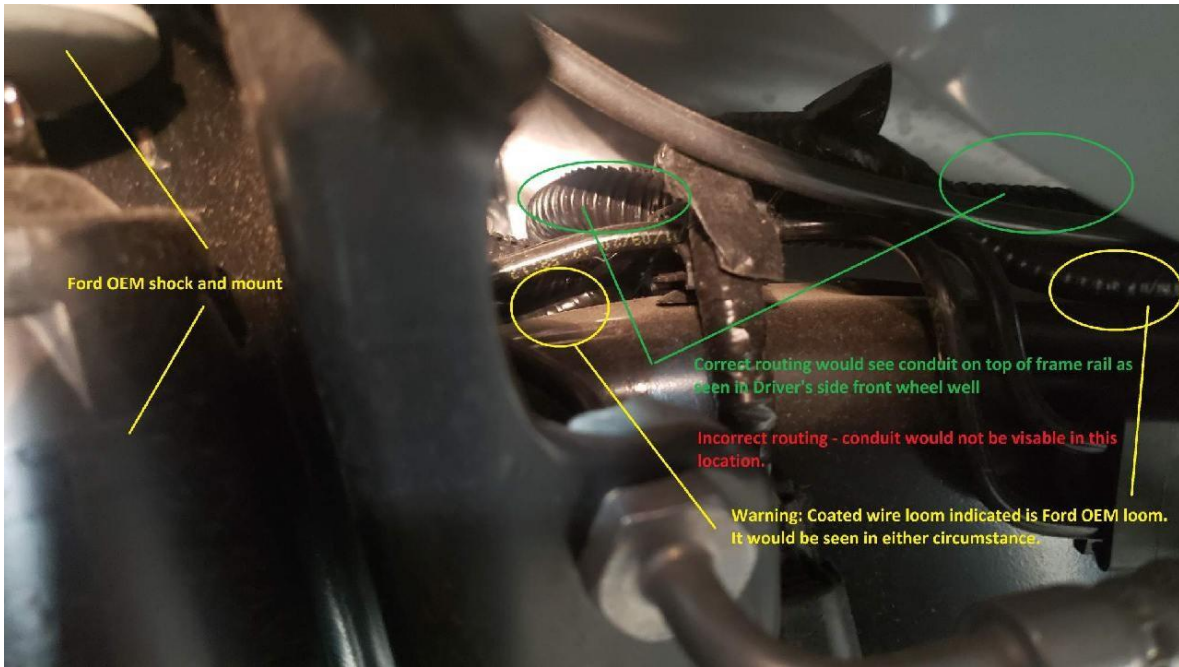
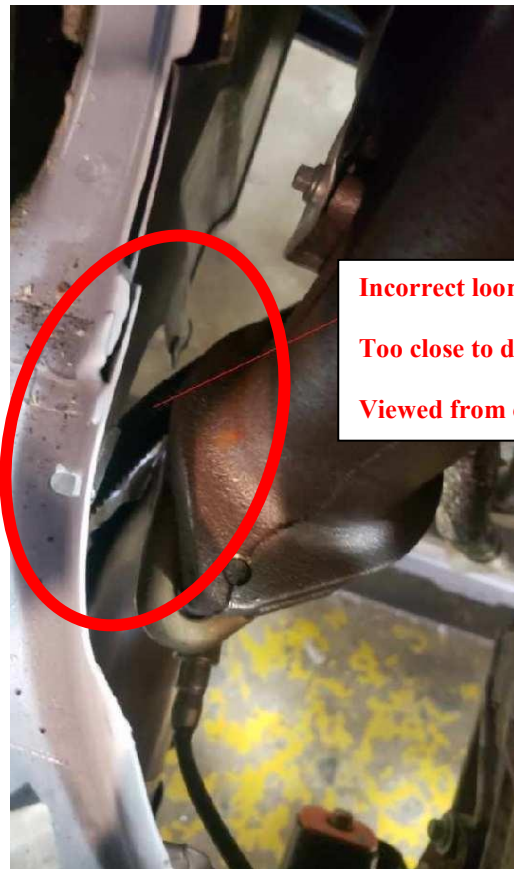
Incorrect loom location

Too close to driver side manifold

Viewed from cab with engine cover removed

4. If needing to secure cable, use UV rated zip ties to properly secure cable to frame rail and away from manifold.
5. If cable will need to be re-routed:
 - a. Lift entry step lid to access house batteries.
 - b. Remove positive cable from batteries.
 - c. Remove ½ in. nut off battery solenoid to remove cable.
 - d. Re-route as needed along frame rail to ensure cable is away from heat shield and conduit is visible on top of frame rail from driver's side front wheel well. Be sure to properly secure once re-routed.
 - e. Re-install cable to solenoid.
