GROUP
Safety Recall

MODEL
**2020MY
Stinger (CK)**

NUMBER
SC193

SUBJECT: REPLACEMENT OF THE R-MDPS ASSEMBLY (SC193)

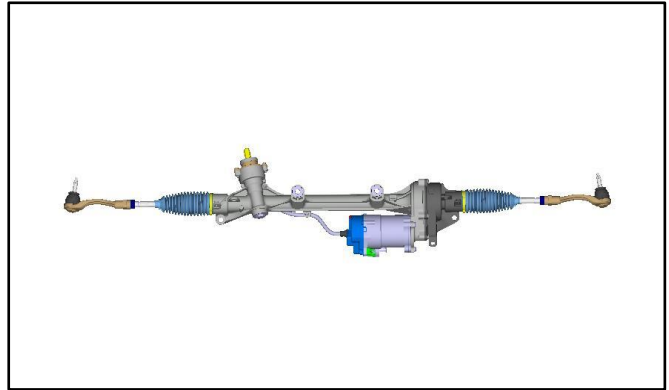
This bulletin provides the procedure to replace the rack mounted motor driven power steering (R-MDPS) / steering gear box assembly on some 2020MY Stinger (CK) vehicles equipped with THETA II 2.0L T-GDI (RWD/AWD) vehicles produced from October 7, 2019 through December 12, 2019. The Rack & Ball/Nut Assembly (RBNA), an internal component of the R-MDPS Assembly, may have been manufactured incorrectly. Over time, the incorrectly manufactured RBNA component may fracture, causing the steering to lock or become difficult to steer while driving. Before conducting the procedure, verify that the vehicle is included in the list of affected VINs.

1. Save radio presets and disconnect battery negative (-) terminal.
2. Replace the R-MDPS by referring to the “Steering System → Electrical Power Steering → Steering Gear Box → Repair procedures” chapter in the applicable Shop Manual on KGIS.

3. Install the R-MDPS in the reverse order of removal.
4. Refer to the “Steering System → Electrical Power Steering → Repair procedures” chapter in the applicable Shop Manual on KGIS.
