Thor Motor Coach Recall Repair Instructions

Recall #	20V-424 2020-338		
Description/Title:	20A/AT Dinette Seatbelt Length		
Affected Product Line(s):	Certain model year 2020/2021 20A/AT Sequence and Tellaro motorhomes		
Service Campaign # :	RC000198	Released Date:	9/11/2020
Repair Code:	Inspect Only: TMCRC80490Y Inspect & Repair: TMCRC80490V	Document Date:	9/11/2020
Time Allowed:	Inspect Only: 0.1 Inspect & Repair: 0.3	Document Revision:	A

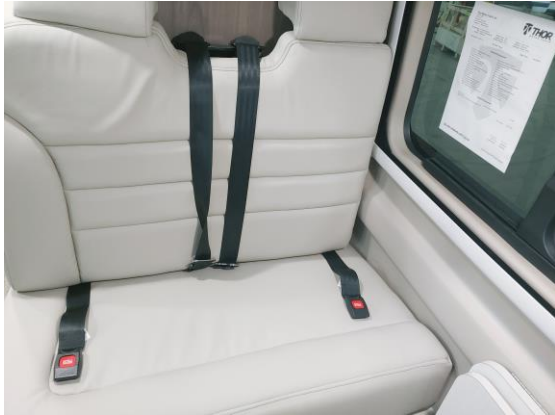
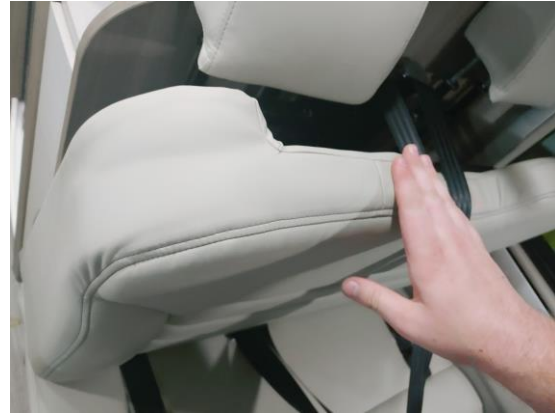
1. Remove back and bottom cushions from velcro strips on dinette booth.

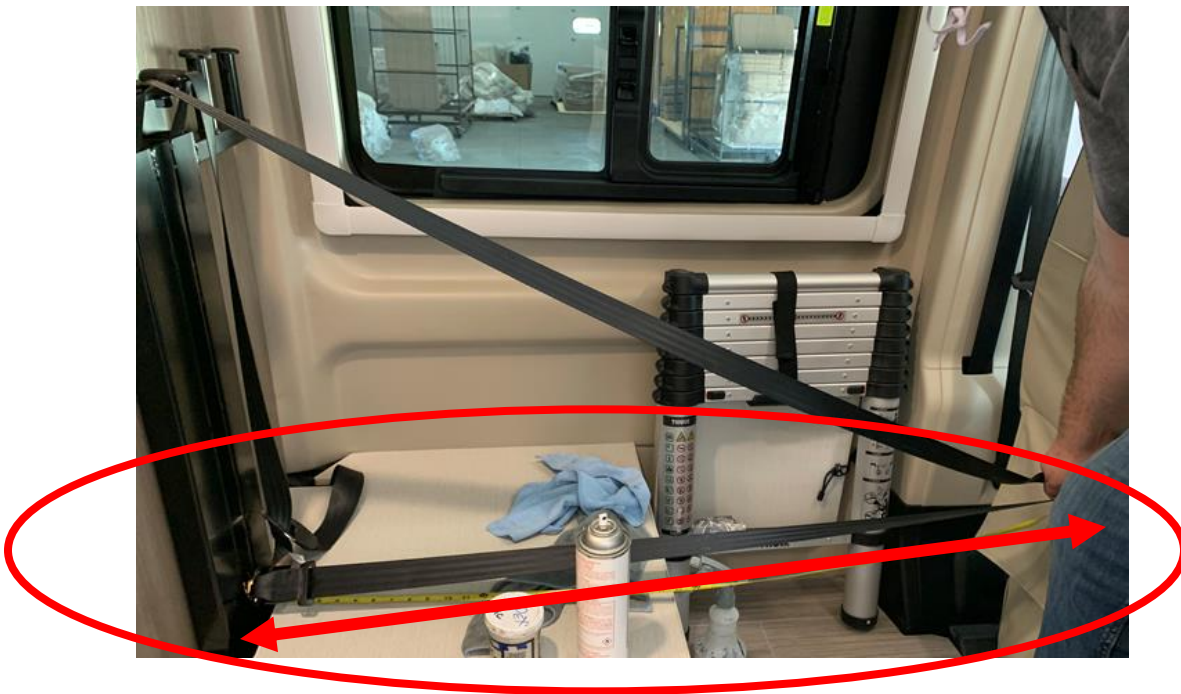
2. Extend the seatbelt all the way out. Measure from the bracket flat along the seat base to end of extension.

If correct seatbelt is installed, this measurement should be at least 45" and no further repair will be needed.

If seatbelt measurement is less than 45", continue to Step 3 for repair procedure.
