# Federal Recall Information

20PBD

**Peterbilt**

Safety Recall - Certain Model 520 vehicles with Right-Hand Stand-Up ("RHSU") configuration may have incorrect bolts installed on the steering assist cylinder bracket.

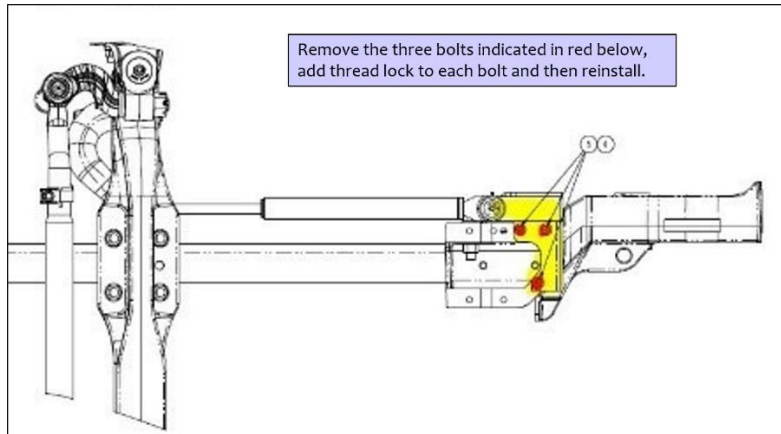
Peterbilt Motors Company has decided a defect which relates to motor vehicle safety may exist in certain Model 520 vehicles with Right-Hand Stand-Up ("RHSU") configuration built between February 15, 2019 and December 20, 2019. Vehicles may have incorrect steering assist cylinder bracket bolts installed, which prevents proper retention of these bolts. The steering assist cylinder bracket attached to the right front spring bracket with these bolts may also be damaged. The bolts installed may not have the required thread lock and this could result in loose or missing hardware. This may cause the bracket to flex or break and cause damage to adjacent components or lock up steering.

**Review the image below for bracket and bolt location.**

1. Locate the steering assist cylinder bracket attached to the right front spring bracket.
2. Remove and reinstall the 3 bolts with Loctite 243 thread locker attaching the bracket to the front spring bracket.
3. Torque (3) M12 bolts to 75 lbft/102 Nm
