IMPORTANT SAFETY RECALL

NHTSA Recall # 20V-433
Transport Canada # 2020-357
Tiffin Recall # TIF-113

VIP Wiper Module Power Source Recall

Tiffin Recall TIF-113, VIP Wiper Module Power Source Recall

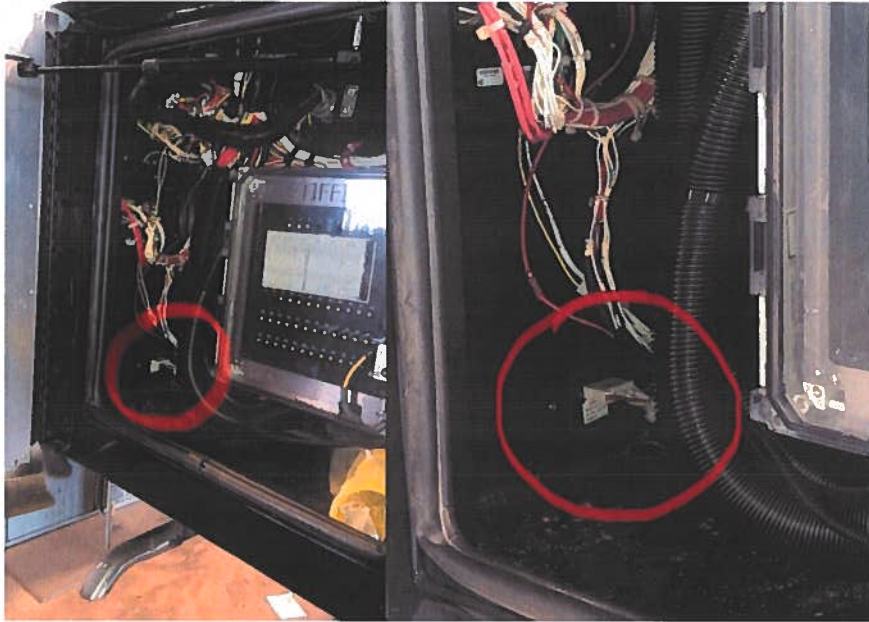
plug it back up. We have included the following pictures to show the location on the VIP power module plug. The plug is circled in RED.

Please take your motorhome to a reputable service center **OR** dealer of **your** choice to have this inspection completed and the repairs made if needed. Please allow up to 15 minutes to have this inspection completed. If the wiring is determined to be incorrect and repair is needed, the repair will take another 15 minutes. This work will be completed at no charge to you, the owner. We have included the inspection and repair instructions for this recall. We have included a return sheet to be submitted by the repairing service center with their claim for payment.

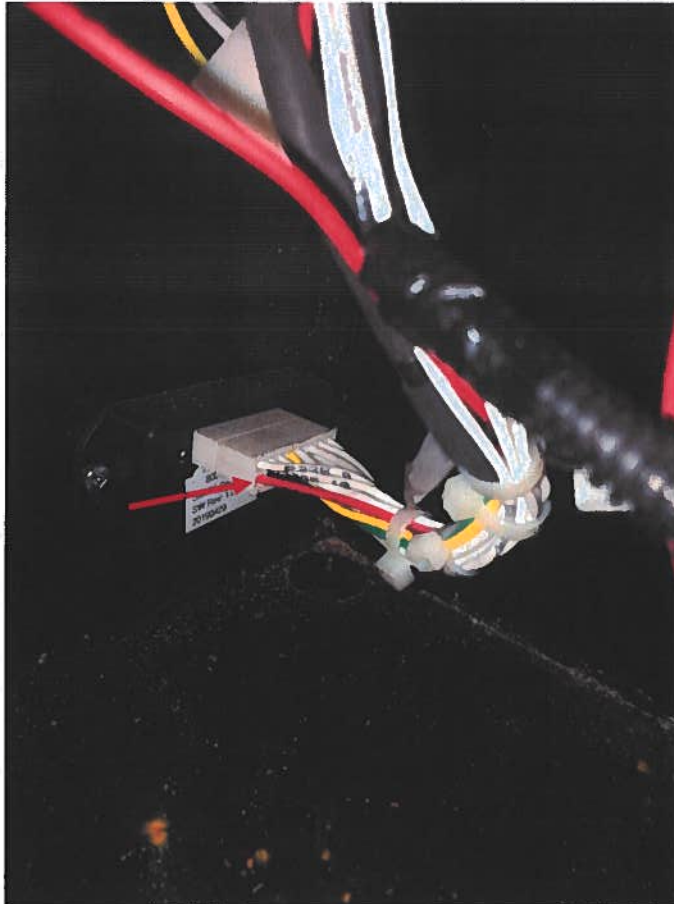
(figure 1)

This document will go through a step by step process to fix the VIP module power source. The VIP module is a small, black module with a single plug. The module is located in the bottom left of the front electrical box. The module and plug being modified are pictured below (figure 1).

The sockets should be numbered on the plug itself. Also shown in figure 1 with a red arrow. Socket 1 will be the only wiring change being made.

- 1) With the ignition key in the **OFF** position, use a volt meter or test light to check for 12 volts at socket 1 of the VIP module connector (see figure 1). If there is 12 volts present with the ignition key OFF proceed to step 3.
- 2) If you do not have 12 volts at socket 1 with the key off turn the ignition key to the on position and again check for 12 volts at socket 1. If 12 volts is present **only** when the ignition is on no further work is required.

- 3) Locate the wire in socket 1 (wire color may vary). Cut this wire approximately 4 inches back from the connector leaving a "pigtail" coming from socket 1. Use heat shrink material to safely protect any exposed conductor on the harness end of the wire. Tie this wire up and out of the way so that it cannot become shorted.
- 4) Locate the spare ignition wire in the electrical box (see figure 2). This wire will be labeled "SPEAR" with a flag label. This wire will be located in the same breakout as the single diode. The wire be marked as DH904 on the insulation of the wiring.

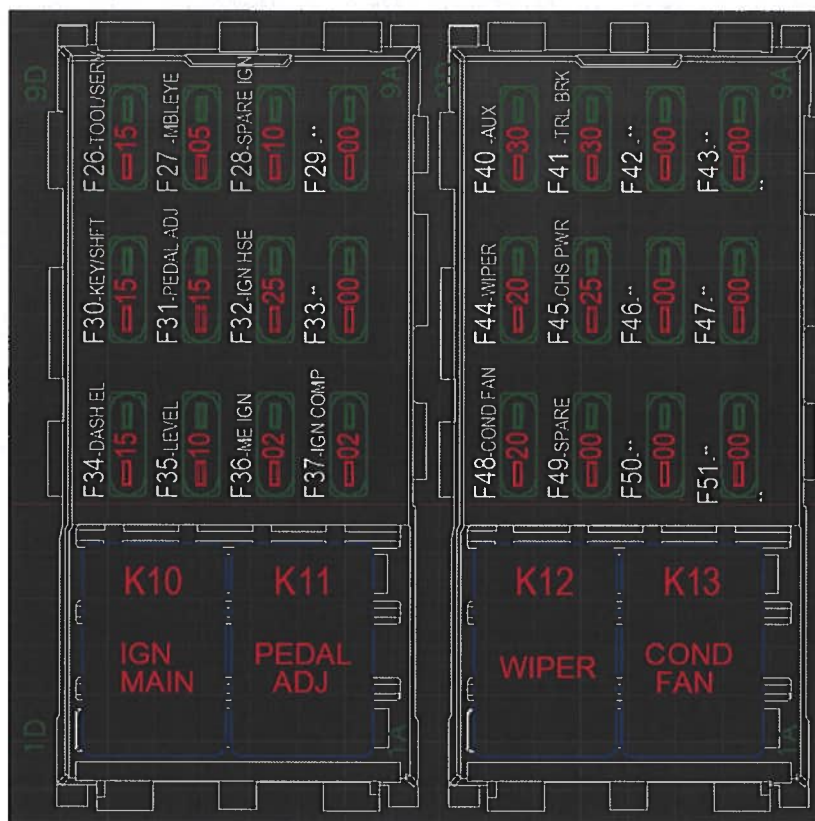
(figure 3)

NOTE: Due to design changes, some 2020 models will not have the wiper fuse located at “F44”. These units do not need any changes to the wiper fuse. If you have a 2020 Model Year coach Step 7 may possibly be disregarded.

- 6) Locate the fuse blocks mounted in the electrical box (see figure 3). Locate fuse F28 pictured below and labeled on the door of the electrical box. This will be a 10-amp fuse. Replace it with a 2-amp fuse.

- 7) Locate the fuse labeled “F44 wiper” (see figure 3). This should be a 30-amp fuse. If the fuse in F44 is a 20-amp fuse remove the 20 amp and replace it with a 30 amp.
