SIB 32 02 20

RECALL 20V-434: REWORK STEERING SPINDLE (STOP DRIVE).

This Service Information Bulletin (Revision 1) replaces SI B32 02 20 **dated July 2020**.

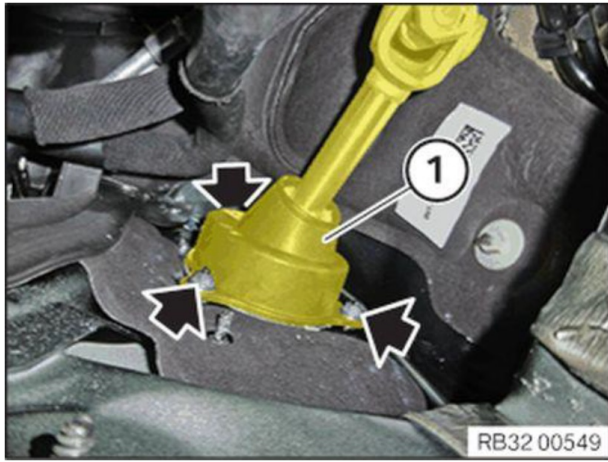
The steering spindle may not have been properly attached to the vehicle structure. Over time, it could become loose and, in an extreme case, could affect vehicle handling and control, increasing the risk of a crash.

During the assembly process, the steering spindle collar may not have been screwed on properly.

2. Using a borescope ([SI B04 08 17](#) or [B04 14 18](#)) identify the 3 nuts securing the steering spindle (1) to the bulkhead.

Note: Photo is shown looking up from underneath the vehicle.

3. Using a 10mm socket on a long extension, check whether the 3 nuts can be turned by hand. Document finding on the attached Feedback Form.

4. Inspect the steering shaft collar position.

Are the collar guides still on the stud bolts of the bulkhead?

No: Replace the steering shaft as per REP 32 21 070

Yes: Tighten the nuts to the specified torque 8 Nm as per the REP 32 21 070 and, if necessary, replace the nuts if found to be damaged. **Do not use a swivel adapter when torquing the nuts.**
