GROUP  
**Safety Recall  
Campaign**

MODEL  
**2019MY  
Forte (BDm)**

NUMBER  
**SC195**

### LEFT FRONT AXLE DRIVESHAFT INSPECTION AND/OR REPLACEMENT (SC195)

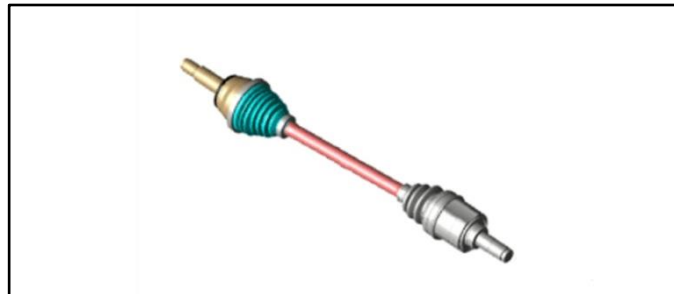
Left Front Axle Driveshaft (BDm)

This bulletin provides information to inspect and, if necessary, replace the left front axle driveshaft assembly on some 2019MY Forte (BDm) vehicles produced from April 26, 2019 through May 22, 2019. The left front axle driveshaft may not have been heat-treated. A driveshaft that has not been heat-treated is more susceptible to breaking. A broken driveshaft can result in a sudden loss of motive power, thus increasing the risk of a crash. Before conducting the procedure, verify that the vehicle is included in the list of affected VINs.

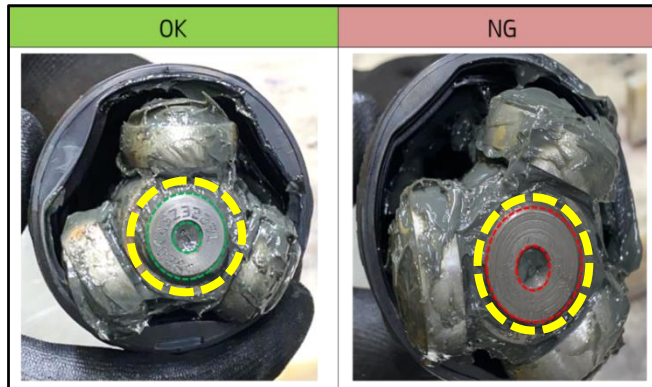
- 3a. Inspect the end of the shaft spline and confirm if the heat treatment stamping is present.
- 3b. If the stamping is present (OK), **take photo**, no further action is required. Proceed to step 4.
- 3c. If the stamping is not present (NG), **take photo**, proceed to the 'Repair Procedure' at the bottom of this page.
