# F/CMVSS Noncompliance Recall

## N202309350 Interior Trunk Release Button Inoperative Ten Minutes After Power Off

**Release Date:** August 2020

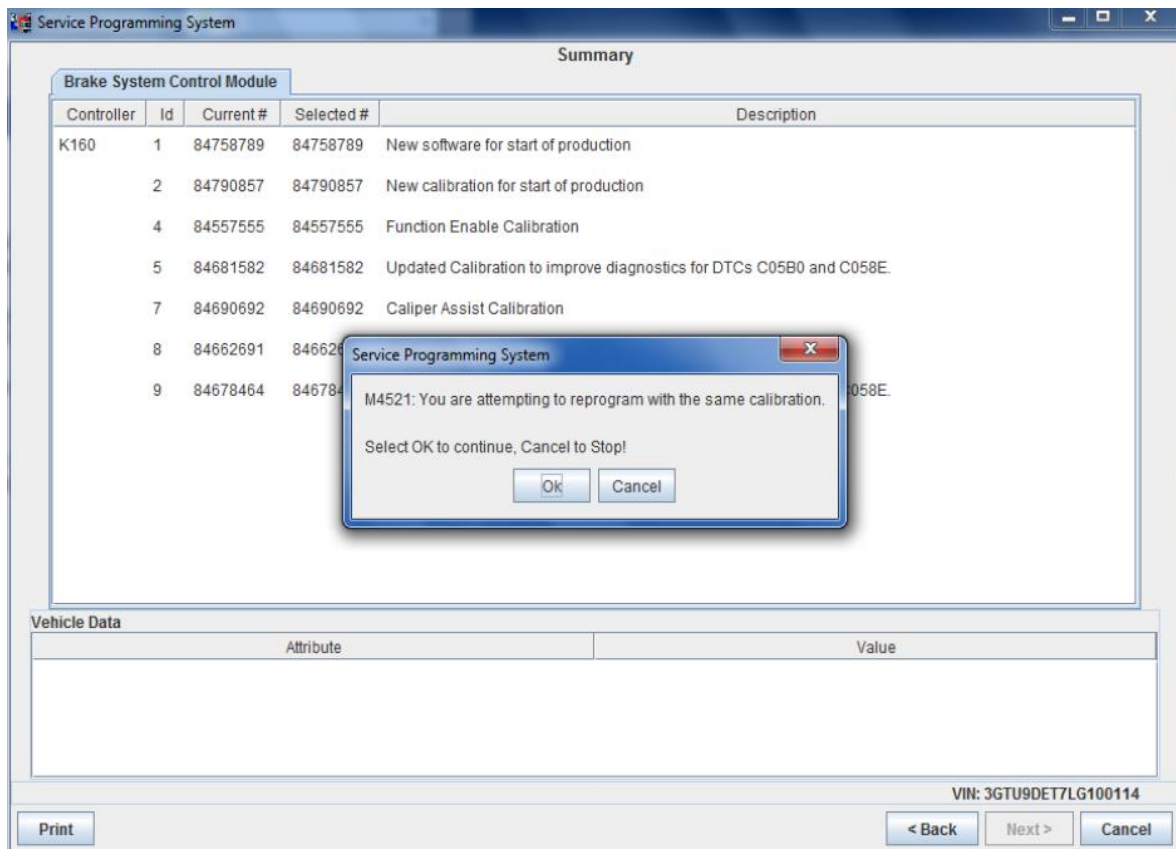
5431207

**Important:** TIS2WEB screen shown. Techline Connect screen is similar and will be included in the near future.

**Important:** If the Same Calibration/Software Warning is noted on the SPS Summary screen, select OK and follow screen instructions. After a successful programming event, the WCC is located in the Service Programming System dialogue box of the SPS Summary screen. No further action is required. Refer to the Warranty section of the bulletin.

1. Reprogram the body control module. Refer to *K9 Body Control Module: Programming and Setup* in SI.

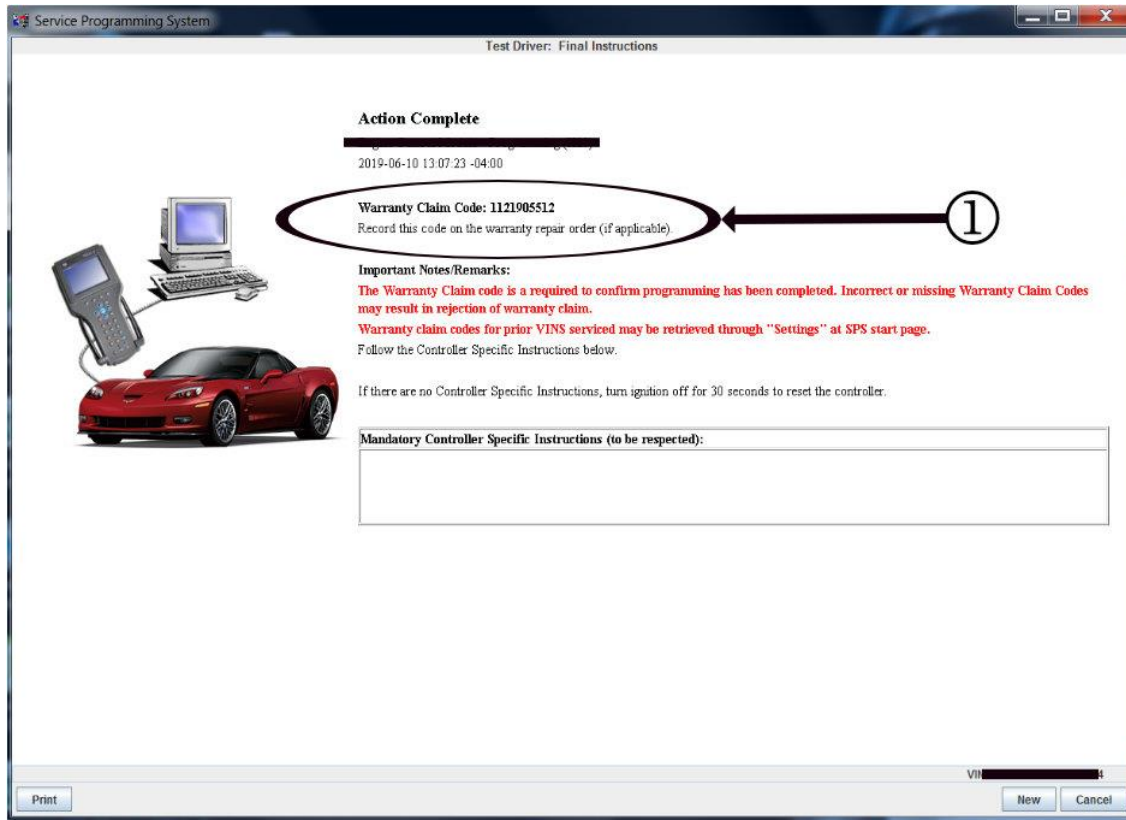
5431209

**Important:** TIS2WEB screen shown. Techline Connect screen is similar and will be included in the near future.

**Important:** To avoid warranty transaction rejections, you **MUST** record the warranty claim code provided on the SPS Warranty Claim Code (WCC) screen on the job card. Refer to callout 1 above for the location of the WCC on the SPS screen.

2. Record SPS Warranty Claim Code on job card for warranty transaction submission.
