October 2020
FL858A-C
NHTSA #20V-466
Transport Canada #2020-365

Subject: Freightliner Business Class M2 Engine Harness Clearance

Models Affected: Specific Model Year 2017-2021 Freightliner Business Class M2 vehicles manufactured February 18, 2016, through July 31, 2020, and equipped with a Detroit Diesel DD5 engine.

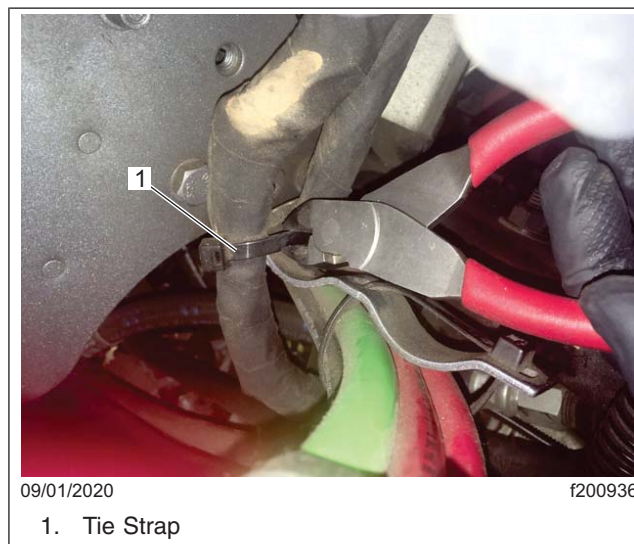
Fig. 1, Harness Tie Strap Removal

7. Cut open the tie straps that secure the DD5 engine harness to access the complete harness for inspection of the key chaffing points. The key chaffing points include air compressor-mounted bracket and discharge line, fuel lines, transmission dip stick tube, and at the cab frontwall-mounted bracket on the innermost edge of the left frontwall. See [Fig. 1](#).

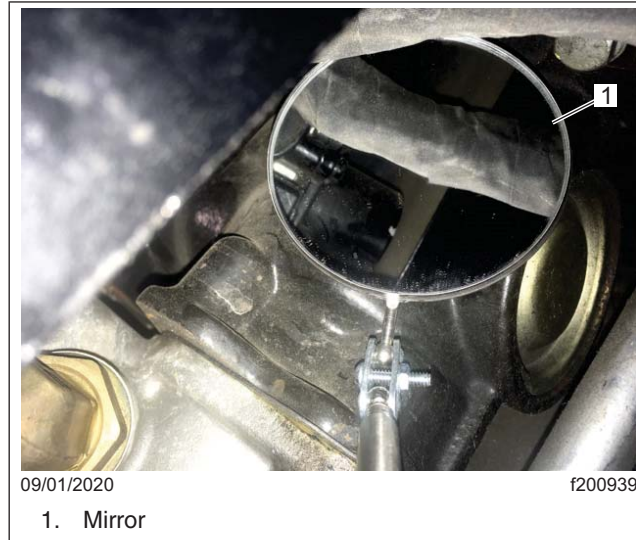
Fig. 2, Inspection by Mirror

8. At the key chaffing points, inspect the engine harness for damage. Pull the harness away from the brackets, using a mirror as needed. See [Fig. 2](#).

NOTE: Wiring harnesses are considered damaged when chaffing has worn through the harness fiber wrap and the wire insulation resulting in exposed strands of copper wire.

9. If damage to the wiring is found, cut and unwrap the harness wrap in the damaged area to determine the extent of damage.
- If five or fewer wires (approximately 30% or less) in the harness are damaged, the harness can be repaired.
 - If more than five wires in the harness are damaged, the harness must be replaced. (Less than 1% of vehicles are expected to need the harness replaced.)

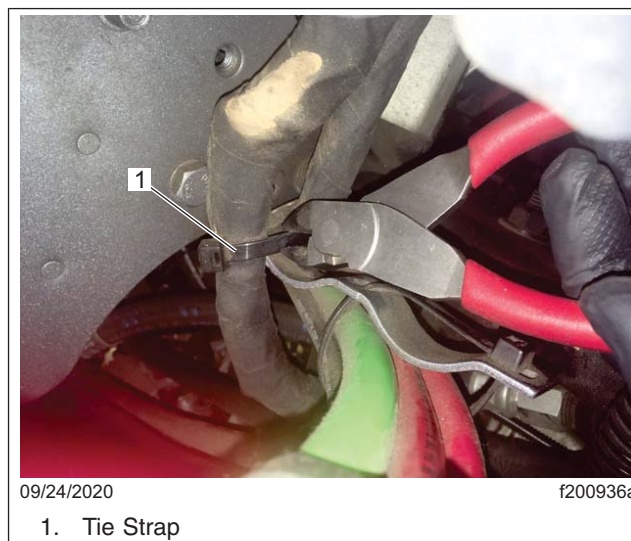
Fig. 15, Harness Tie Strap Removal

7. Cut open the tie straps that secure the DD5 engine harness to access the complete harness for inspection of the key chaffing points. The key chaffing points include air compressor-mounted bracket and discharge line, fuel lines, transmission dip stick tube, and at the cab frontwall-mounted bracket on the innermost edge of the left frontwall. See [Fig. 15](#).

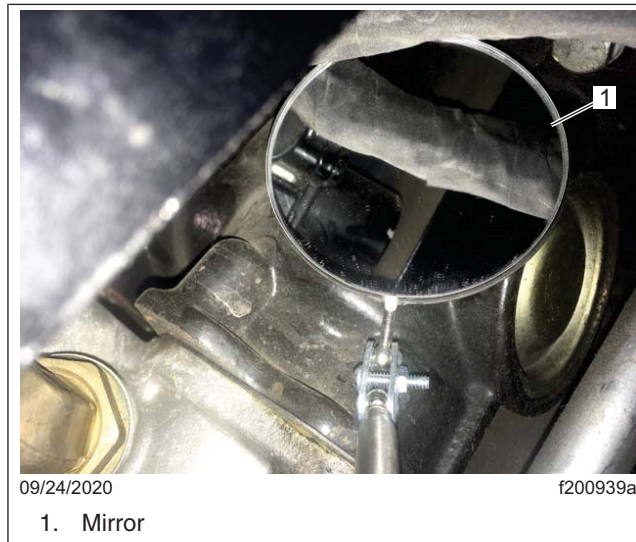
Fig. 16, Inspection by Mirror

- At the key chaffing points, inspect the engine harness for damage. Pull the harness away from the brackets, using a mirror as needed. See [Fig. 16](#).

NOTE: Wiring harnesses are considered damaged when chaffing has worn through the harness fiber wrap and the wire insulation resulting in exposed strands of copper wire.

- If damage to the wiring is found, cut and unwrap the harness wrap in the damaged area to determine the extent of damage.
 - If five or fewer wires (approximately 30% or less) in the harness are damaged, the harness can be repaired.
 - If more than five wires in the harness are damaged, the harness must be replaced. (Less than 1% of vehicles are expected to need the harness replaced.)
