## Safety Recall Action Notice 584 Issue 2 - 10.2020

Subject: VIN Label Protector Fitment			
Bulletin Number	Models Affected	VIN Range	Markets Affected
584	Street Scrambler	From VIN 914448 to VIN AC6893	All Markets Except China
584	Street Twin	From VIN 914973 to VIN AC6893	All Markets Except China

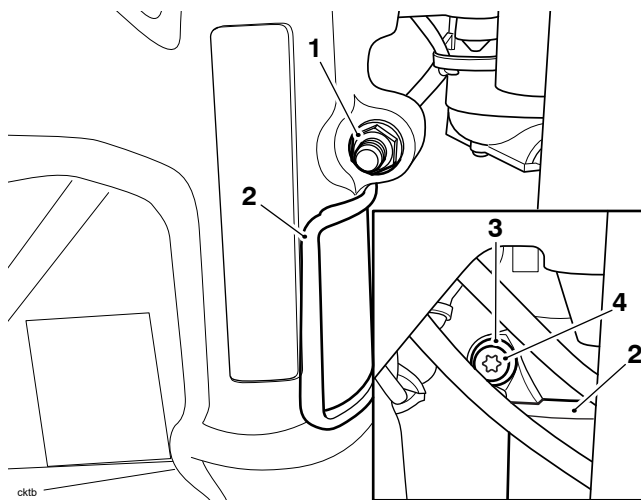
1. Lock nut
2. VIN label protector
3. Flanged sleeve
4. Screw

3. Align the new VIN label protector to the frame as shown. Fit the flanged sleeve, screw and new lock nut to the VIN label protector and tighten the screw to **3 Nm** whilst holding the lock nut.

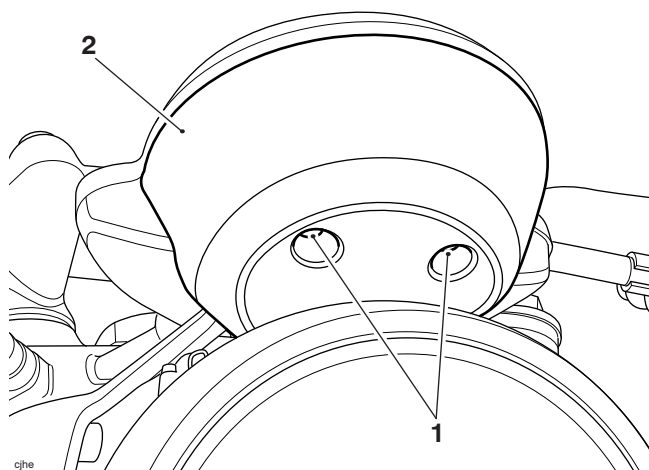
**1. Fixings**

**2. Instruments cover**

- 
5. Remove the instruments cover and discard the two fixings.

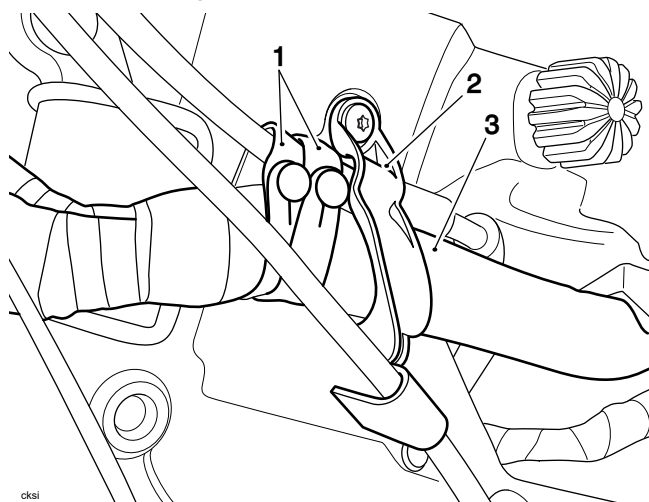
**1. Rubber bands**

**2. Harness guide**

**3. Harness**

6. Disconnect the instruments electrical connector.
7. Remove the two fixings securing the harness guide to the frame. Discard the fixings.
8. Remove the two rubber bands securing the harness to the brake hose.

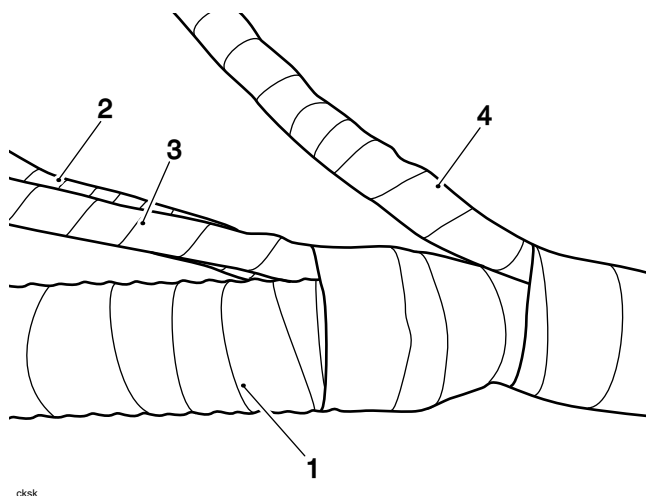
cksk

1. Ignition branch (switch housing branch behind, not shown)
2. Headlight branch
3. DRL branch
4. Instruments branch

12. Check the orientation of the harness. The switch housing branch should sit behind the ignition branch and the headlight and DRL branches should be situated above. The DRL branch should be inboard of the headlight branch. The instrument branch should be situated above as shown in the illustration below.

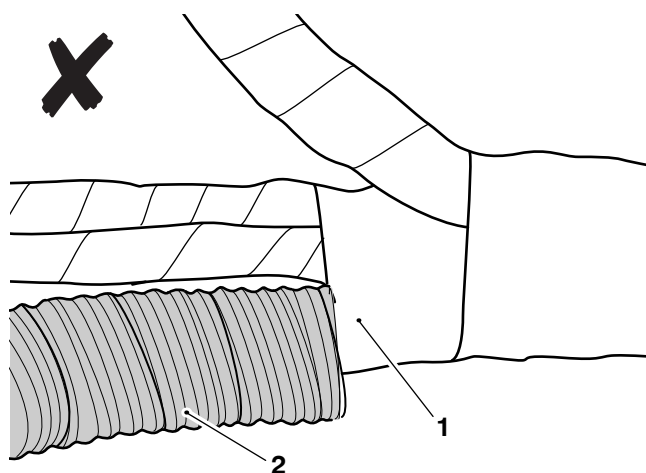
cksd\_1

Graphic showing incorrect taping of ignition branch conduit

1. Fabric tape
2. Ignition branch conduit

14. If the ignition branch conduit taping is incorrect, apply tape to all four branches forward of the instruments branch. The tape should be overlapped by at least 10 mm working forward until the ignition branch conduit is overtaped by 10-15 mm as in the illustration above.
15. If the ignition branch conduit taping is correct or has been corrected, continue from the next step.
16. Lift the headlight and DRL branches upwards and apply tape across the ignition and switch housing branches. The tape should wrap round at least twice, be one tape width wide, with the tape squarely aligned with itself.

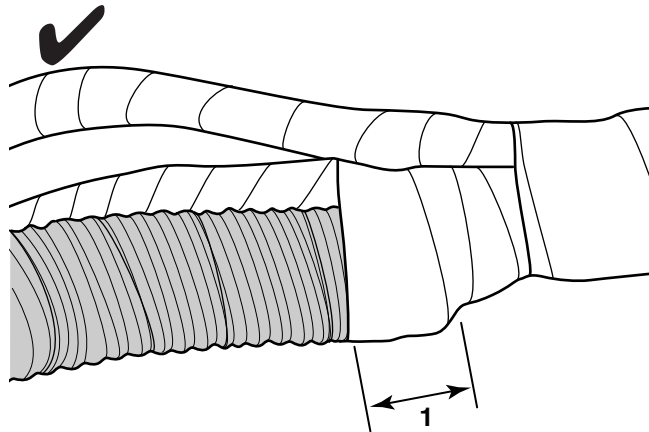
ckse\_1

Graphic showing correct taping of ignition branch conduit

**1. 10 - 15 mm fabric tape overlap**

13. Check the ignition branch conduit has been correctly taped. The tape covering the four branches (Ignition branch, Switch Housing branch, Headlight branch and DRL branch) should overlap the ignition branch conduit by 10 - 15 mm.

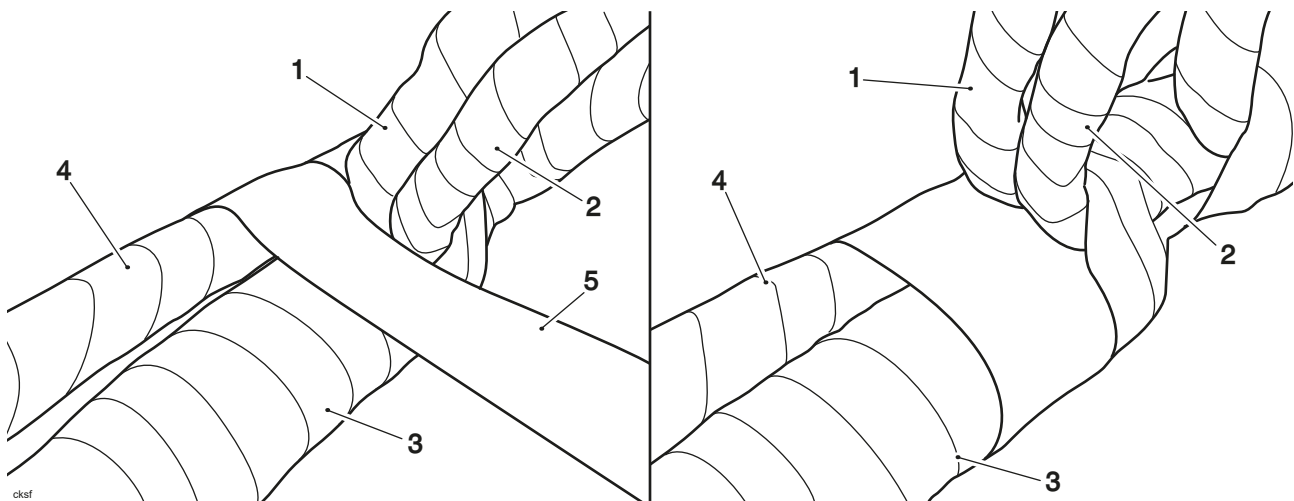
cksf

- 1. Headlight branch**
- 2. DRL branch**
- 3. Ignition branch**
- 4. Switch housing branch**
- 5. Fabric tape**

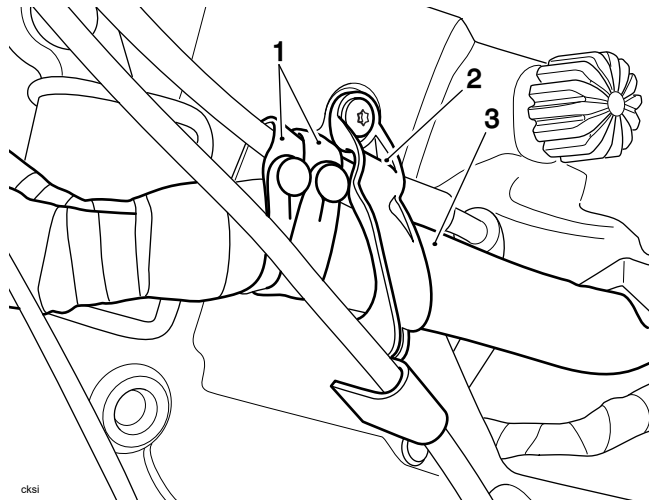
- 1. Rubber bands
- 2. Harness guide
- 3. Harness

17. Feed the harness behind the clutch cable then in between the left hand fork leg and headstock.
18. Reconnect the harness instruments connector.
19. Refit the instrument cover with two new fixings and tighten to **3 Nm**.
20. Refit the headlight and headlight bowl as described in the Service Manual.
21. Refit the harness guide with two new fixings and tighten to **1.5 Nm**.

22. Refit the two rubber bands securing the harness to the brake hose.
