## Safety Recall Action Notice 584 Issue 1 - 08.2020

Subject: VIN Label Protector Fitment			
Bulletin Number	Models Affected	VIN Range	Markets Affected
584	Street Scrambler	From VIN 914448 to VIN AC6893	All Markets Except China
584	Street Twin	From VIN 914973 to VIN AC6893	All Markets Except China

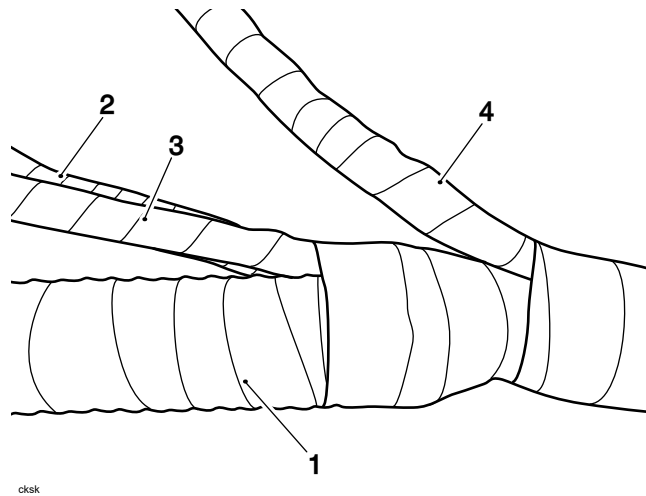
12. Check the orientation of the harness. The switch housing branch should sit behind the ignition branch and the headlight and DRL branches should be situated above. The DRL branch should be inboard of the headlight branch. The instrument branch should be situated above as shown in the illustration below.

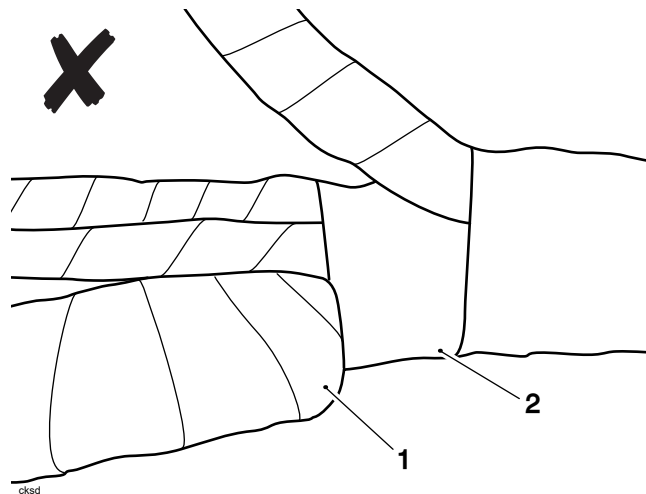
Graphic showing incorrect taping of ignition branch conduit

14. If the ignition branch conduit taping is incorrect, apply tape to all four branches forward of the instruments branch. The tape should be overlapped by at least 10 mm working forward until the ignition branch conduit is overtaped by 10-15 mm as in the illustration above.
15. If the ignition branch conduit taping is correct or has been corrected, continue from the next step.
16. Lift the headlight and DRL branches upwards and apply tape across the ignition and switch housing branches. The tape should wrap round at least twice, be one tape width wide, with the tape squarely aligned with itself.

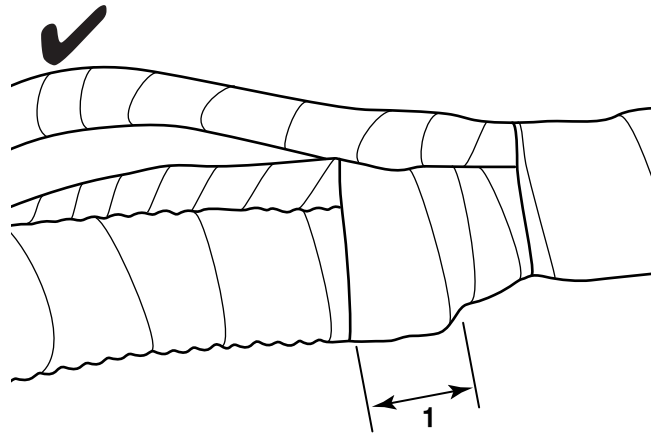
13. Check the ignition branch conduit has been correctly taped. The tape covering the four branches (Ignition branch, Switch Housing branch, Headlight branch and DRL branch) should overlap the ignition branch conduit by 10 - 15 mm.

Graphic showing correct taping of ignition branch conduit
