TO: Mercedes-Benz Dealer Principals, General Managers, Sales Managers, Service Managers, Parts Managers	FROM: Gregory Gunther, Department Manager, Vehicle Compliance and Analysis, Engineering Services
RE: <b>Recall Campaign Launch Notification</b> <b>Check Rear Spoiler</b> <b>MY20 247 (GLB-Class)</b>	DATE: October 16, 2020

Campaign No. 2020090006, October 2020

SUBJECT: **Model GLB-Class vehicles (247 platform)**  
**Model Year 2020**  
**Check Rear Spoiler**

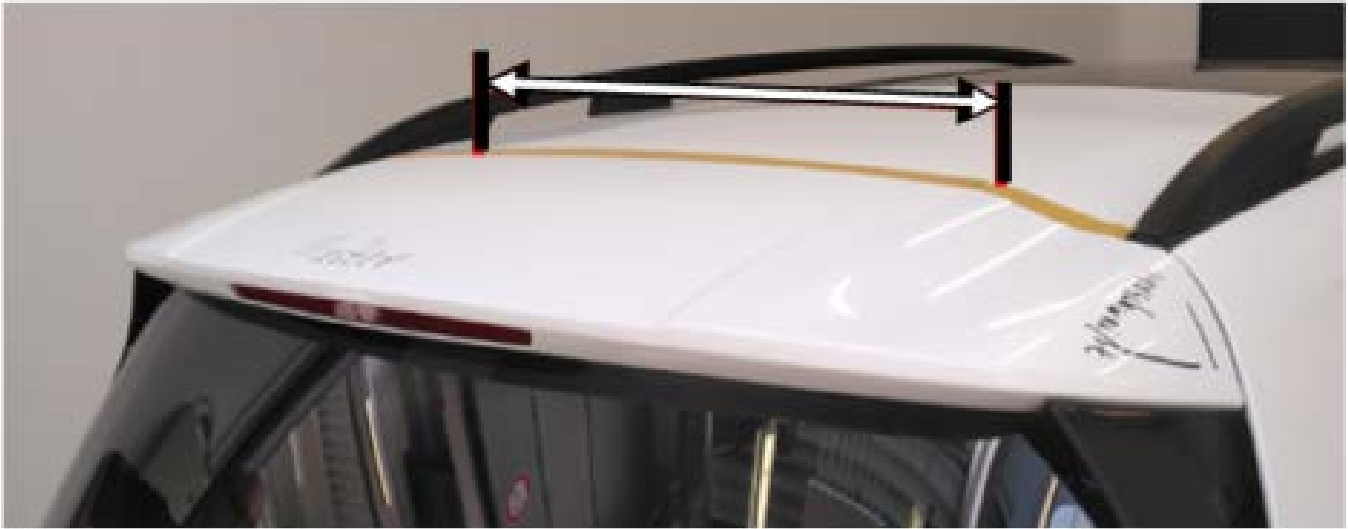
**Figure 1**

1. Open tailgate and apply masking tape to roof edge between left and right roof railings. **(Figure 1)**

**i** The masking tape is applied to protect the paintwork.

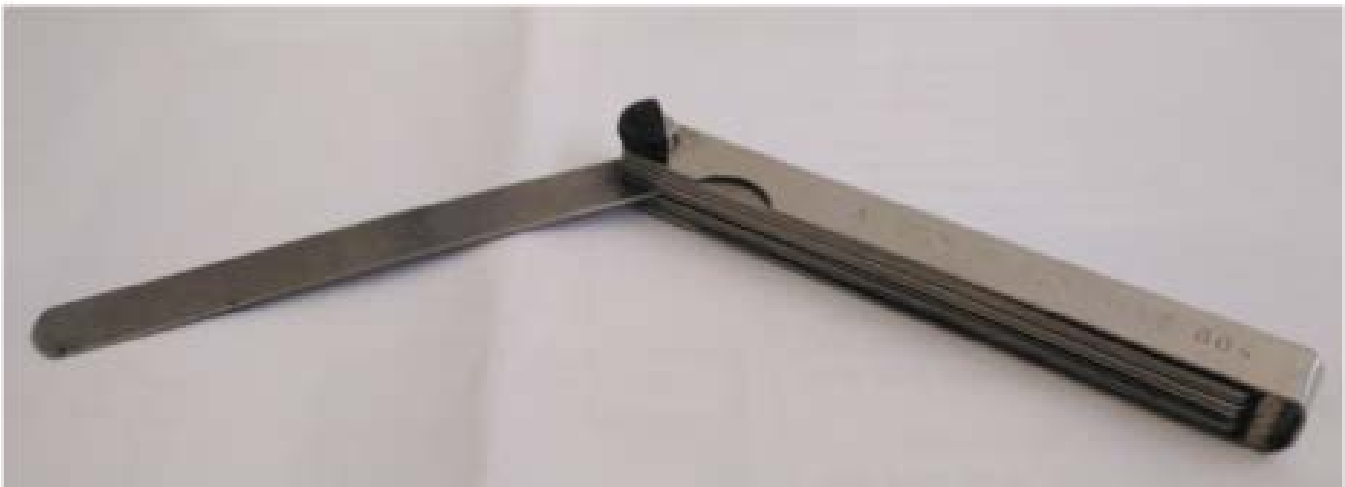
**Figure 2**

2. Lay out gauge with **0.5 mm**.

**i** E.g. feeler gauge **(Figure 2)**

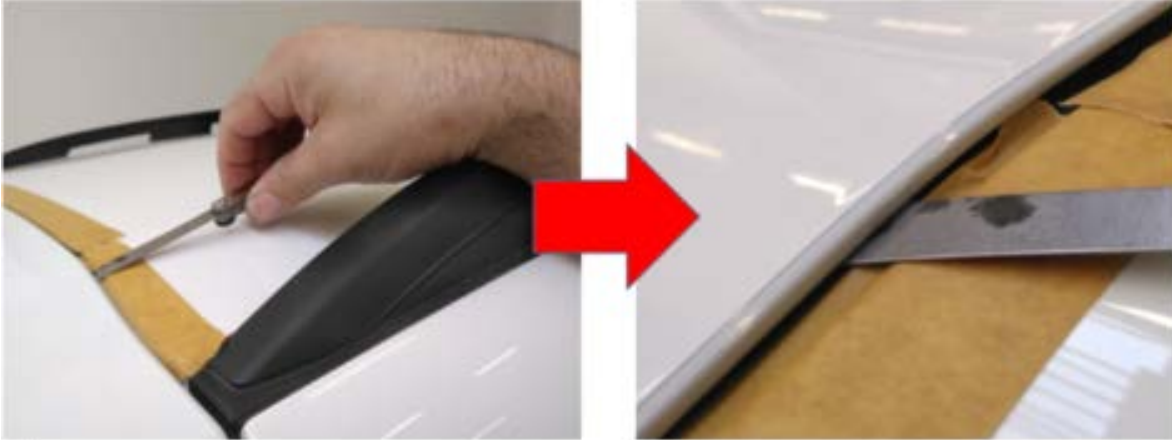
Figure 3 (OK)

3. Carefully attempt to slide the gauge between the outer shell and the spoiler lip.

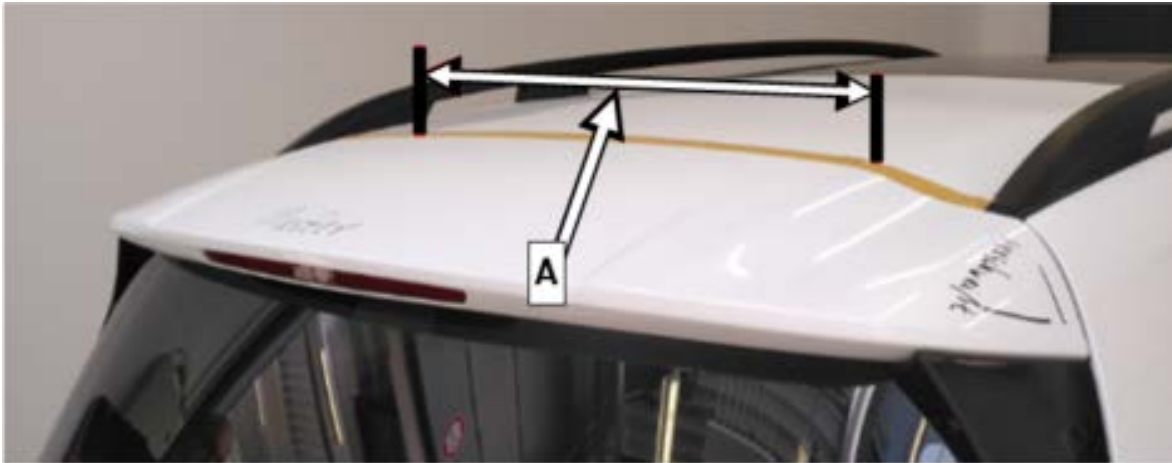
Figure 4

**i** The test must be performed along the length shown (A, Figure 4), starting from the roof center and extending approx. 100 mm to the left and right roof railings.

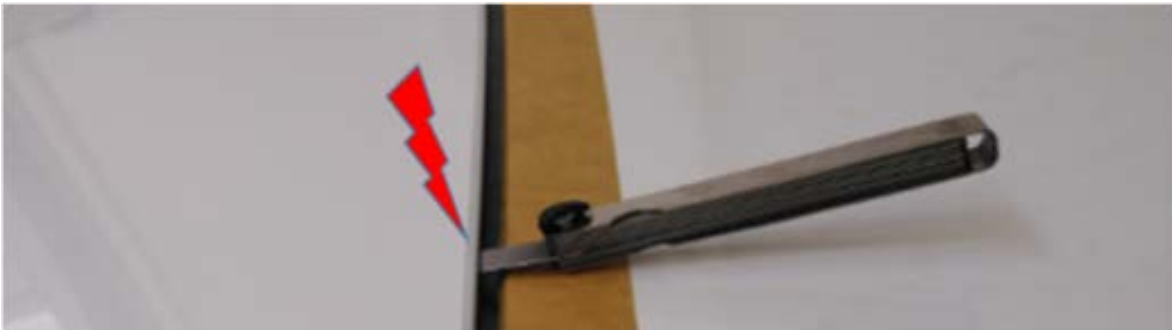
Figure 5 (not OK)

**i** It **must not be possible** to slide the gauge between the spoiler lip and the outer shell of the center rear spoiler. (Figure 5, not OK)

1. Replace center rear spoiler (**AR72.20-P-4000MFD**).

**i** Also replace mounting screws, retaining clips, and adhesive strips.

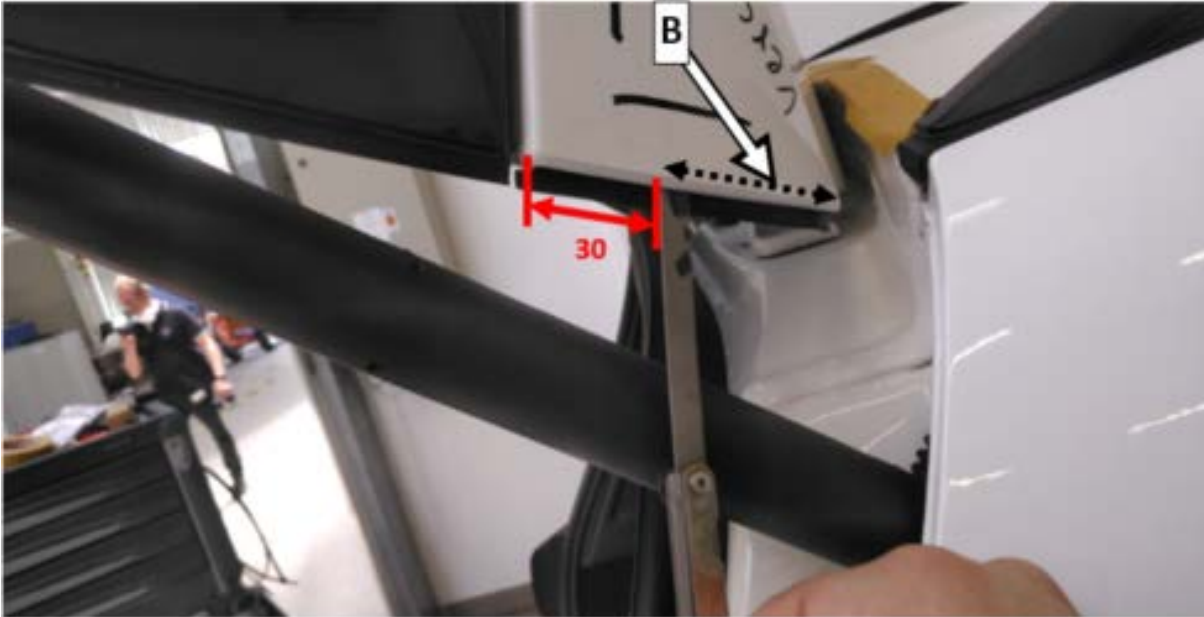
Figure 6

4. Open tailgate and carefully check at a distance of **30 mm** to the left and right of the edge in the test area **(B, Figure 6)** whether the gauge can be slid between the outer skin and the spoiler lip.

**i** It **must not be possible** to slide the gauge between the spoiler lip and the outer shell of the center rear spoiler.

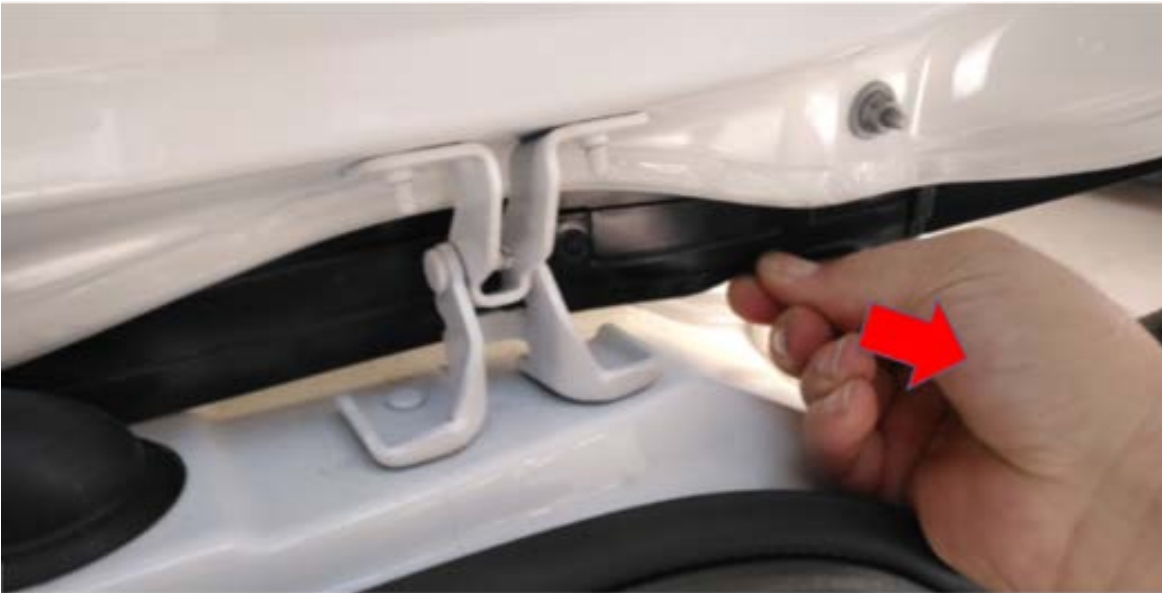
Figure 7

5. Carefully pull on the spoiler lip in the area of the hinges on the left and right of the tailgate.

**i** The spoiler lip **must not** detach from the outer shell of the center rear spoiler.

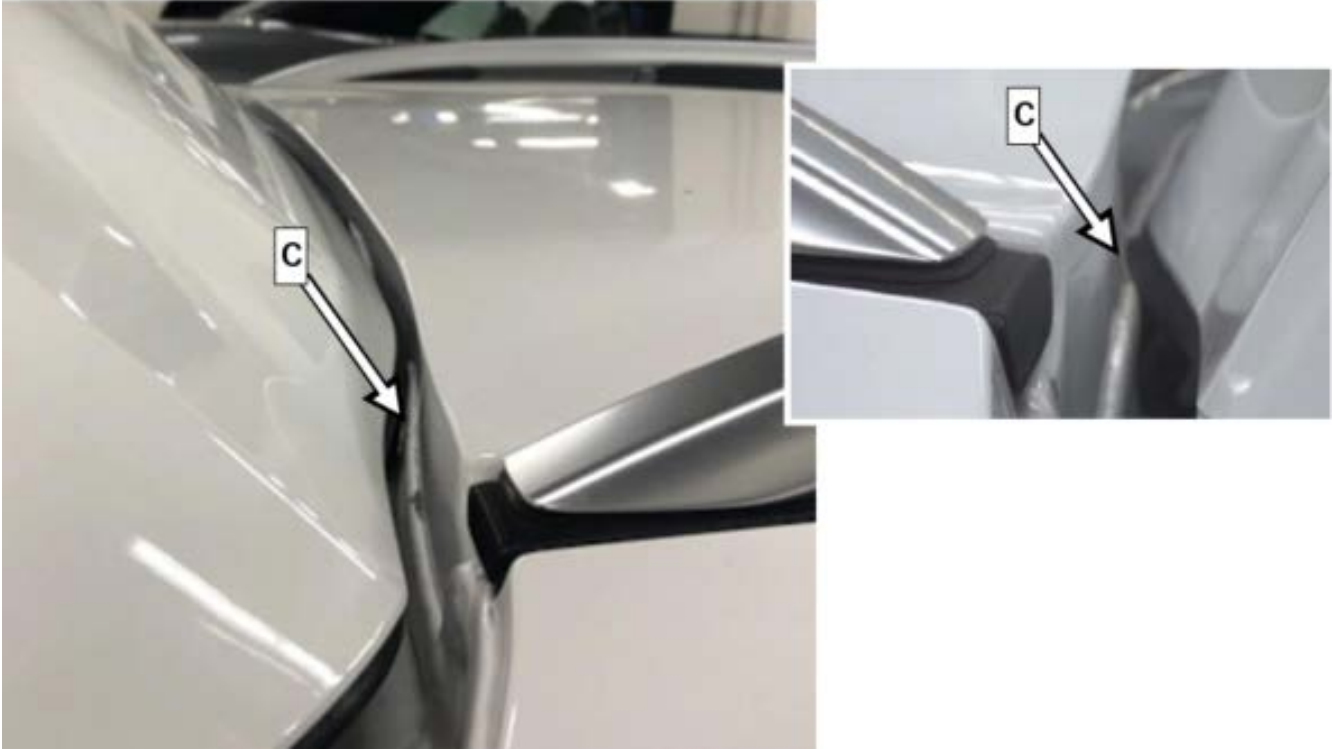
Figure 8

6. Open and close tailgate and check whether the spoiler lip brushes against the seam seal in the area of the roof edge (C, Figure 8).

**i** Minimal brushing without the spoiler lip snapping is acceptable.

**i** The test must be performed along the entire length of the seam seal.

**i** Should the spoiler lip have been damaged by the collision the complete center rear spoiler must be replaced.

2. Check again whether the spoiler lip brushes against the seam seal in the area of the roof edge (**C, Figure 8**).

**i** Should the spoiler lip still brush heavily against the seam seal, the seam seal must be removed or replaced in the collision area. (To do this, the tailgate must be removed)

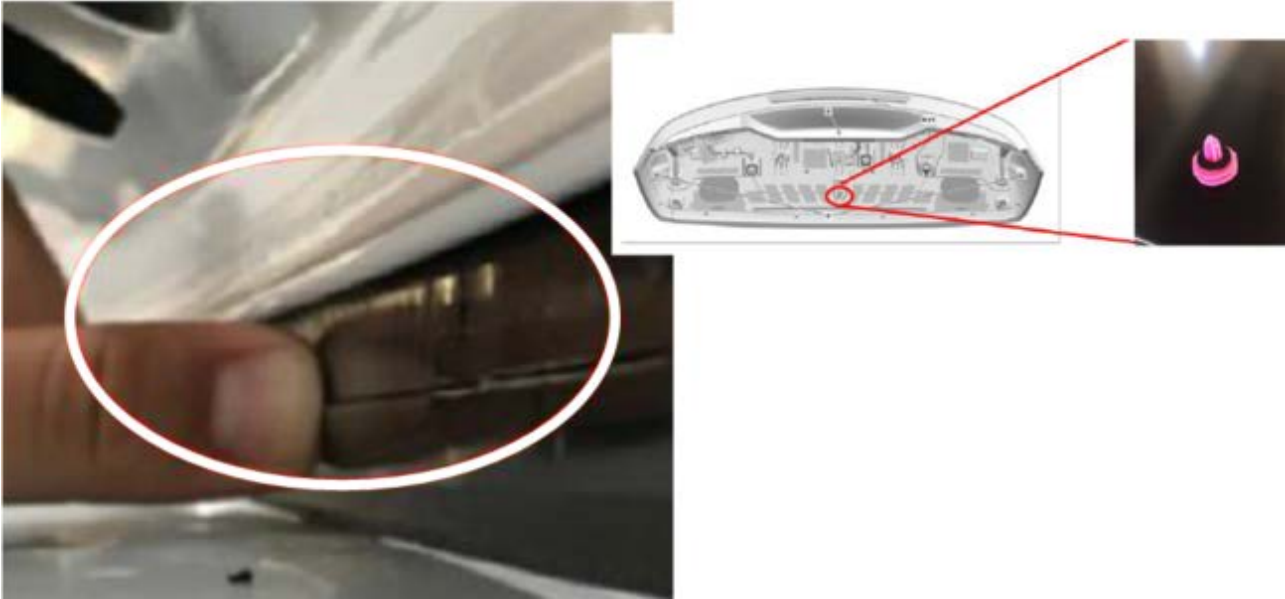
Figure 9

7. Check whether the retaining clip in the center of the center rear spoiler is engaged.

**i** To do so, fully open the tailgate and then lower it by **approx. 25 cm**. The test is meaningful only in this position.

**i** While the tailgate is open, press against the center rear spoiler from the inside with your thumbs (force applied: approx. 10 lbs.).

**i** If the center rear spoiler can easily be pressed against the roof edge the center retaining clip is not engaged and possibly damaged.

1. Remove center rear spoiler and replace all retaining clips, screws, and adhesive strips.

**i** For basic data, see **AR72.20-P-4000MFD**.

**i** Check whether the retaining clips of the center rear spoiler are engaged correctly after the repair.
