Thor Motor Coach Recall Repair Instructions

Recall #	20V-498 2020-389		
Description/Title:	Firefly G9		
Affected Product Line(s):	Certain model year 2019-2021 Hurricane & Windsport motorhomes		
Service Campaign # :	RC000203	Released Date:	10/12/2020
Repair Code:	Model years 2019 & 2019.5 TMCRC80494V Model years 2020 & 2021 TMCRC80495V	Document Date:	10/12/2020
Time Allowed:	Model years 2019 & 2019.5 0.5 Model years 2020 & 2021 0.3	Document Revision:	A

G9 Protection Module – Installation Instructions

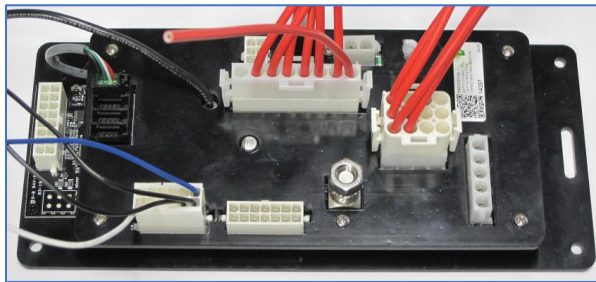
G9 Electronic Control Module (ECM)

The motorhomes included in this recall population were manufactured with a Firefly Integrations electronic control center that contains a defective G9 control circuit board. When the G9 control board is subject to a voltage load greater than 17 volts, components on the board may become damaged. The damaged components allow continuous conduction, which can result in thermal flammability.

The following service technician instructions are for the installation of the **G9 Protection Module** to comply with the National Highway Transportation Safety Association (NHTSA) product safety recall. The G9 Protection Module will provide overvoltage protection for the G9 Electronic Control Module (ECM).
