Compliance Recall - USA

Code: 94N7

Subject	Driver Headlight Aim																		
Release Date	September 03, 2020																		
Affected Vehicles

Subject: Compliance Recall 94N7 - Driver Headlight Aim

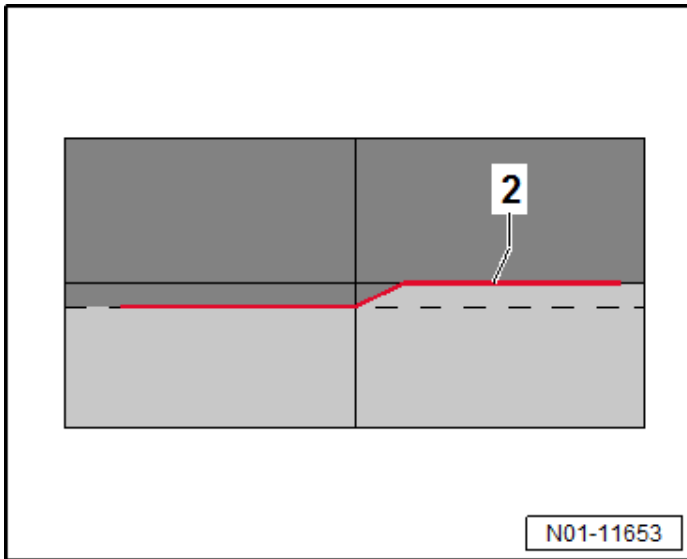
- Check if the right level cut-off line contacts the dividing line <2> on the headlamp adjusting unit test surface.

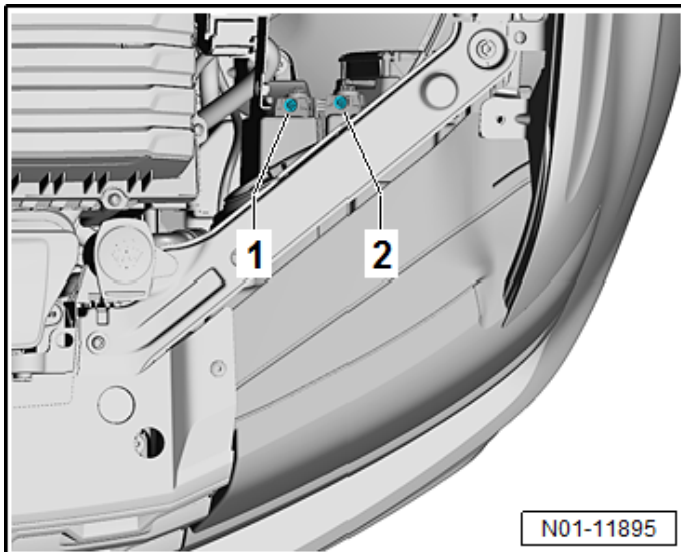
LED Headlamp, Adjusting, Version 1

- 1 - Lateral adjustment
- 2 - Height adjustment

- Turn the adjusting screw for height adjustment <2> until the correct setting is achieved.

The lateral adjustment should be sealed. DO NOT attempt to make a lateral adjustment.

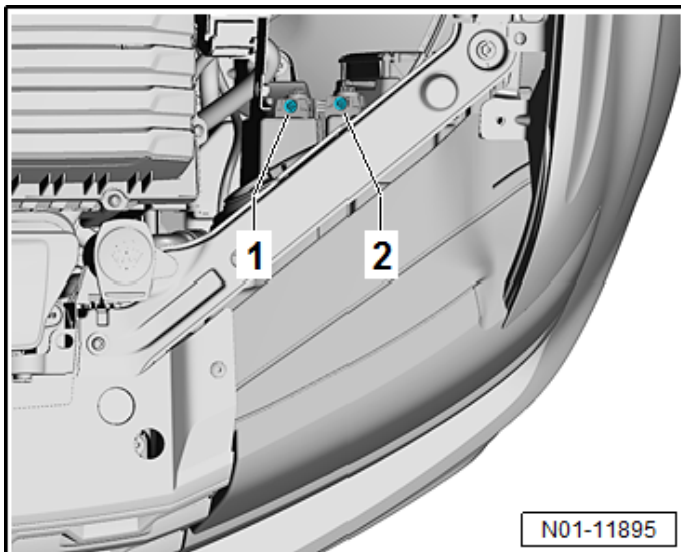
LED Headlamp, Adjusting, Version 2

- 1 - Height adjustment
- 2 - Lateral adjustment

- Turn the height adjustment adjusting screw <1> until the correct setting is achieved.

The lateral adjustment should be sealed. DO NOT attempt to make a lateral adjustment.
