# Safety Recall

## Code: 72L1

Audi

<b>Subject</b>	Front Seat Backrest Frame Welds																												
<b>Release Date</b>	September 23, 2020																												
<b>REVISION SUMMARY</b>	<p>Revised inspection procedure to clarify how to inspect the backrest frames.</p> <p>The expected failure rate is less than 1% for this Safety Recall.</p> <ul style="list-style-type: none"> <li>Some unexpected parts ordering activity was noticed early on with this action.</li> <li>With guidance and feedback from the field, it was determined that further clarification of the inspection procedure would be useful to help avoid parts ordering in cases where replacement parts are not needed.</li> <li>Please note: ordering parts for stock will create back orders, unnecessary returns, obsolescence and scrapping. DO NOT order parts unless they are absolutely needed for a repair.</li> </ul>																												
<b>Affected Vehicles</b>

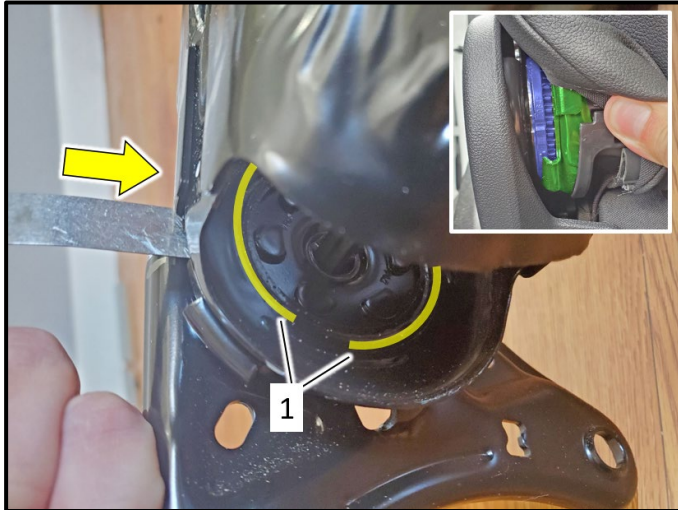
- The inboard and outboard recline mechanisms must be inspected on both front seats.
- The inspection must be done with the seats fully reclined and with the seats in the fully upright position.
- When using the 0.5 mm feeler gauge in the following steps, you are not checking the width of the gap; the feeler gauge will act as a probe.
- When inserting the feeler gauge, push the gauge in between the components in the direction of <arrow>. You are checking to see if the gauge passes by the laser welds <1>.

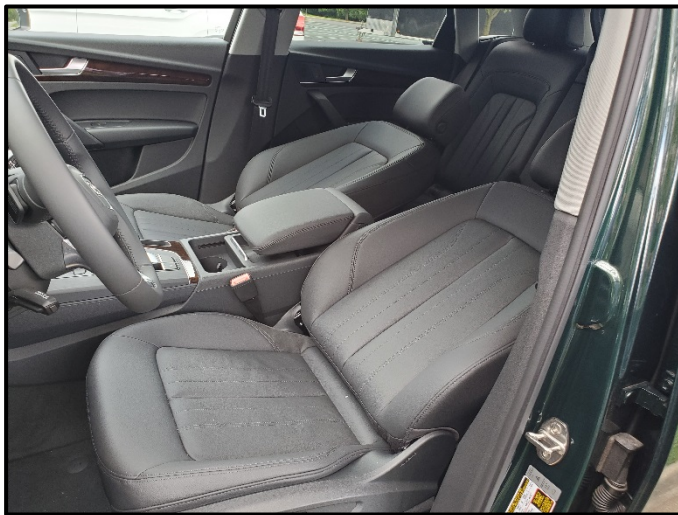
Backrest shown in the full upright position. The process for both sides on both front seats, in the upright and reclined position is similar. The welds for the power backrest are not exposed.

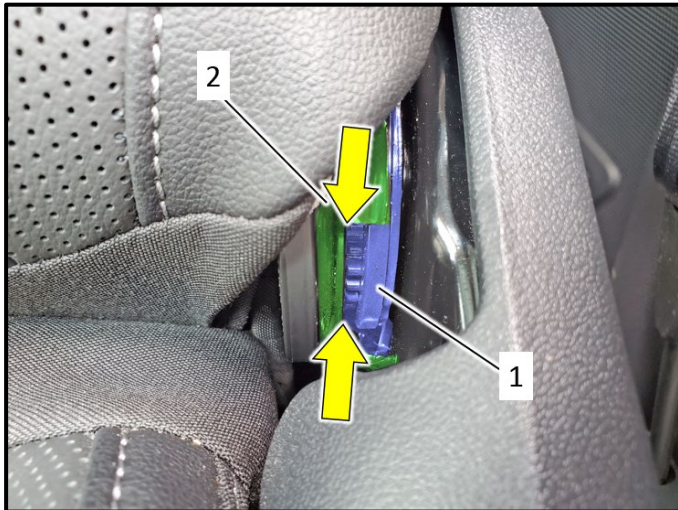
Outboard Recline Mechanism (closest to the door):

- Pull back the seat covering to expose the recline mechanism.
- Inspect the gap between recline mechanism <1> and mounting bracket <2> in the area shown <between arrows> using the 0.5 mm gauge.
- You will be checking for the presence of a complete weld between recline mechanism <1> and backrest frame <2>.
- If the 0.5 mm gauge can be fully inserted between the components:
  - The seat frame must be replaced.

There may be a chamfer on the power recline mechanism gear. The feeler gauge may pass through the chamfer by 2-3 millimeters. This is normal. You are checking to see if the feeler gauge passes through the laser weld that would be in place.

IF THE BACKREST FRAME IS BEING REPLACED, THE VEHICLE MUST NOT BE RETURNED TO THE CUSTOMER UNTIL THE REPLACEMENT HAS BEEN COMPLETED.

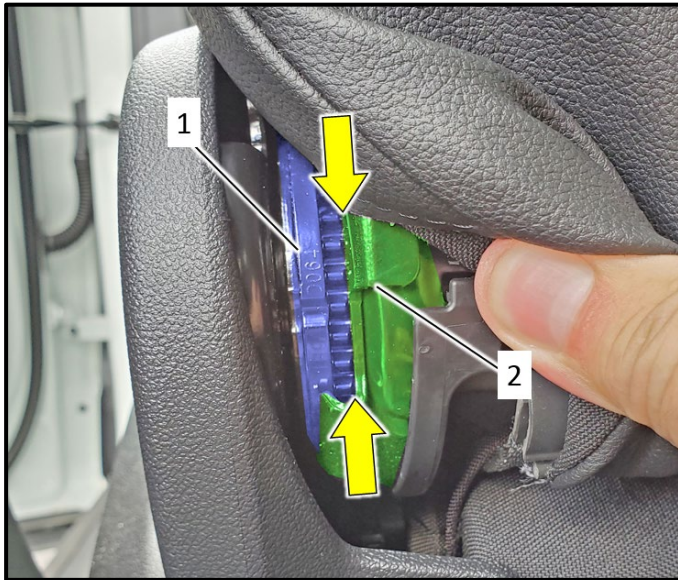
Outboard Recline Mechanism (closest to the door):

- Pull back the seat covering to expose the recline mechanism on the back of the seat.
- Inspect the gap between recline mechanism <1> and backrest frame <2> in the area shown <between arrows> using the 0.5 mm gauge.
- You will be checking for the presence of a complete weld between recline mechanism <1> and backrest frame <2>.
- If the 0.5 mm gauge can be inserted between the components:
  - The seat frame must be replaced.

There may be a chamfer on the power recline mechanism gear. The feeler gauge may pass through the chamfer by 2-3 millimeters. This is normal. You are checking to see if the feeler gauge passes through the laser weld that would be in place.

IF THE BACKREST FRAME IS BEING REPLACED, THE VEHICLE MUST NOT BE RETURNED TO THE CUSTOMER UNTIL THE REPLACEMENT HAS BEEN COMPLETED.
