TECHNICAL INSTRUCTIONS

SAFETY RECALL 20TA13

HEADLAMP ADJUSTMENT PLUGS INSTALLED IN INCORRECT LOCATIONS

CERTAIN 2020 SUPRA

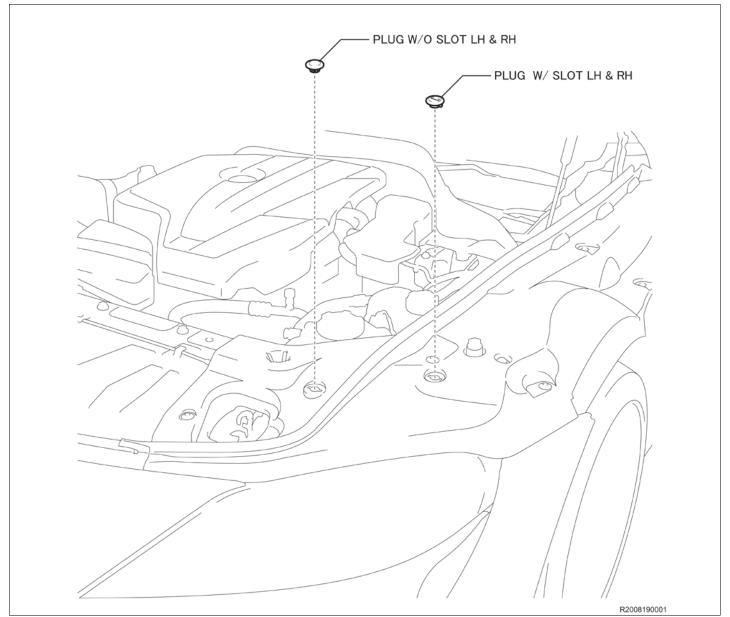
V. COMPONENTS

The plug which covers the headlamp's horizontal adjustment mechanism may have been inserted into the space for the vertical plug, and vice-versa. This can enable horizontal adjustment of the headlamp beam and may not meet a Federal requirement.

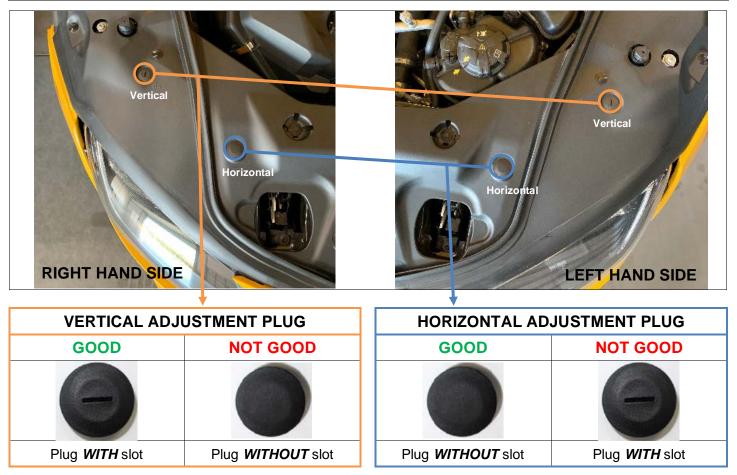
VI. CONFIRM CURRENT POSITION OF PLUGS

a. The vertical adjustment plugs should have a slot. The horizontal adjustment plugs should not have a slot.

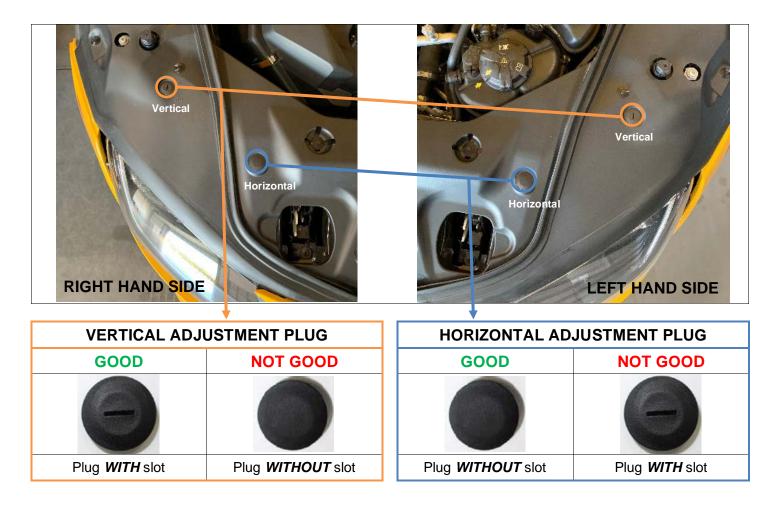
VIII. CONFIRM REPAIR

b. The vertical adjustment plugs should have a slot. The horizontal adjustment plugs should not have a slot.

- Confirm that all four plugs are fully seated
- Confirm there is no damage on the plugs and any of the parts surrounding them
