SIB 63 05 20

RECALL 20V-XXX: HEADLAMP ADJUSTMENT PLUGS

E-Series	Model Description	Production Date
G29	Z4 Roadster	February 7, 2018 – June 5, 2019

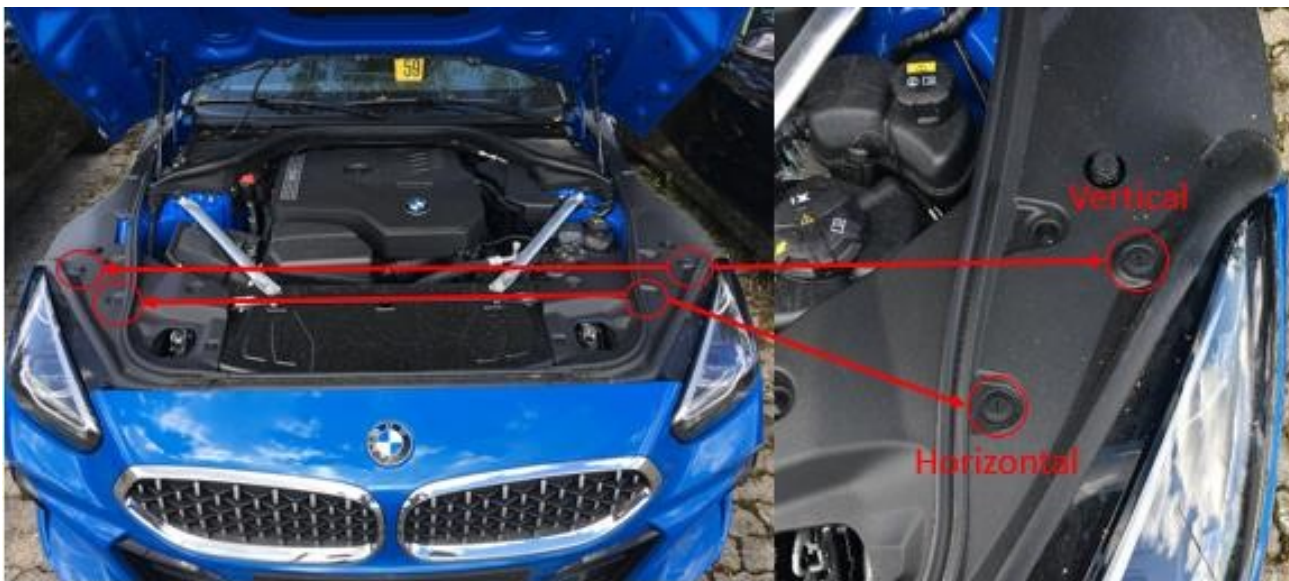
1. Refer to the photo below to familiarize yourself with which adjuster is horizontal, and which is vertical:

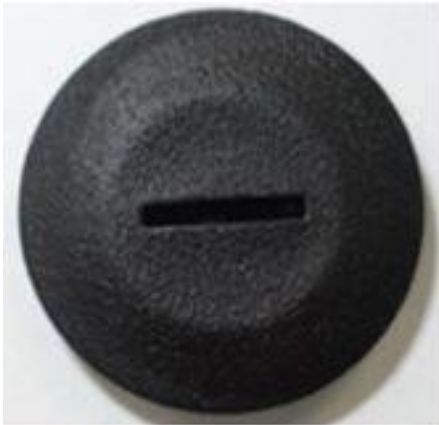
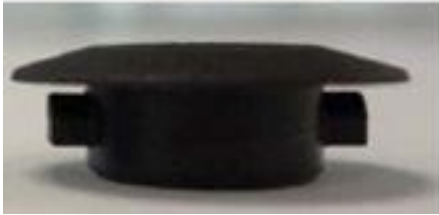
2. Inspect the vertical adjustment plugs first. Do both plugs have a slot as shown below?

Yes: Continue to step 3.

No: Install plugs with slot and continue to step 3.

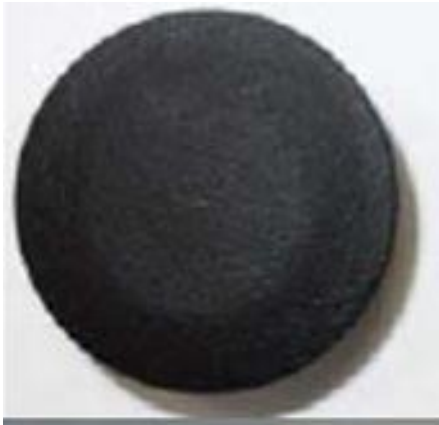
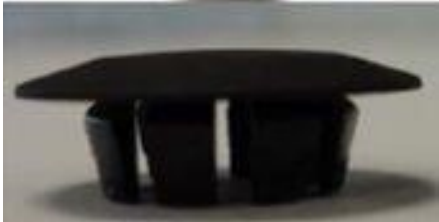
3. Inspect the horizontal adjustment plugs.
Are both plugs smooth without a slot as shown below?

**Yes: No further correction is needed.
No: Install smooth plugs without a slot.**
