GROUP  
**Safety Recall Campaign**

MODEL  
**2018-2021MY  
Stinger (CK)**

NUMBER  
**SC196 (Rev 2, 05/13/2021)**

**NEW MULTI-FUSE AND JUNCTION BOX COVER  
INSTALLATION (SC196/SC196A)**

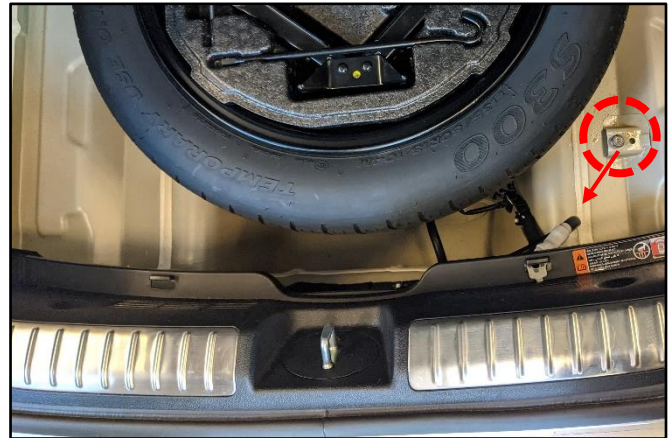
1. Open the tail gate and remove the rear luggage cover mat and then the center tray to expose the main battery.
2. Disconnect the negative (-) battery cable and place aside ensuring that it does not contacting any metal surface.

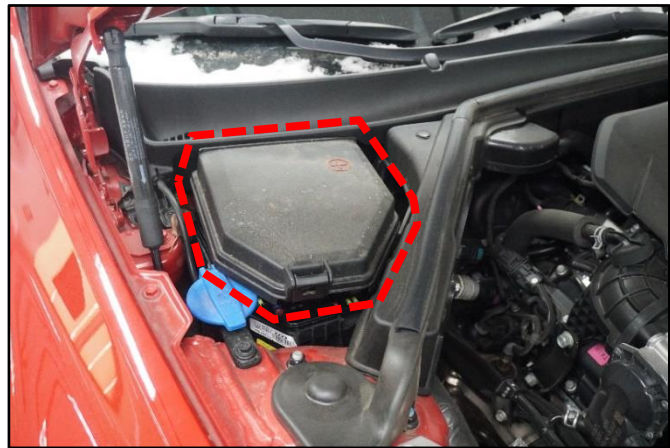
3. Remove the junction box cover.

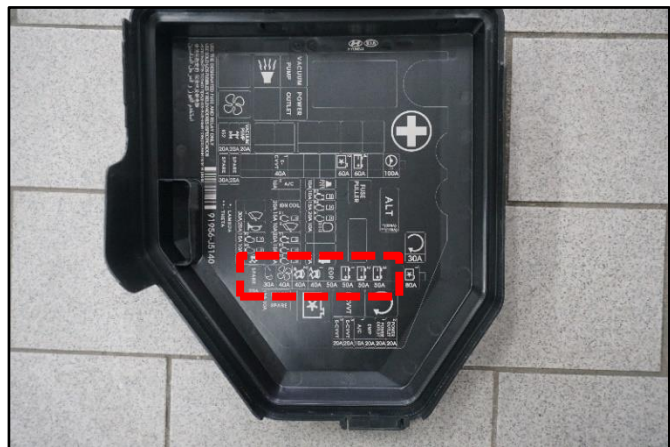
4. Identify the multi-fuse location.

Note: Discard the removed junction-box cover so it is no longer usable.

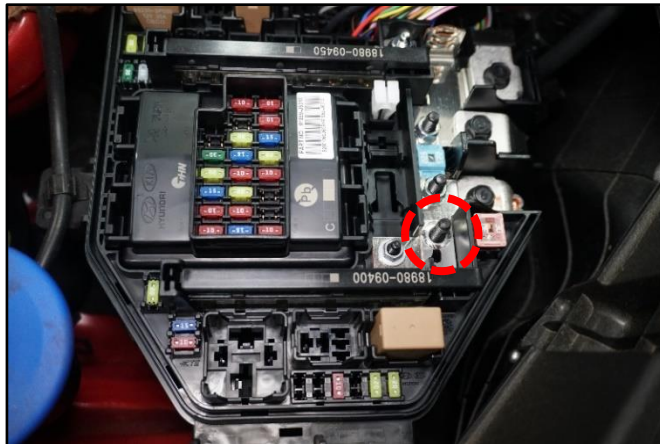
5. On the junction box, loosen the multi-fuse retaining nut.

**Torque Specifications for nut:**  
16.6 - 19.5 lb.ft (22.5 - 26.5 N.m,  
1.0 - 1.2 kgf.m)

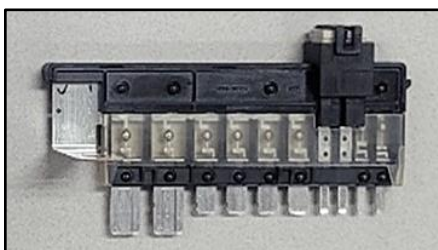
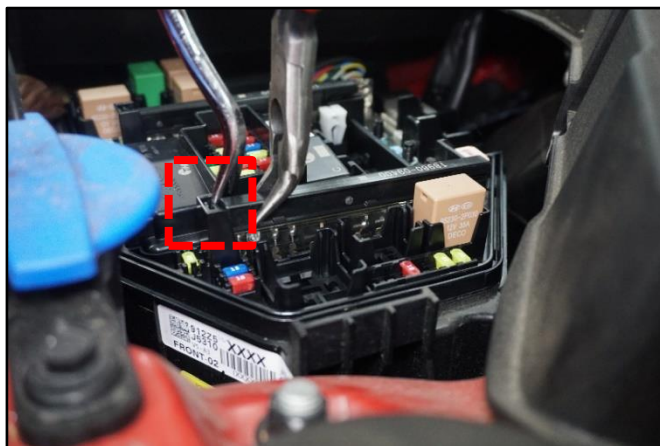
6. Push the lock pin to release and remove the multi-fuse.
7. Install the new multi-fuse in the reverse order of removal.

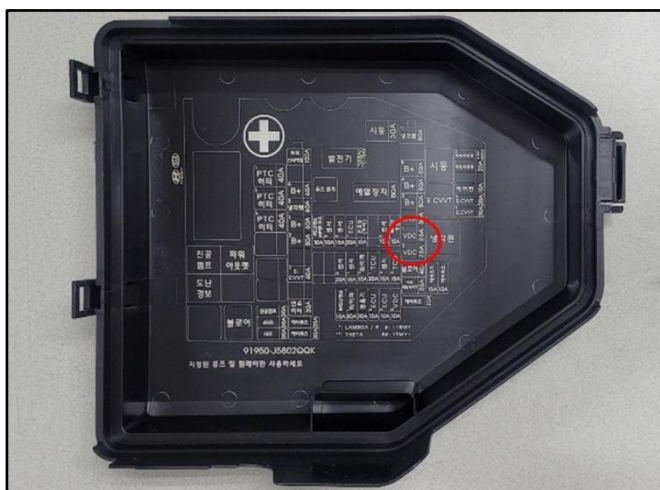
7. Install the new junction box cover.
8. Reconnect negative battery (-) battery terminal.
9. Confirm normal vehicle operation and that no instrument cluster indicator lamps are displayed/ON.
