October 2020
FL860AB
NHTSA #20V-527
Transport Canada #2020-408

Subject: Freightliner Engine Harness Clearance

Models Affected: Specific Model Year 2018-2021 Freightliner 108SD, 114SD, and Business Class M2 vehicles manufactured May 24, 2017, through August 26, 2020, and equipped with a Detroit Diesel DD8 engine.

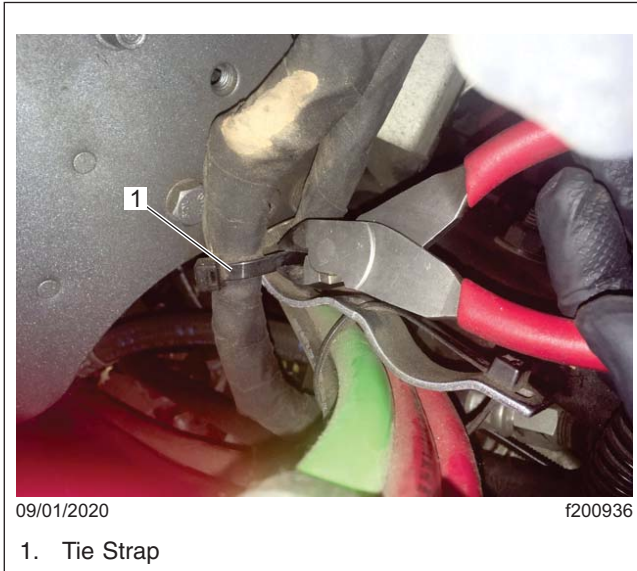
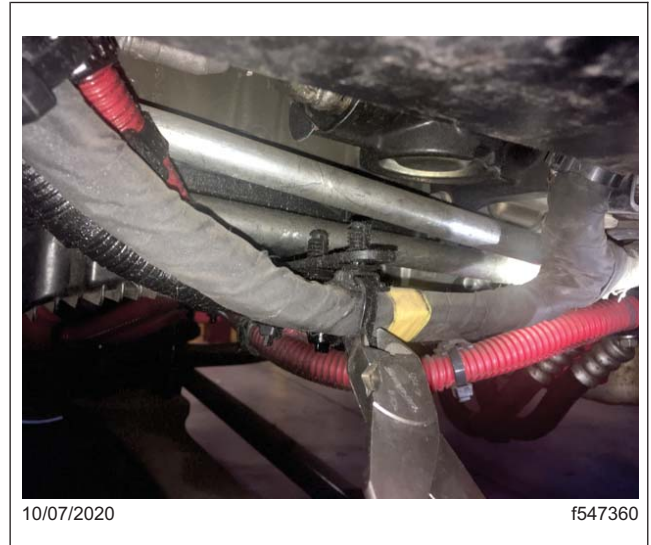
7. To gain access to the complete DD8 engine harness to enable inspection of all key chaffing points, cut the tie straps that secure the engine harness. See [Fig. 1](#) and [Fig. 2](#). Key DD8 engine harness chaffing points include:

Fig. 1, Harness Tie Strap Removal

Fig. 2, Harness Tie Strap Removal

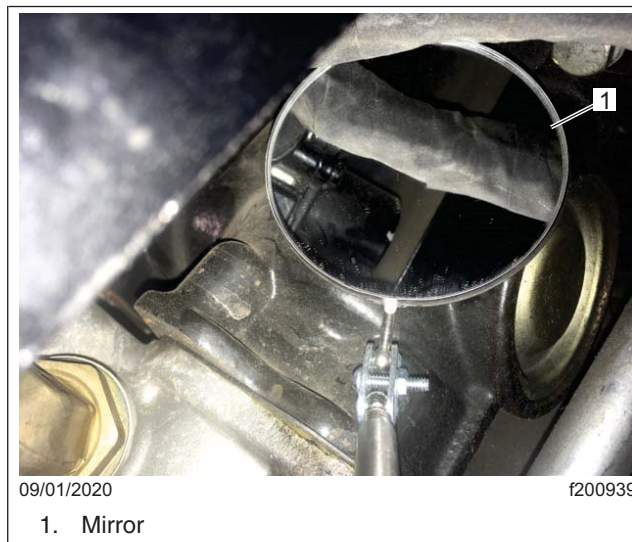
Fig. 3, Inspection by Mirror

8. If necessary to access the engine harness for inspection, remove the transmission dipstick tube brackets, fuel line brackets, and clipping points for the airline bundle.
9. Inspect the engine harness for damage at the key chaffing points. Pull the harness away from the brackets to make a complete inspection, using a mirror as needed. See [Fig. 3](#).

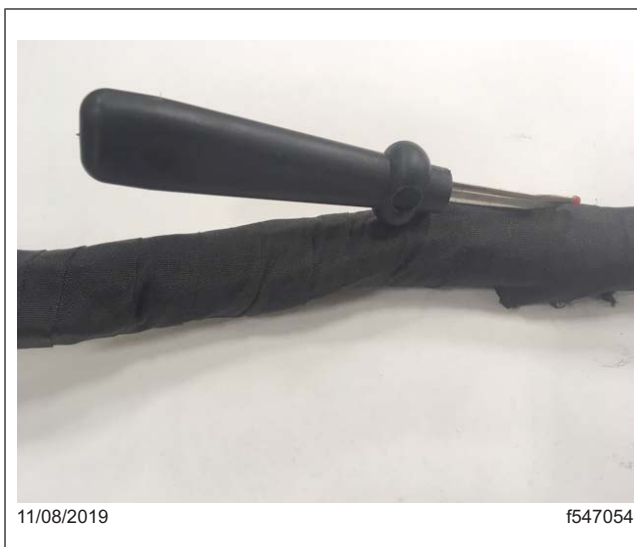
Fig. 4, Cutting an Opening into the Fiber Wrap

IMPORTANT: Do **not** use a hook razor blade to cut the fiber harness wrap. Use a sewing seam ripper (see [Fig. 4](#)), and take care not to cut the harness wires.

- 11.1 Locate the damaged area and carefully cut open the fiber wrap using a sewing seam ripper tool. See [Fig. 4](#).
- 11.2 Flip the seam ripper tool over so that the blunt end is facing the wiring, then cut enough length to allow the fiber wrap to be unwrapped. See [Fig. 5](#).

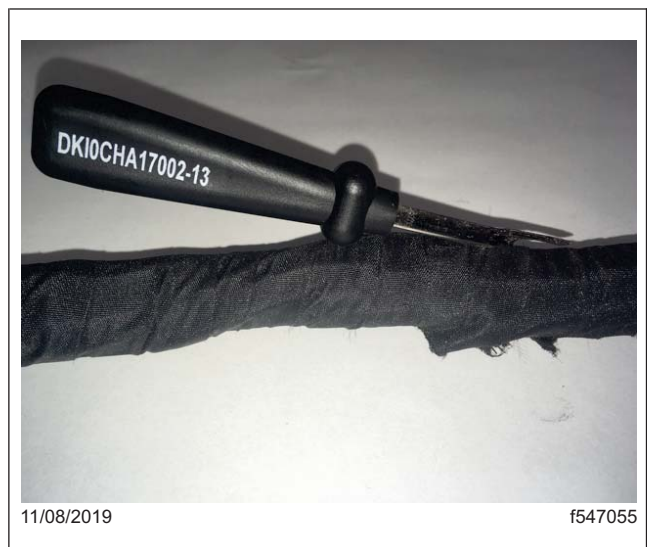
Fig. 5, Cutting the Fiber Wrap Using the Blunt End of the Seam Ripper

10. If damage to the wiring is found, cut and unwrap the harness wrap in the damaged area to determine the extent of damage. See [Fig. 5](#).

- If five or fewer wires (approximately 30% or less) in the harness are damaged, the harness can be repaired.
- If more than five wires in the harness are damaged, the harness must be replaced.

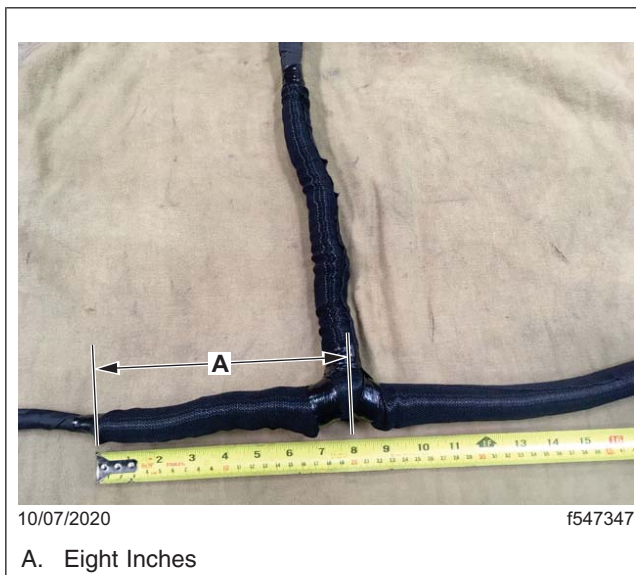
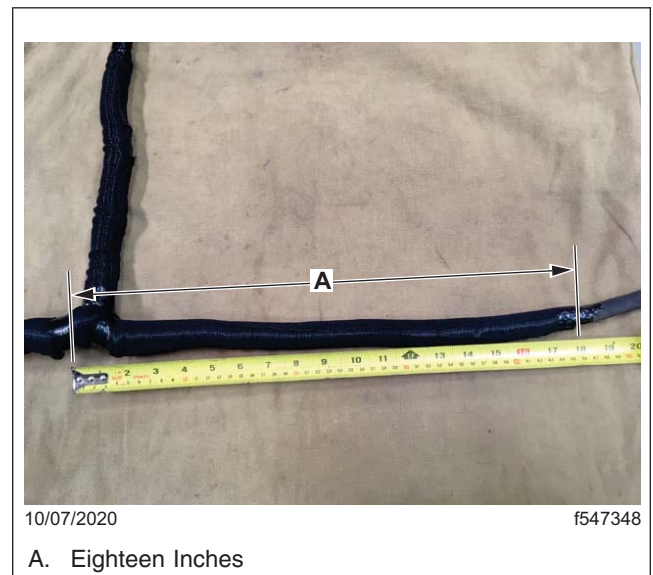
Fig. 9, Eight Inch Horizontal Section of TwistTube

Fig. 10, 18-inch Horizontal Section of TwistTube

Add TwistTube over the first 8 inches (203 mm) of the horizontal section ahead of the vertical section (see [Fig. 9](#)) and over the first 18 inches (457 mm) behind the vertical section (see [Fig. 10](#)). There will be a total of 26 inches (660 mm) of added TwistTube. See [Fig. 11](#).

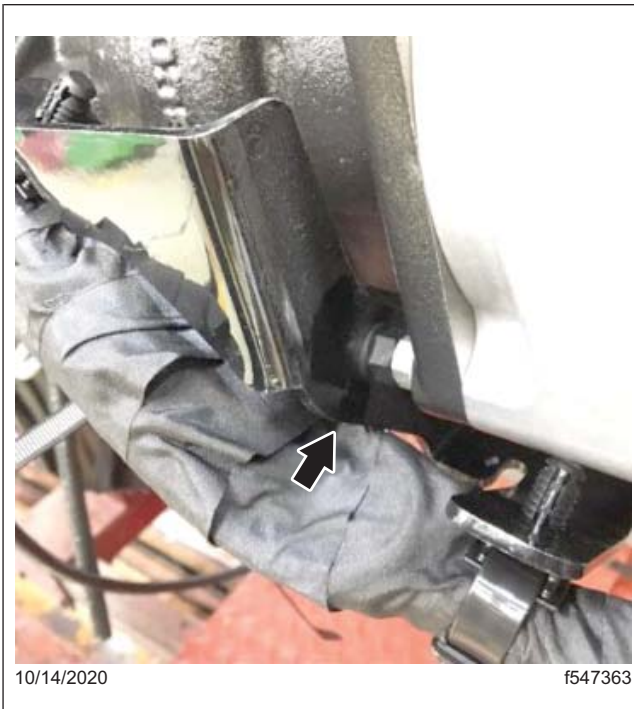
Fig. 13, Current Air Compressor Mounted Bracket Showing Area of Possible Harness Rub

1. Replace the existing air compressor-mounted bracket (see [Fig. 13](#)) with the one supplied in the kit (part number 66-13326-000). See [Fig. 14](#).
 - 1.1 Remove the two fasteners securing the old bracket to the air compressor and remove the bracket.
 - 1.2 Install the new bracket (part number 66-13326-000) then torque the fasteners 27 to 32 lbf-ft (36 to 43 N-m).
