October 2020
FL861AB
NHTSA #20V-529

Subject: FCCC Motorhome Valve Stem Stabilizers

Models Affected: Specific Model Years 2017 - 2020 FCCC MC, XCL, XCM, XCR, and XCS chassis manufactured February 20, 2017, through August 15, 2020, and equipped with a valve stem extension and stabilizer configured with a specific tire valve stem and wheel combination.

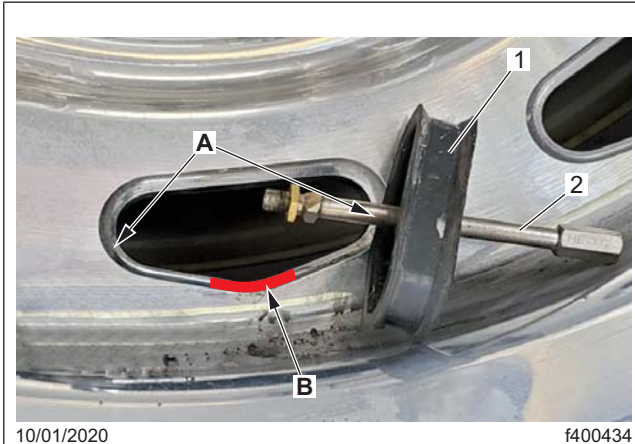
Fig. 1, Valve Stem with Stabilizer

Certain chassis may have been built with the tire valve stem extension for the inner wheel contacting the outer wheel rim opening, potentially damaging the valve stem resulting in a loss of air pressure in the inner tire. A loss of air pressure in the inner tire on a motorhome with a single drive axle may overload the outer tire and increase the risk of a crash.

4. Inspect the valve stem extensions for rubbing on the outer wheel rim opening on both drive axle wheels. Also inspect the valve stem stabilizer, which may be dislodged from the wheel rim opening.

Due to the rotation of the wheel, the 'top' of the wheel rim opening is reversed and appears at the bottom in this photo.

- A. If the valve stem extension is rubbing the side of the wheel rim opening, gently swivel the inner valve stem so that it aligns with the center of the wheel rim opening.
- B. If the inner-wheel valve stem extension is rubbing at the top of the wheel rim opening (shown here at the bottom of the wheel rim opening due to the rotation of the wheel in the photo), or if the valve stem stabilizer is dislodged, remove the stabilizer and inner valve stem extension.

5. If the valve stem extension is rubbing the side of the wheel opening, shown in [Fig. 1](#), reference A, gently swivel the inner valve stem so that it aligns with the center of the wheel rim opening. The valve stem should swivel with little resistance.

6. If the inner-wheel valve stem extension is rubbing at the top of the wheel rim opening, shown in [Fig. 1](#), reference B, or if the valve stem stabilizer is dislodged, remove the stabilizer and inner-wheel valve stem extension. Slide a small diameter tube over the end of the valve stem, then gently adjust the angle of the inner-wheel valve stem by bending it so that it aligns with the center of the wheel rim opening. If adjusting the inner-wheel valve stem resolves the issue, go to step 10.

If the bend requires more than a few degrees, replace the inner-wheel valve stem using part number 13-10027-000 (574-F29). See [Fig. 1](#) and [Fig. 2](#).

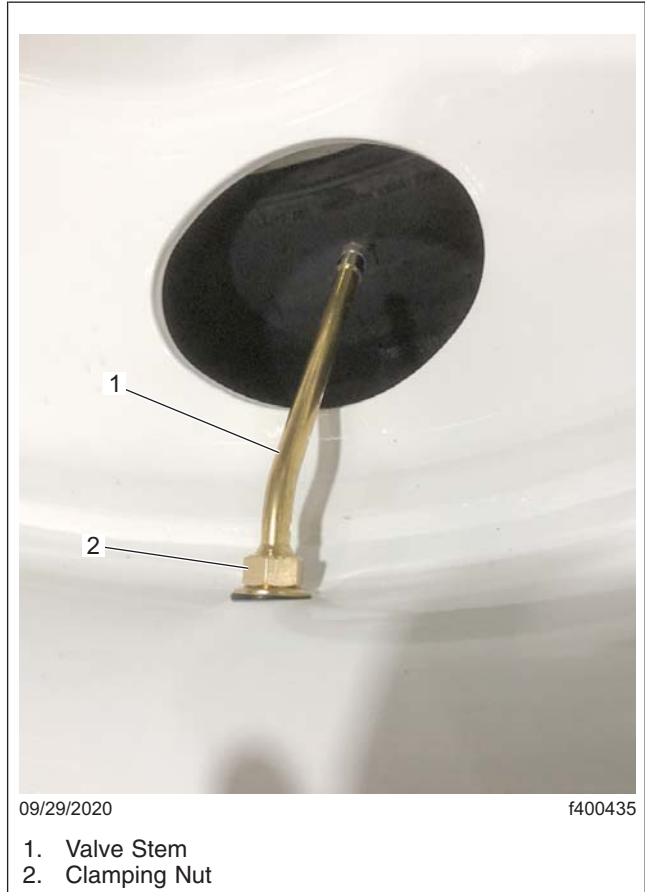
Fig. 2, Clamping Nut

- 1. Valve Stem
- 2. Clamping Nut

NOTE: If there was any adjustment of the inner-wheel valve stem, verify that there is no air leak at the valve stem base or the clamping nut. See [Fig. 2](#). If needed, tighten the clamping nut 35 to 55 lbf-in (395 to 621 N-cm).
