IMPORTANT SAFETY RECALL
NHTSA Recall# 20V-551

Subject: Safety Tethers on units with Flat Bottom Floors

No.: B20012

Re.: Inspection and Repair of Safety Tethers
on units with Flat Bottom Floors

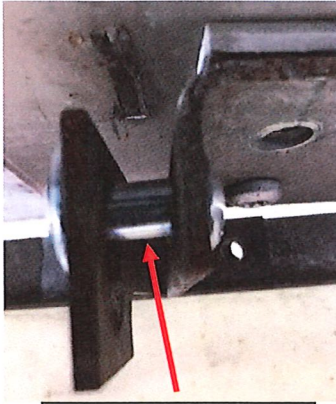
Tether Bolt Present

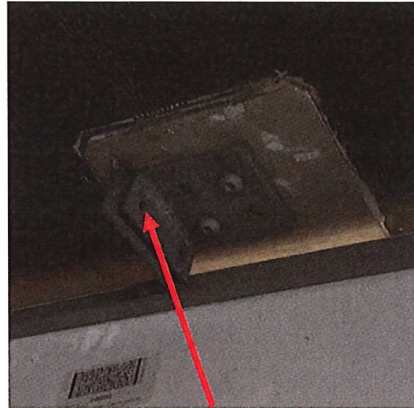
Inspection: An immediate inspection should be completed on all affected units to confirm that the bolts securing the two piece Safety Tether are present and secure. If these bolts are **not** present the unit should be taken out of service until the bolts have been replaced, or the instruction in this bulletin can be completed. It is preferred that this recall be completed in conjunction with campaign bulletin B20008 to reduce unit downtime. If the bolts are present the unit can remain in service, but it is recommended that the steps in this bulletin be completed as soon as practical.

Tether Bolt Missing

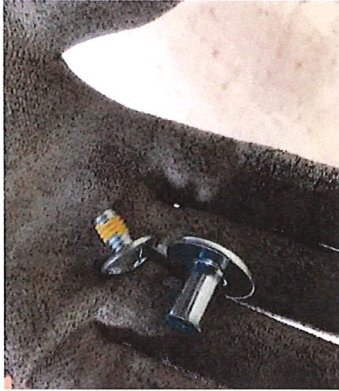
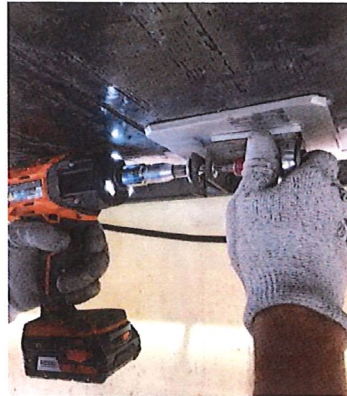
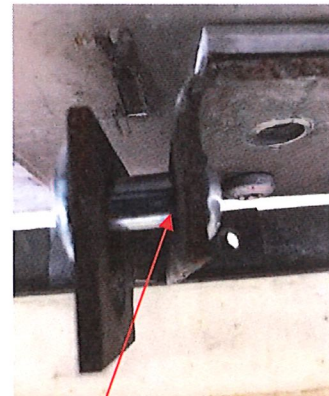
No Gap Here

9. Install the new Tether bolt and nut. When tightening be sure that there is no gap between the Tubular nut, and the mating surface of Tether Angle bracket.
