**IMPORTANT SAFETY RECALL**  
**NHTSA Recall# 20V-551**

**Subject:** Safety Tethers on units with Flat Bottom Floors

No.: B20012

Re.: Inspection and Repair of Safety Tethers  
on units with Flat Bottom Floors

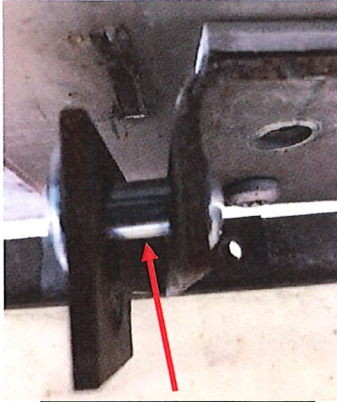
Tether Bolt Present

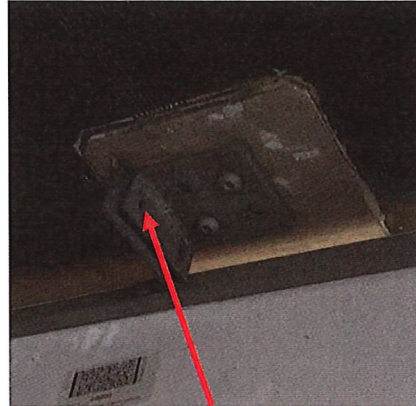
**Inspection:** An immediate inspection should be completed on all affected units to confirm that the bolts securing the two piece Safety Tether are present and secure. If these bolts are **not** present the unit should be taken out of service until the bolts have been replaced, or the instruction in this bulletin can be completed. It is preferred that this recall be completed in conjunction with campaign bulletin B20008 to reduce unit downtime. If the bolts are present the unit can remain in service, but it is recommended that the steps in this bulletin be completed as soon as practical.

Tether Bolt Missing

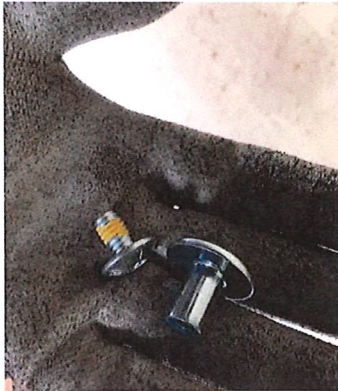
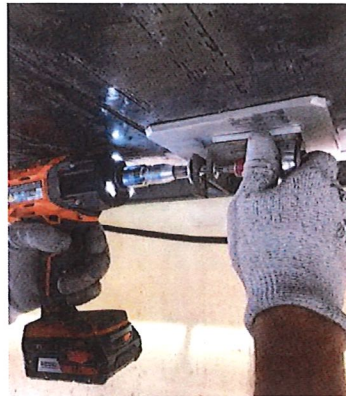
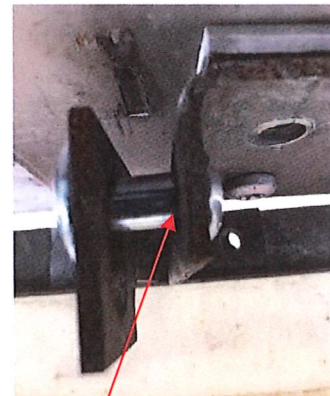
No Gap Here

9. Install the new Tether bolt and nut. When tightening be sure that there is no gap between the Tubular nut, and the mating surface of Tether Angle bracket.
