BULLETIN

Subject: Safety Tethers on units with Flat Bottom Floors

No.: B20012

Re.: Inspection and Repair of Safety Tethers
on units with Flat Bottom Floors

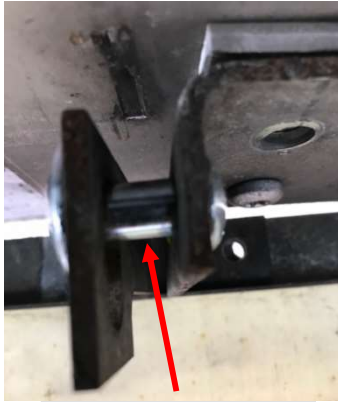
Tether Bolt Present

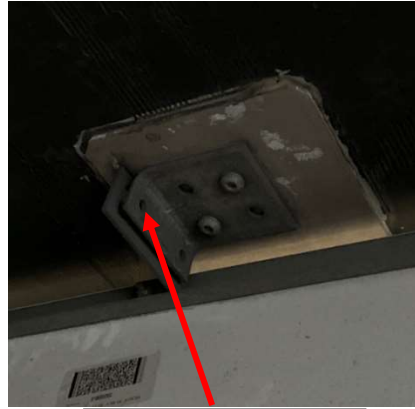
We have received reports of the bolts connecting the two pieces of the redundant Safety Tether assembly not being present. This bulletin is intended to explain the need for an immediate inspection confirming the presence of these fasteners, and to also provide a remedy for correcting the cause of this issue long term.

Tether Bolt Missing

Inspection: An immediate inspection should be completed on all affected units to confirm that the bolts securing the two piece Safety Tether are present and secure. If these bolts are **not** present the unit should be taken out of service until the bolts have been replaced, or the instruction in this bulletin can be completed. It is preferred that this recall be completed in conjunction with campaign bulletin B20008 to reduce unit downtime. If the bolts are present the unit can remain in service, but it is recommended that the steps in this bulletin be completed as soon as practical.

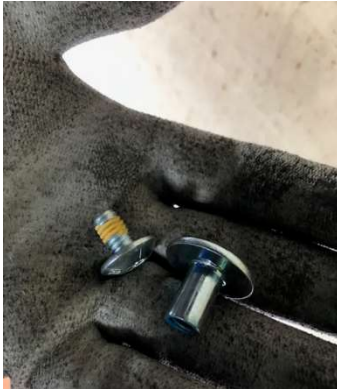
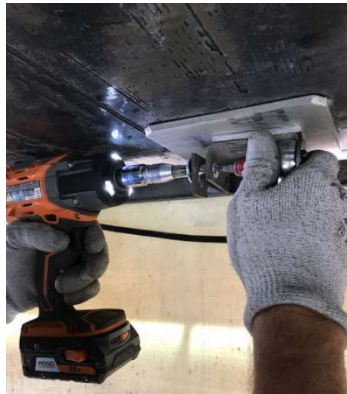
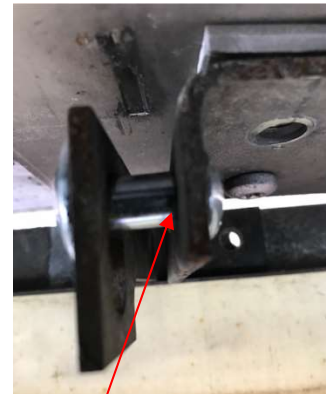
No Gap Here

9. Install the new Tether bolt and nut. When tightening be sure that there is no gap between the Tubular nut, and the mating surface of Tether Angle bracket.
