BULLETIN NUMBER:
CB20-N-002A

IMPORTANT SAFETY RECALL

GROUND CABLE REPLACEMENT – 20V-554
(Transport Canada 2020-429)

- 2018-2021MY Isuzu FTR Vehicles Produced Before 8/14/2020

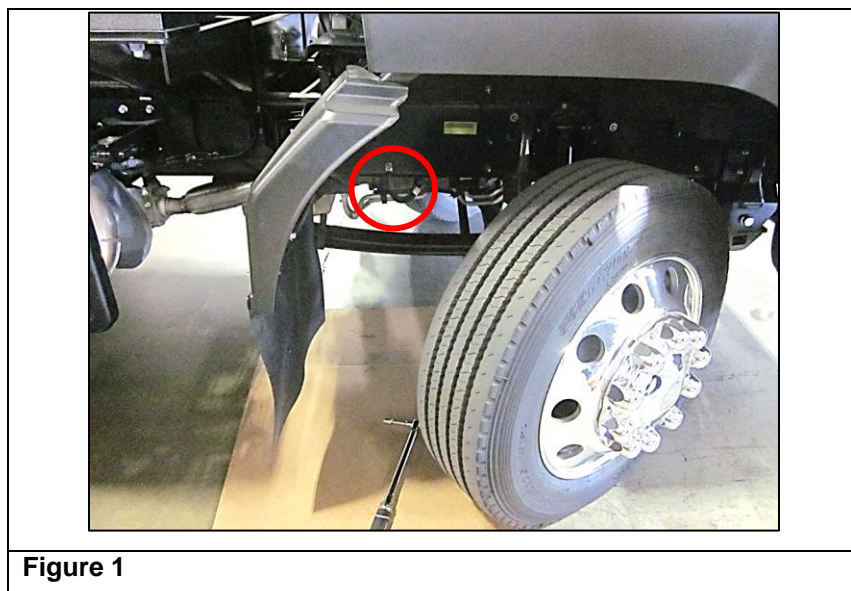
1. Place the vehicle in park, apply the parking brake, turn the engine off and block the rear tires.
2. At the right side of the vehicle, close to rear of the front tire, locate the ground cable. See Figure 1.

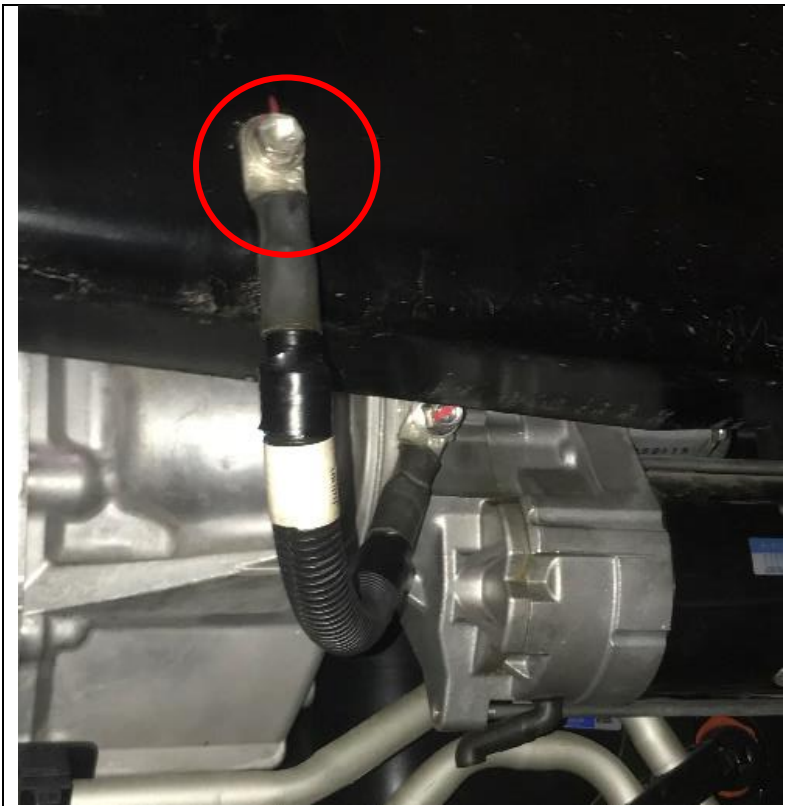
Figure 2

3. Remove the bolt from the frame end of the ground cable. See Figure 2.

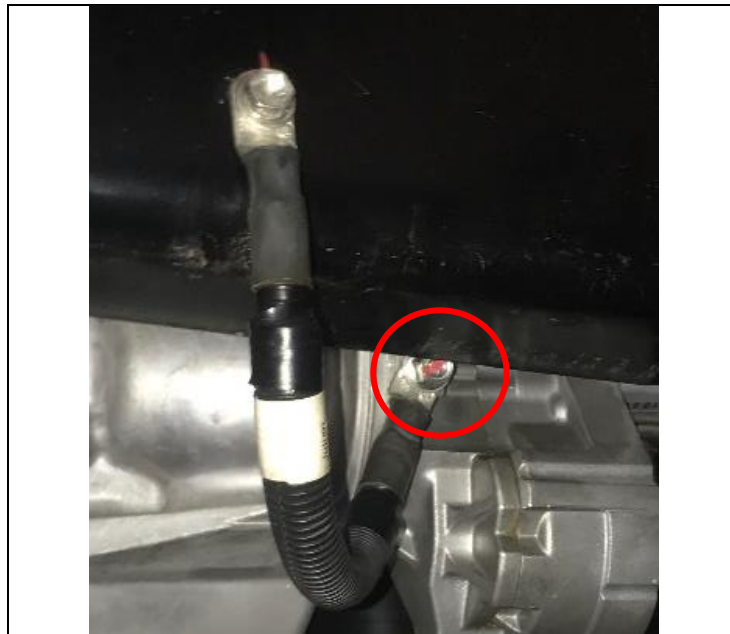
Figure 3

4. Remove the bolt from the starter end of the ground cable. See Figure 3.

5. Did the ground cable break during removal, or was it found broken when removed?
 - If the ground cable breaks or is found broken, take a photo of it and email it to isuzuta@icta-us.com. Order a replacement power steering hose, and after obtaining the order reference number, call the Isuzu Technical Assistance Line at 1-877-478-9828, Prompt 3. Provide the part number and order reference number and TAL will confirm and approve the replacement of the power steering hose (8-98212-319-0). Document the TAL case number on the repair order. This will be required for claim submission. Continue to Step 6.

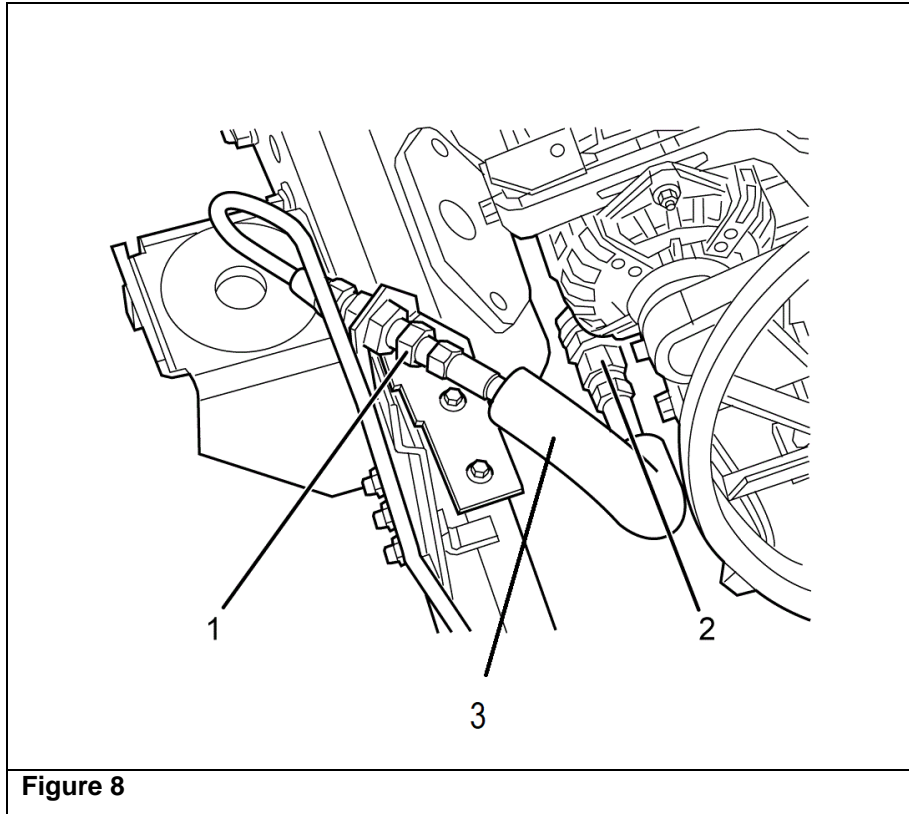
13. Inspect the power steering hose (no.3), shown in Figure 8, for unusual bulging/swelling or leaking from the rubber flexible section of the hose.

- If the power steering hose is bulging/swelling or leaking, take a photo of it and email it to isuzuta@icta-us.com. Order a replacement power steering hose, and after obtaining the order reference number, call the Isuzu Technical Assistance Line at 1-877-478-9828, Prompt 3. Provide the part number and order reference number, and TAL will confirm and approve the replacement of the power steering hose (8-98212-319-0). Document the TAL case number on the repair order. This will be required for claim submission. Continue to the Power Steering Hose Replacement section in this bulletin to complete this campaign.
- If the hose is not bulging/swelling or leaking, proceed to the Applying the Campaign Label section in this bulletin.

16. Remove the lower power steering hose nut (no. 2) from the power steering pump pipe. See Figure 8.
17. Remove the upper power steering hose nut (no. 1) from the frame union. See Figure 8.
18. Remove the power steering hose from the vehicle.

21. Install the lower power steering hose nut (no. 2) to the power steering pump pipe. Tighten the hose to 49-74 N·m (36-55 lb ft). See Figure 8.
22. Install the upper power steering hose nut (no. 1) to the frame union. Tighten the hose to 49-74 N·m (36-55 lb ft). See Figure 8.
23. Fill the power steering system to the proper level indicated on the power steering reservoir using Dexron VI fluid only.
24. Install the right side noise cover onto the frame using the five (5) bolts set aside in Step 13. Tighten the bolts to 20.0 N·m (14 lb·ft). See Figure 7.
