# Product Safety Recall

## N202316700 Starter Ground Cable Breakage – US Only

**Release Date:** October 2020

| <b>Condition</b> | Isuzu Motors Limited has decided that a defect, which relates to motor vehicle safety, exists in certain 2018-2021 model year Chevrolet 6500XD Low Cab Forward vehicles produced before August 14, 2020. In the affected vehicles, the ground cable connecting the starter motor to the vehicle frame may break at the starter-side eyelet, which can result in an engine no-crank or slow-crank condition, causing the vehicle not to start. If the driver attempts to start the engine after the cable has broken, electrical current will flow through the steel braiding of the power steering hose rather than through the broken cable, generating heat within the power steering hose. Once the cable is broken, if the driver makes repeated efforts to restart the engine or if the key is held in the engine start position for an extended period of time, enough heat may be generated to melt and potentially to rupture the power steering hose. If the power steering hose ruptures, power steering fluid may leak onto a hot engine or exhaust surface increasing the risk of a fire. |

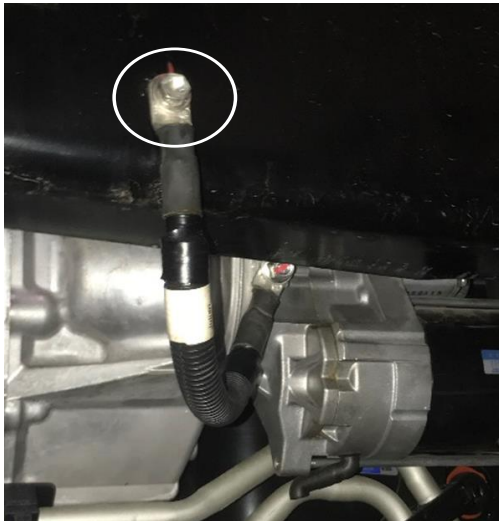
5652003

2. At right side of vehicle, close to rear of the front tire, locate starter ground cable.
