RECALL CAMPAIGN BULLETIN

Classification: EL20-035	Reference: NTB20-063	Date: September 14, 2020
-----------------------------	-------------------------	-----------------------------

VOLUNTARY RECALL CAMPAIGN 2019 TITAN AND TITAN XD; LED HEADLAMPS

CAMPAIGN ID #: PC751
APPLIED VEHICLES: 2019 Titan and Titan XD (A61)
APPLIED SYSTEM: LED Headlamps

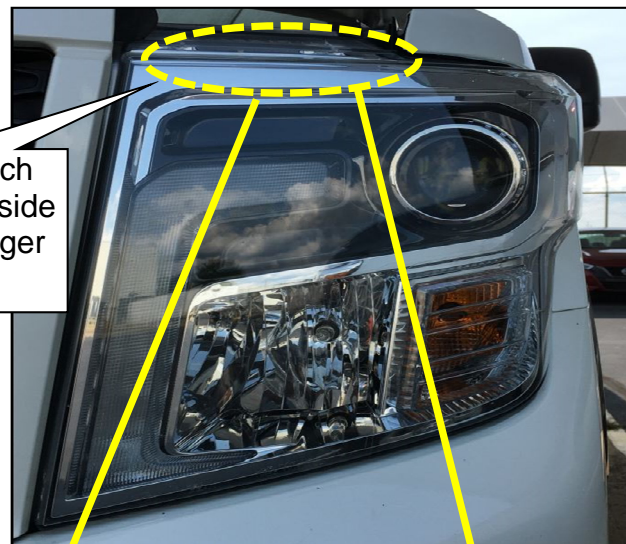
Figure 2

2. Locate and inspect the upper laser etch markings on both the driver side (left) and passenger side (right) LED headlamps.

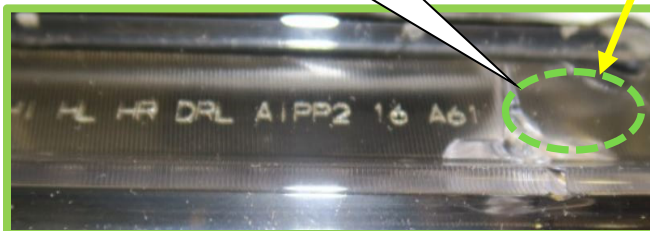
Figure 3

Correct upper laser etch marking (blank)

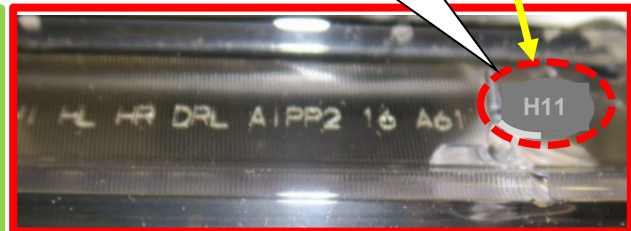
Figure 4

Incorrect upper laser etch marking (H11)

5. Replace any headlamp that has the incorrect laser etch marking.
- To replace the headlamp(s), refer to the ESM: **DRIVER CONTROLS > EXTERIOR LIGHTING SYSTEM > LED HEADLAMP > REMOVAL AND INSTALLATION > FRONT COMBINATION LAMP > Removal and Installation.**
 - If ALL laser etch markings are correct, close the hood and go to the **CLAIMS INFORMATION** on page 5.

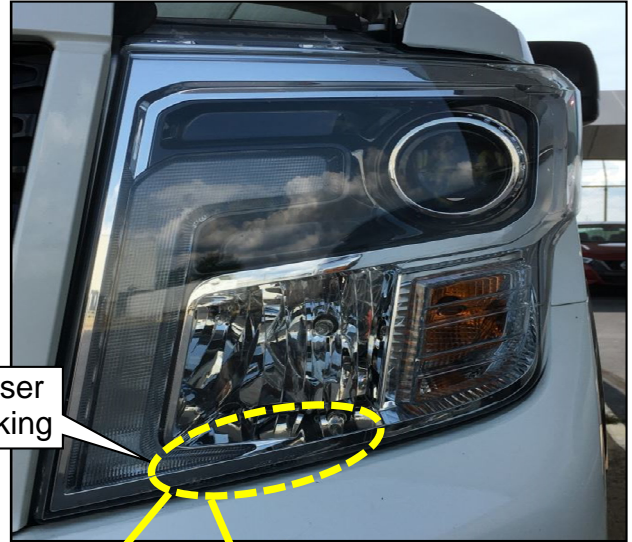
Figure 5

3. Locate and inspect the lower laser etch marking on the driver side (left) LED headlamp.

Lower laser etch marking

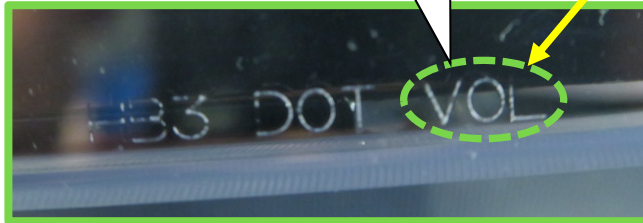
Figure 6

Correct lower laser etch marking on driver side (VOL)

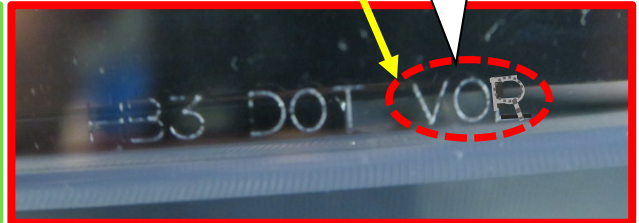
Figure 7

Incorrect lower laser etch marking on driver side (VOR)

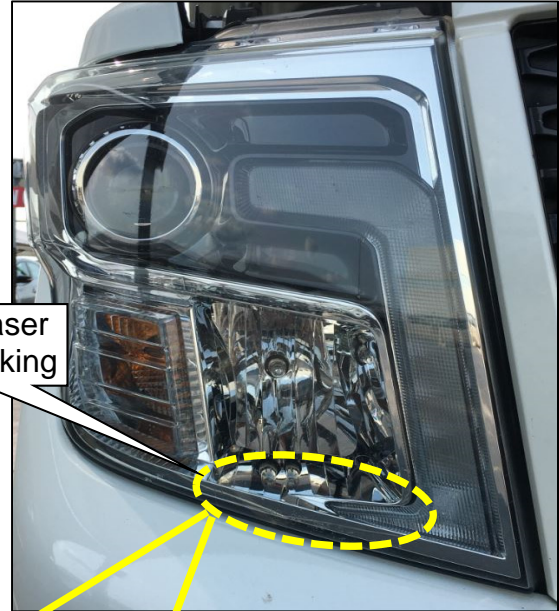
Figure 8

4. Locate and inspect the lower laser etch marking on the passenger side (right) LED headlamp.

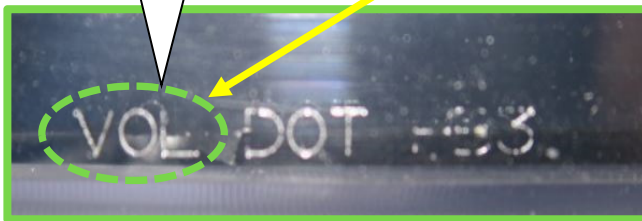
Figure 9

Correct lower laser etch marking on passenger side (VOL)

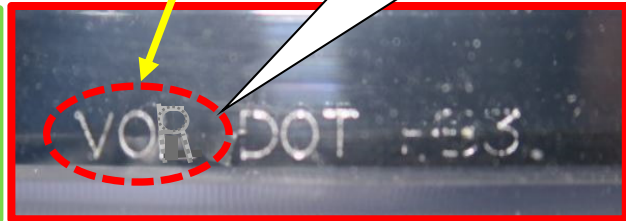
Figure 10

Incorrect lower laser etch marking on passenger side (VOR)
