2021-01-09

SIM 61 07 20

RECALL 20V-601: HIGH-VOLTAGE BATTERY

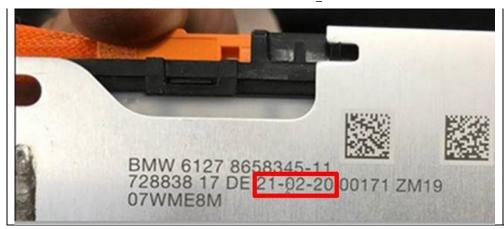
The date in the serial number of the high-voltage module can be displayed in two different formats.

Variant A : YY-MM- DD
		Variant B (shown): DD-MM-YY
	 (D) (() ()
