SIB 61 23 20

RECALL 20V-601: HIGH-VOLTAGE BATTERY RECALL

This Service Information Bulletin (Revision 4) replaces SI B61 23 20 dated December 2020.

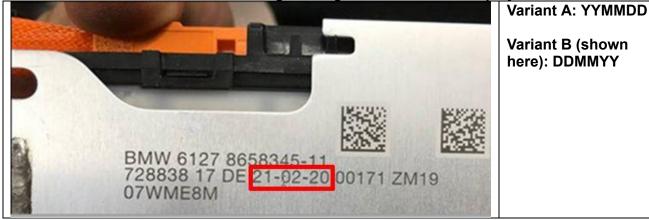
The date in the serial number of the High-voltage module can be displayed in two different formats:

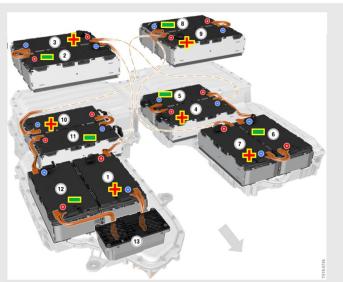
SP44 HV Battery (G05) modules

G05 modules (SP44 HV battery) are:

NEG (01) or POS (02)

- Module 12 is NEG (01)
- Module 1 is POS (02)
- Module 11 is NEG (01)
- Module 10 is POS (02)
- Module 2 is NEG (01)
- Module 3 is POS (02)
- Module 8 is NEG (01)
- Module 9 in POS (02)
- Module 5 is NEG (01)

- Module 4 is POS (02) Module 6 is NEG (01) Module 7 in POS (02)

Modules are designed as Positive and Negative modules (with different orientation and part numbers). When replacing modules, verify in EPC the correct part (POS/NEG) and reinstall according to their original position. See below.

Use EPC diagram to verify the correct module part number (01/02) for NEG or POS modules.

Use the illustration on the right to match the part# with the correct module installation location.
