SIB 61 23 20

RECALL 20V-601: HIGH-VOLTAGE BATTERY

Service Information Bulletin (Revision 1) replaces SI B61 23 20 dated November 2020.

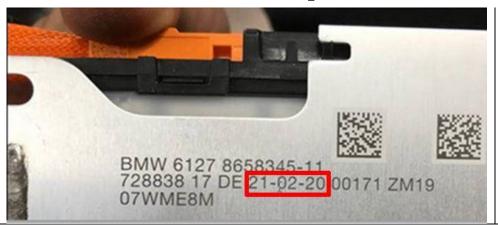
The date in the serial number of the High-voltage module can be displayed in two different formats:

Variant A: YYMMDD
Copyright ©2020 BMW of North Americ	a. Inc.

Variant B (shown here): DDMMYY
