SIB 61 23 20

RECALL 20V-601: HIGH-VOLTAGE BATTERY RECALL

This Service Information Bulletin (Revision 9) replaces SI B61 23 20 **dated December 2020**.

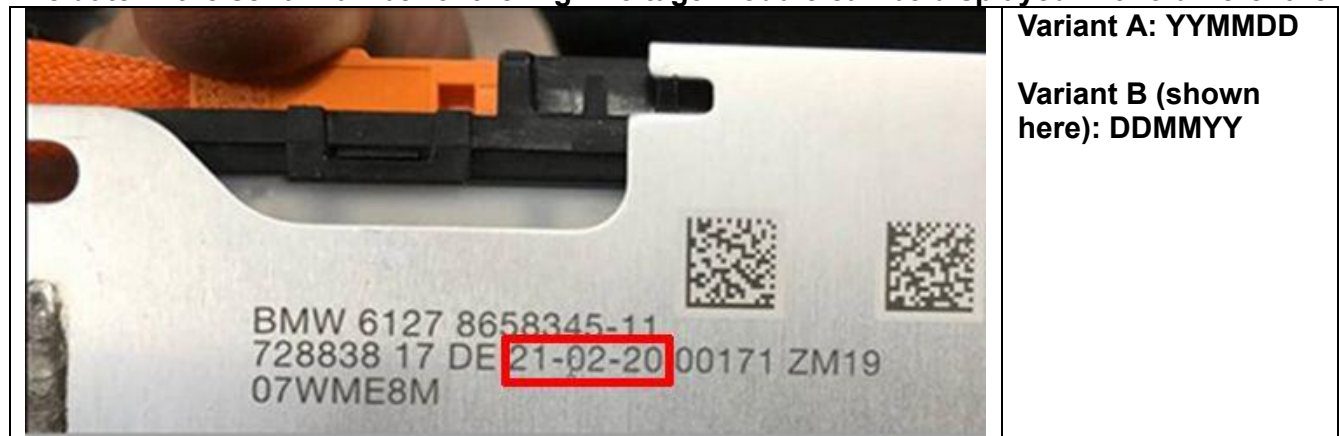
The date in the serial number of the High-voltage module can be displayed in two different formats:
