SIM 61 07 20

RECALL 20V-601: HIGH-VOLTAGE BATTERY

E-Series	Model Description	Production Date
F60	MINI Cooper SE Countryman ALL4–	March 12, 2020 – September 15, 2020
	PHEV Only

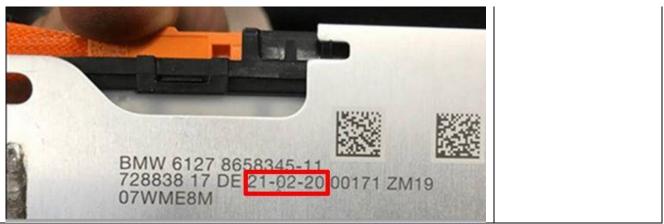
The date in the serial number of the high-voltage module can be displayed in two different formats.

Variant A : YY-MM- DD
Variant B (shown): DD-MM-YY
