SIB 61 23 20

2021-04-02

## RECALL 20V-601: HIGH-VOLTAGE BATTERY RECALL

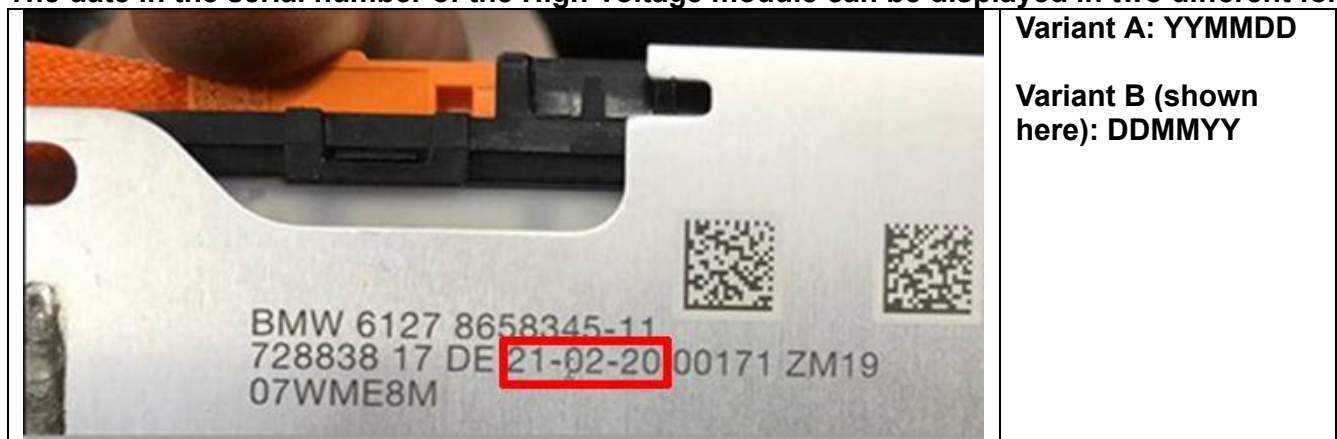
The date in the serial number of the High-voltage module can be displayed in two different formats:

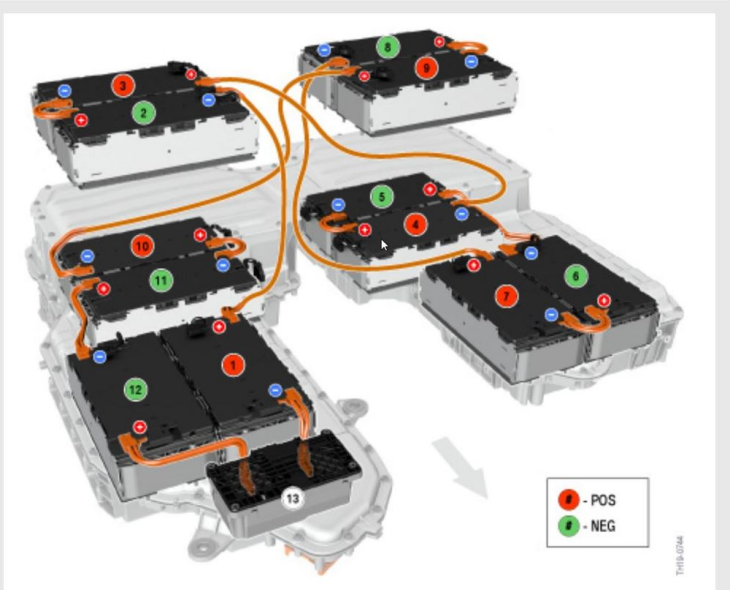
**SP44 HV Battery (G05) modules-**

**G05 modules (SP44 HV battery) are:**

**NEG (01) or POS (02)**

- Module 12 is **NEG (01)**
- Module 1 is **POS (02)**
- Module 11 is **NEG (01)**
- Module 10 is **POS (02)**
- Module 2 is **NEG (01)**
- Module 3 is **POS (02)**
- Module 8 is **NEG (01)**
- Module 9 in **POS (02)**
- Module 5 is **NEG (01)**
- Module 4 is **POS (02)**
- Module 6 is **NEG (01)**
- Module 7 in **POS (02)**

**Modules are designed as Positive and Negative modules (with different orientation and part numbers). When replacing modules, verify in EPC the correct part (POS/NEG) and reinstall according to their original position. See below.**

Use EPC diagram to verify the correct module part number (01/02) for NEG or POS modules.

Use the illustration on the right to match the part# with the correct module installation location.

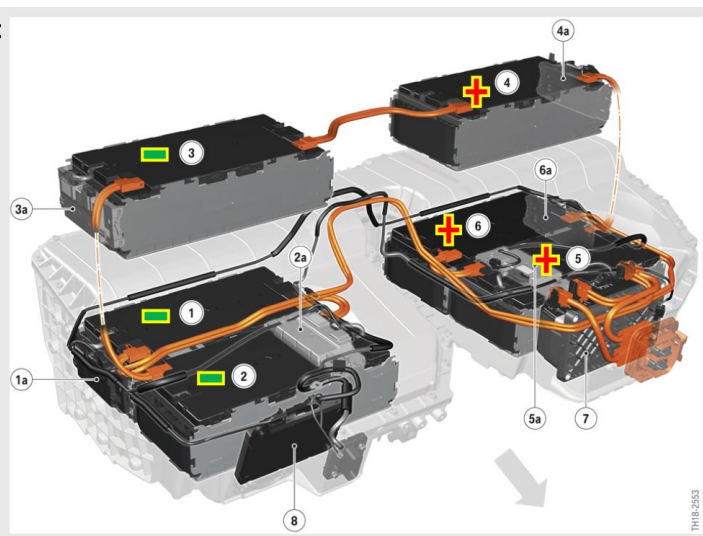
**SP41 HV Battery (G01/G20/G20/G12) modules-**

**G01/G20/G30/G12 LCI modules (SP41 battery) are:**

**NEG (01) or POS (02)**

- Module 1 is **NEG (01)**
- Module 2 is **NEG (01)**
- Module 3 is **NEG (01)**
- Module 4 is **POS (02)**
- Module 5 is **POS (02)**
- Module 6 is **POS (02)**

Use EPC diagram to verify the correct module part number (01/02) for NEG or POS modules.

Use the illustration on the right to match the part# with the correct module installation location.
