SIM 61 07 20

RECALL 20V-601: HIGH-VOLTAGE BATTERY

E-Series	Model Description	Production Date
F60	MINI Cooper SE Countryman ALL4– PHEV Only	March 12, 2020 – September 15, 2020

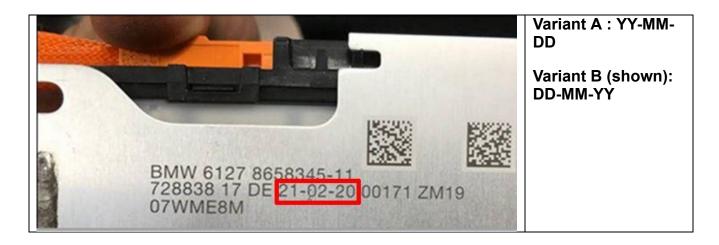
The date in the serial number of the high-voltage module can be displayed in two different formats.
