# Product Safety Recall

## N202300860 Loss of Brake Assist

**Release Date:** November 2020

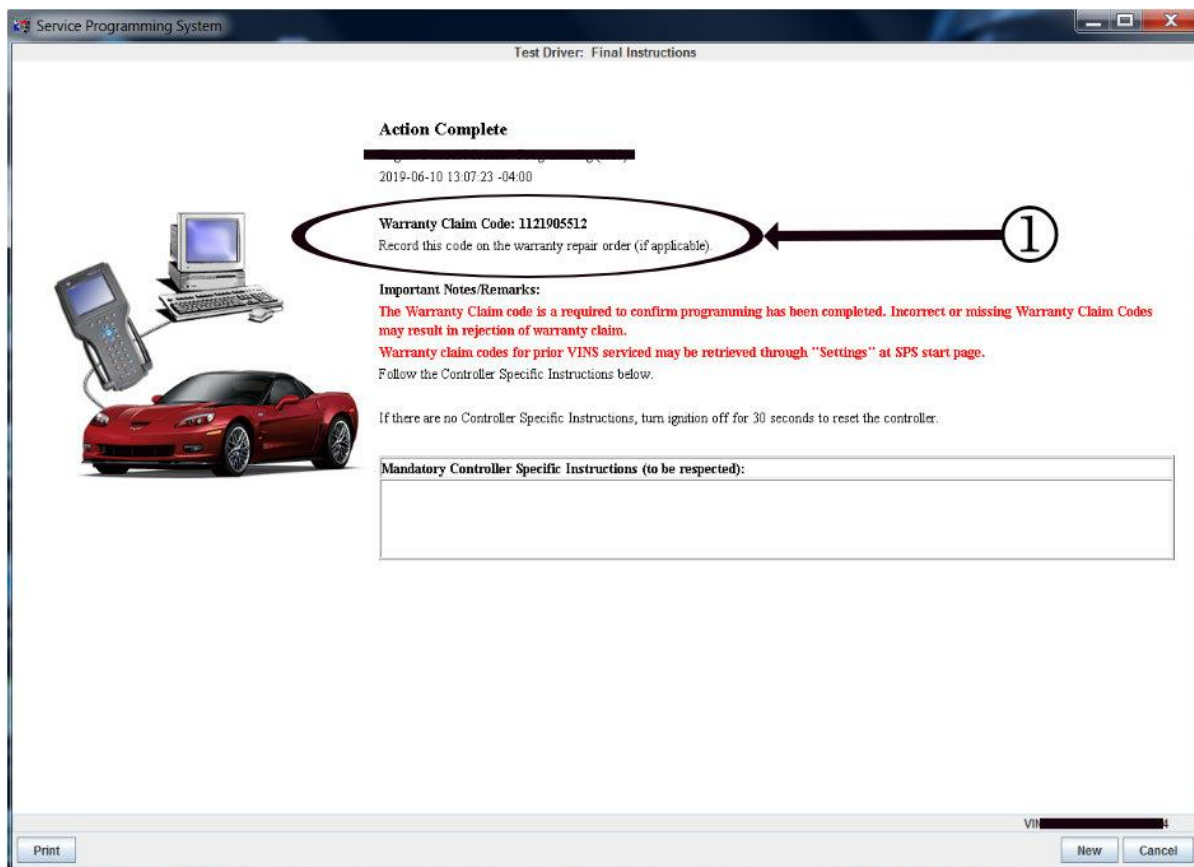
5431209

**Important:** To avoid warranty transaction rejections, you MUST record the warranty claim code provided on the Warranty Claim Code (WCC) screen shown above on the job card. Refer to callout 1 above for the location of the WCC on the screen.

- Record SPS Warranty Claim Code on job card for warranty transaction submission.
