SAFETY RECALL ACTION

Reference number:	RA-01-1418	Issued: 29th September, 2020
Subject:	Incorrect Installation of the Front Seat Airbags	
Model(s):	DB11, Vantage, DBS Superleggera	
VIN Range:	Refer to the separately published list of Vehicle Identification Numbers (VINs)	
Applicable to:	All Dealers	
Distribute to:	After Sales Manager Executive Manager Service Manager Sales Manager	Warranty Staff Technician(s) Parts Staff

Safety Recall Action RA-01-1418 – Incorrect Installation of the Front Seat Airbags

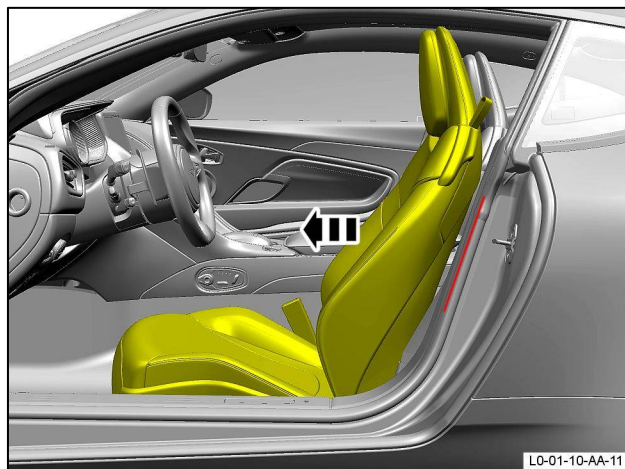
Figure 3

1. Operate the seat to its fully forward position (refer to Figure 3).

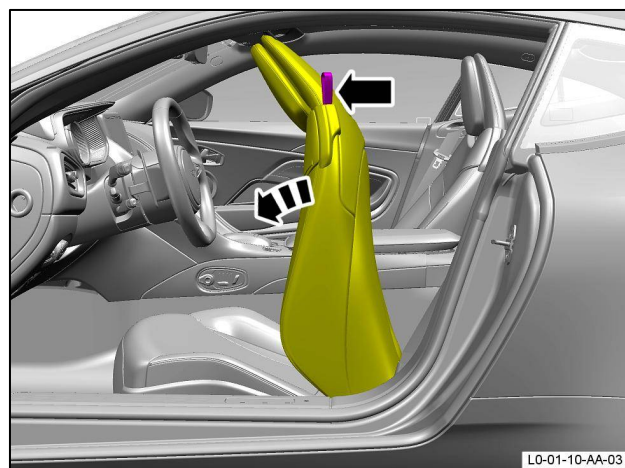
Figure 4

2. Pull the release handle to tilt the seat to its fully forward position (refer to Figure 4).

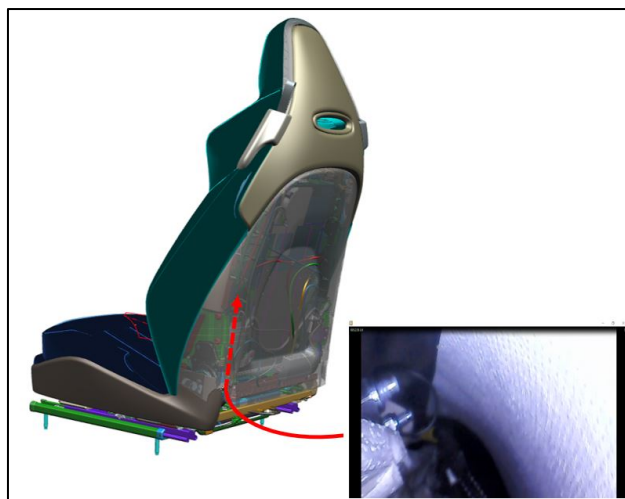
Figure 5

3. Use an endoscope on the underside of the seat to examine the two locking nuts for the seat airbag (refer to Figure 5).

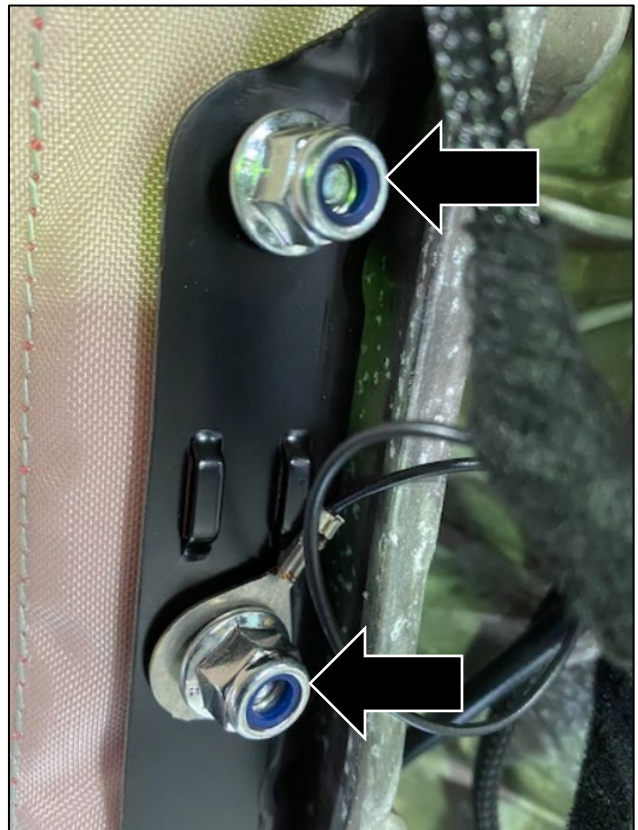
Figure 6

On the affected vehicles, it is possible the locking nuts that attach the front seat airbags to the seat are not torqued to the correct specification.

- This image shows two locking nuts that are incorrectly installed (Figure 6).

- If any of the locking nuts are not installed correctly go to Part B: Torque the Locking Nuts to the Correct Specification.

3. Torque the two locking nuts that attach the seat airbag to the seat to 5.5 Nm. Align the ground eyelet to the bracket.
4. Install the seat back shell to the seat (refer to Workshop Manual Procedures 01.10.DU for the left side seat and 01.10.DR for the right side seat).
5. Install the seat assembly to the vehicle (refer to Workshop Manual Procedures 01.10.AA for the left side seat and 01.10.AB for the right side seat).

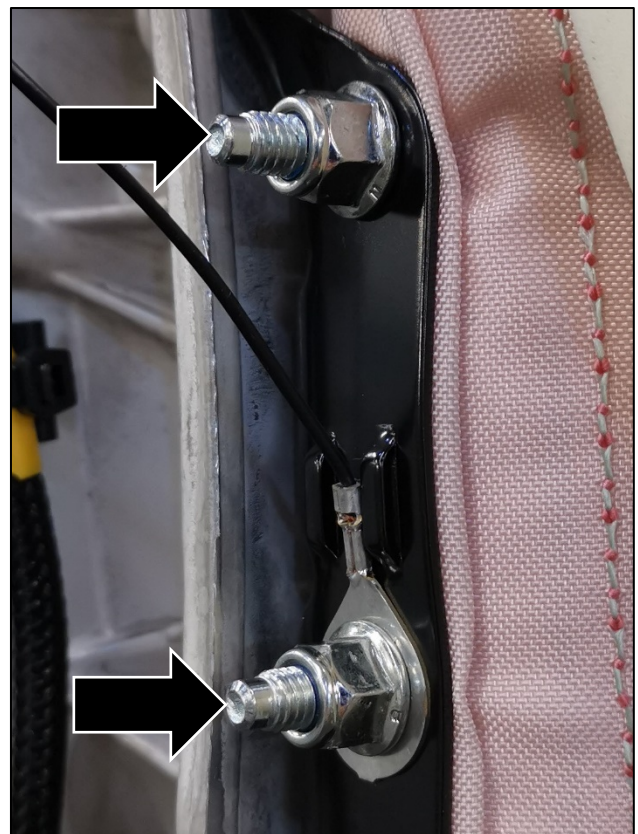
Figure 7

- The lower fixing that clamps the ground eyelet must show a minimum of 4 visible threads. The upper fixing must show a minimum of 5 threads (refer to Figure 7).

Note: *This image shows two locking nuts that are correctly installed with the ground eyelet correctly aligned.*
