RECALL 20V605 REMEDY INSTRUCTIONS – GEORGETOWN ONLY

Make(s): GEORGETOWN Model(s): MANY <u>Model Year(s): 2021</u> Concern: The motor in the P2K Bunk System has a potential to fail due to an internal gear failure. Repair Code: RC-098-01-00-003807 Allotted Time: GT5 1.0 hrs /GT7 2.0 hrs. Inspection Code: N/A Allotted Time: N/A Photo(s) Required: NO Prior Authorization Required: YES Part(s) Kit Number: Part(s) Return: YES

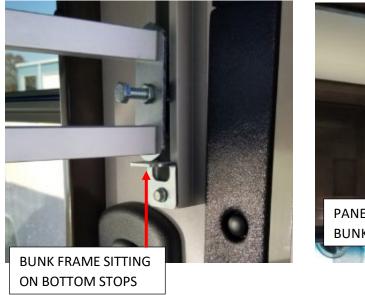
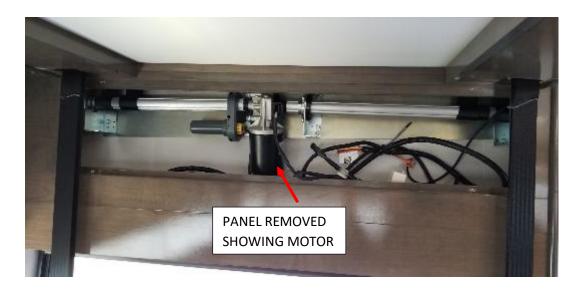
Forest	Make(s): GEORGETOWN Model(s): MANY <u>Model Year(s): 2021</u> Concern: The motor in the P2K Bunk System has a potential to fail due to an internal gear	Repair Code: RC-098-01-00-003807 Allotted Time: GT5 1.0 hrs /GT7 2.0 hrs. Inspection Code: N/A Allotted Time: N/A Photo(s) Required: NO Prior Authorization Required: YES
	failure.	Part(s) Kit Number: Part(s) Return: YES

ON THE GT7 SERIES, PRIOR TO CONDUCTING THE LCI REMEDY;

LOWER THE BUNK ALL THE WAY DOWN UNTIL IT CONTACTS THE BOTTOM STOPS;

CLIMB ONTO THE BUNK AND FIND THE RECTANGULAR PANEL INSTALLED ON A CABINET FACE ON THE DOOR SIDE WALL, ABOVE THE BUNK;

REMOVE THE PANEL FROM THE CABINET, SET THE PANEL AND SCREWS ASIDE TO EXPOSE THE BUNK MOTOR;

NOW MOVE ON TO THE LCI REMEDY INSTRUCTIONS;

ONCE COMPLETED, REINSTALL THE PANEL AND SCREWS USING THE MATERIALS SET ASIDE.
