N499NAS1

# TECHNICAL BULLETIN

SAFETY RECALL: Rear Spoiler Outer Surface Retention

MODEL:	MODEL YEAR:	VIN:
Range Rover Sport (LS)	2010-2011	212147-297042

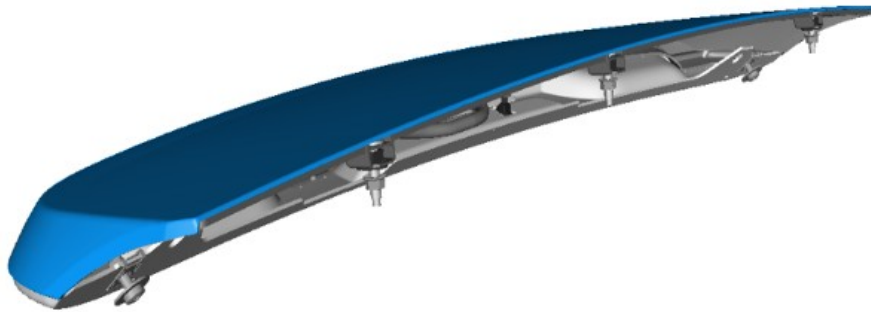
E260468

Inspect the rear spoiler to see if the outer surface of the rear spoiler is fully secured to the inner carrier molding.

- If the outer surface of the rear spoiler **is not** fully secured, **apply adhesive tape to secure the outer surface of the rear spoiler to the inner carrier molding and then continue to step 3.**
- If the outer surface of the rear spoiler **is** fully secured, **continue to step 3.**
