RE: **Recall Campaign Launch Notification**  
**Relocate Grounding for the Illuminated Star**  
**MY20 167 (GLE-Class, GLS-Class)**

Campaign No. 2020100015, November 2020  
Revision A

SUBJECT: **Model GLE-Class and GLS-Class vehicles (167 platform)**  
**Model Year 2020**  
**Installation of the Illuminate Star**

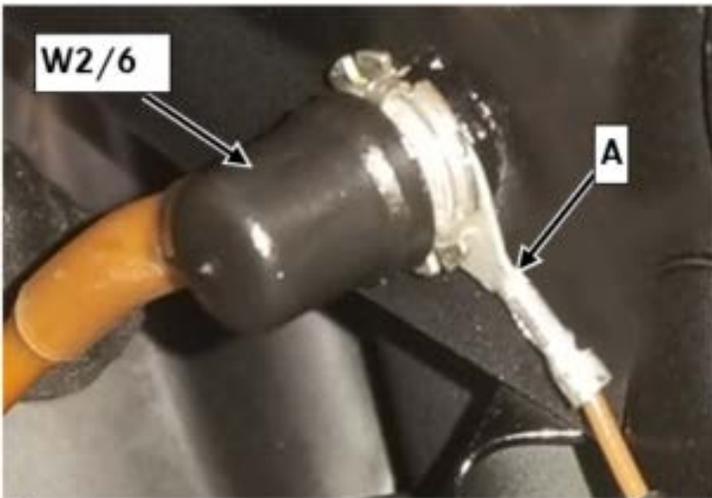
Figure 1

Mercedes-Benz AG ("MBAG"), the manufacturer of Mercedes-Benz vehicles, has determined that certain Model Year ("MY") 2020 GLE-Class and GLS-Class vehicles (167 platform) that are fitted with the optional illuminated Mercedes-Benz star in the front grill may have the electrical grounding installed outside specifications. In this case, the function of other components that share the same ground connection might be impaired. Depending on the individual ground point used for the illuminated star logo, either the power steering control unit, or the left headlamp, and/or the wiper motor might malfunction. This could increase the risk of a crash. A deactivation of the power steering assist as well as the deactivation of the left headlamp and the wiper motor would be indicated by an acoustic warning, as well as by a visual warning message in the instrument cluster.

1. Open hood.
2. Switch off ignition and store transmitter key outside the transmitter range (at least 2 meters).
3. Unscrew ground **point W2/6**.  
i For basic data, see **GF00.19-P-2001-17NCA**.
4. Remove illuminated star ground line (**A, figure 1**).

6. Route illuminated star ground line (**A, figure 1**) to jump-start connection point and attach to threaded pin of jump-start connection point.
7. Screw on brass sleeve (**B, figure 2**).  
Nm Brass sleeve 16 Nm.
8. Secure illuminated star ground line (**A, figure 1**) up to jump-start connection point.  
i Ensure a chafe-free routing and attachment of the illuminated star ground line See **AZ88.40-P-0011-01ME**
9. Check anti-twist protection (**C, figure 3**) of cable lug of ground **point W2/6** for damage.

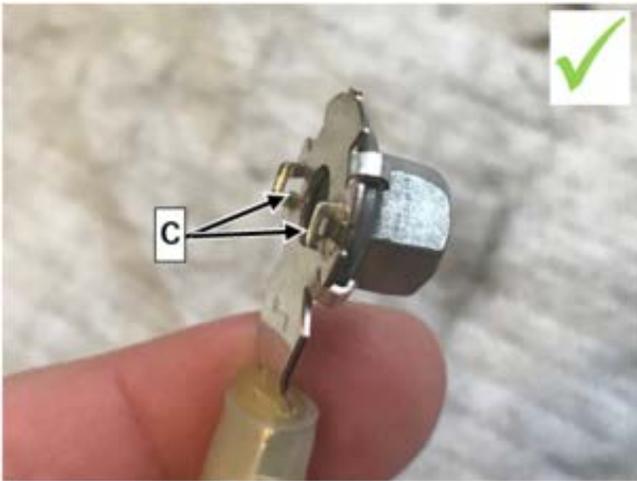
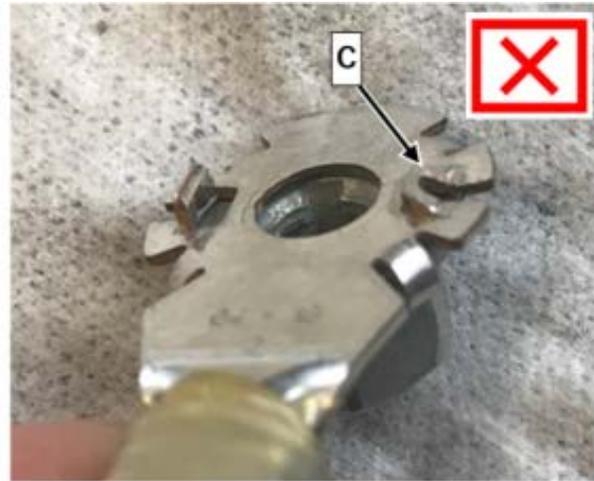
Figure 3 (OK)

- a. Anti-twist protection (**C, figure 3**) **straight** or **bent outwards**, i.e. outside dimension between anti-twist protection lugs (**D, figure 4**) **equal to or greater than 13.6 mm**: Perform operation step 11, then **end measure**.
- b. Anti-twist protection (**C, figure 3**) **bent inwards**, i.e. outside dimension between anti-twist protection lugs (**D, figure 4**) **less than 13.6 mm**: Create **PTSS case**.

Make detailed photos of anti-twist protection of ground line, ground point W2/6 in removed condition. Clarify the further repair procedure via a **PTSS case**. Keep faulty part.

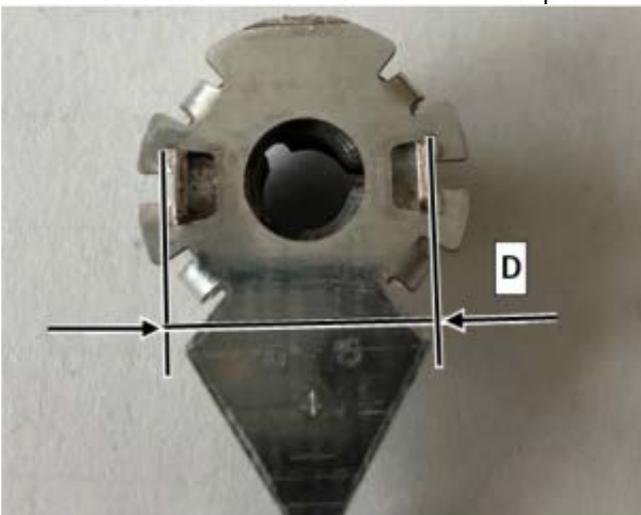
Figure 4

i Outside dimension between anti-twist protection lugs (**D, figure 4**) min. 13.6 mm.

**i** Only if anti-twist protection of cable lug is **bent inwards**, i.e. outside dimension between anti-twist protection lugs (**D, figure 4**) is **less than 13.6 mm**.
