Campaign No. 2020100016, November 2020  
Revision A

SUBJECT: **Model GLE-Class and GLS-Class vehicles (167 platform)**  
**Model Year 2020**  
**Installation of the Illuminate Star**

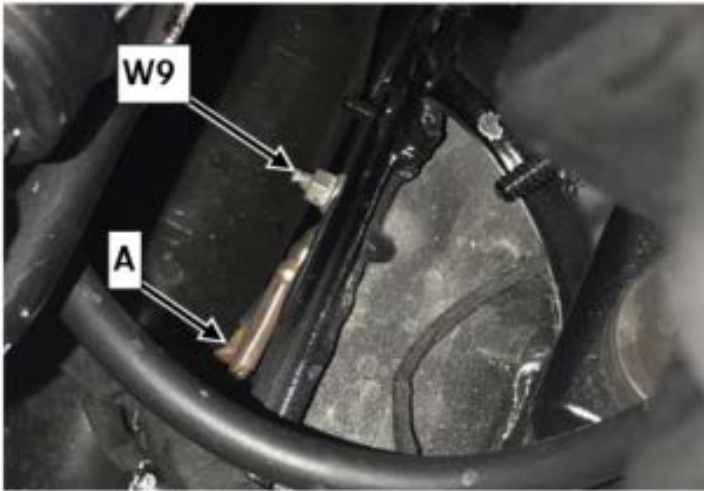
Figure 1

Mercedes-Benz AG ("MBAG"), the manufacturer of Mercedes-Benz vehicles, has determined that certain Model Year ("MY") 2020 GLE-Class and GLS-Class vehicles (167 platform) that are fitted with the optional illuminated Mercedes-Benz star in the front grill may have the electrical grounding installed outside specifications. In this case, the function of other components that share the same ground connection might be impaired. Depending on the individual ground point used for the illuminated star logo, either the power steering control unit, or the left headlamp, and/or the wiper motor might malfunction. This could increase the risk of a crash. A deactivation of the power steering assist as well as the deactivation of the left headlamp and the wiper motor would be indicated by an acoustic warning, as well as by a visual warning message in the instrument cluster.

1. Open hood.
2. Switch off ignition and store transmitter key outside the transmitter range (at least 2 meters).
3. Unscrew ground **point W9**.  
i For basic data, see **GF00.19-P-2001-17NCA**.
4. Remove illuminated star ground line (**A, figure 1**).

6. Route illuminated star ground line (**A, figure 1**) to jump-start connection point and attach to threaded pin of jump-start connection point.
7. Screw on brass sleeve (**B, figure 2**).  
Nm Brass sleeve 16 Nm.
8. Secure illuminated star ground line (**A, figure 1**) up to jump-start connection point.  
i Ensure a chafe-free routing and attachment of the illuminated star ground line. See **AZ88.40-P-0011-01ME**
9. Check anti-twist protection (**C, figure 3**) of cable lug of ground **point W9** for damage.

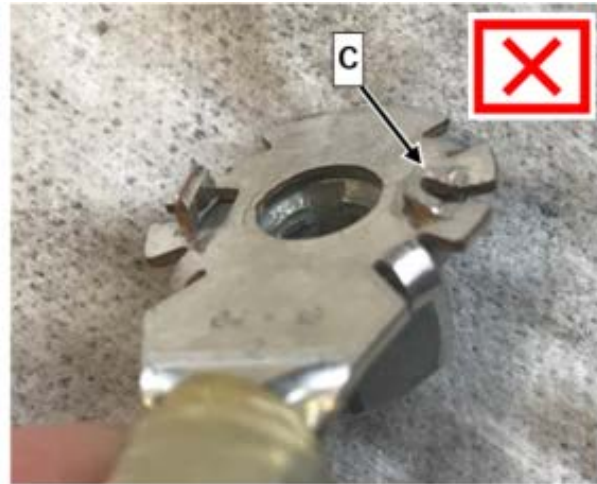
(not OK)

- a. Anti-twist protection (**C, figure 3**) **straight** or **bent outwards**, i.e. outside dimension between anti-twist protection lugs (**D, figure 4**) **equal to or greater than 13.6 mm**: Perform operation step 11, then **end measure**.
- b. Anti-twist protection (**C, figure 3**) **bent inwards**, i.e. outside dimension between anti-twist protection lugs (**D, figure 4**) **less than 13.6 mm**: Create **PTSS case**.

Make detailed photos of anti-twist protection of ground line, ground point W9 in removed condition. Clarify the further repair procedure via a **PTSS case**. Keep faulty part.

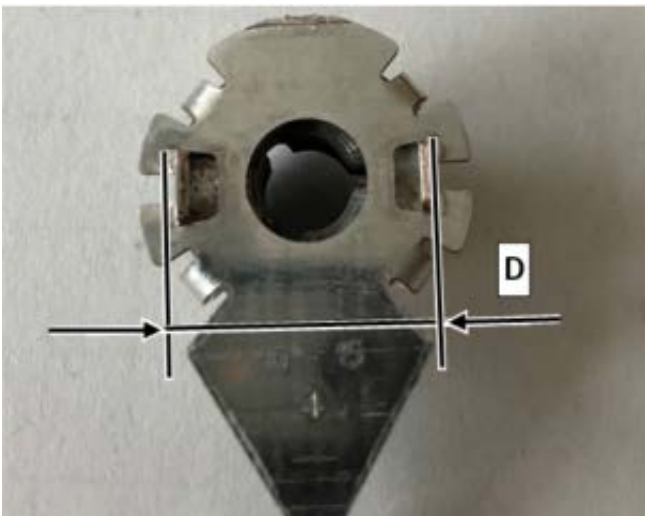
Figure 4

10. Measure outside dimension between anti-twist protection lugs (**D, figure 4**).  
i Outside dimension between anti-twist protection lugs (**D, figure 4**) min. 13.6 mm.

**i** Only if anti-twist protection of cable lug is **bent inwards**, i.e. outside dimension between anti-twist protection lugs (**D, figure 4**) is **less than 13.6 mm**.
