Mercedes-Benz

Campaign No. 2020100015, November 2020

SUBJECT: **Model GLE-Class and GLS-Class vehicles (167 platform)**
Model Year 2020
Installation of the Illuminate Star

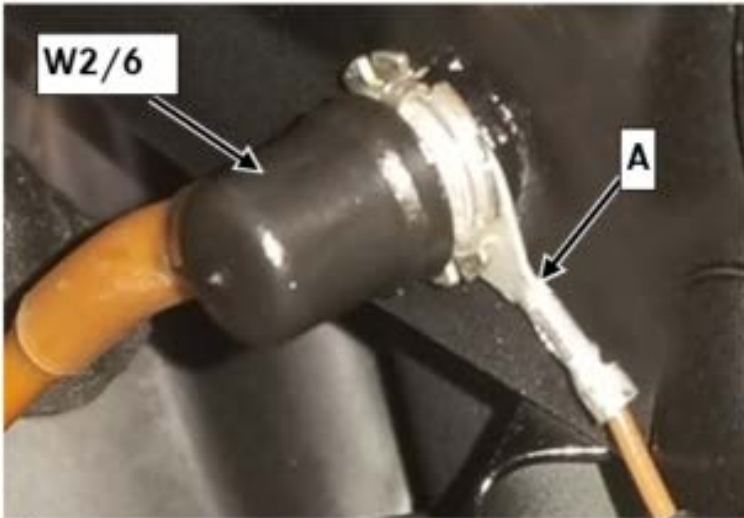
Figure 1

1. Open hood.
2. Switch off ignition and store transmitter key outside the transmitter range (at least 2 meters).
3. Unscrew ground **point W2/6**.
i For basic data, see **GF00.19-P-2001-17NCA**.
4. Remove illuminated star ground line (**A, figure 1**).

6. Route illuminated star ground line (**A, figure 1**) to jump-start connection point and attach to threaded pin of jump-start connection point.
7. Screw on brass sleeve (**B, figure 2**).
Nm Brass sleeve **16 Nm**.
8. Secure illuminated star ground line (**A, figure 1**) up to jump-start connection point.
i Ensure a chafe-free routing and attachment of the illuminated star ground line See **AZ88.40-P-0011-01ME**
9. Check anti-twist protection (**C, figure 3**) of cable lug of ground **point W2/6** for damage.

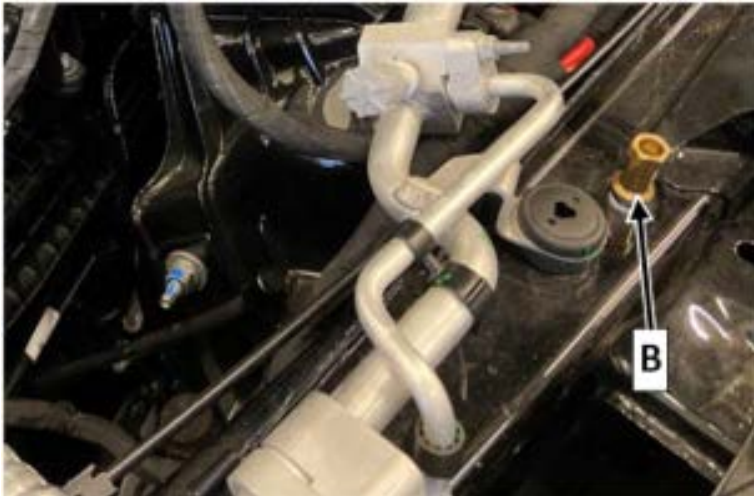
Figure 2

5. Unscrew brass sleeve (**B, figure 2**) at jump-start connection point.

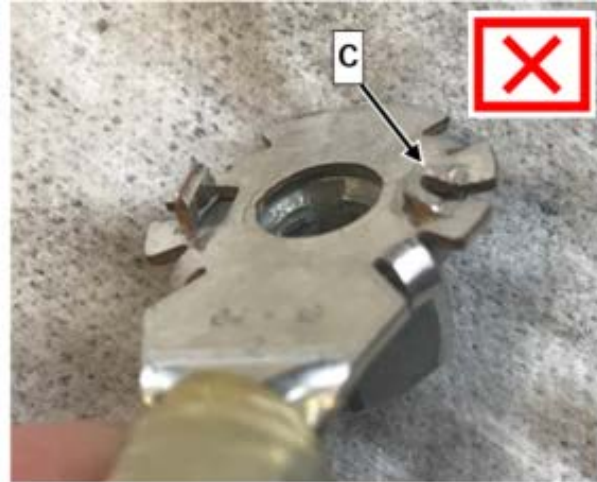
(not OK)

i Only if anti-twist protection of cable lug is **bent inwards** , i.e. outside dimension between anti-twist protection lugs (**D, figure 4**) is **less than 13.6 mm**.

Create **PTSS case**:

Make detailed photos of anti-twist protection of ground line, ground point W2/6 in removed condition. Clarify the further repair procedure via a **PTSS case**. Keep faulty part.

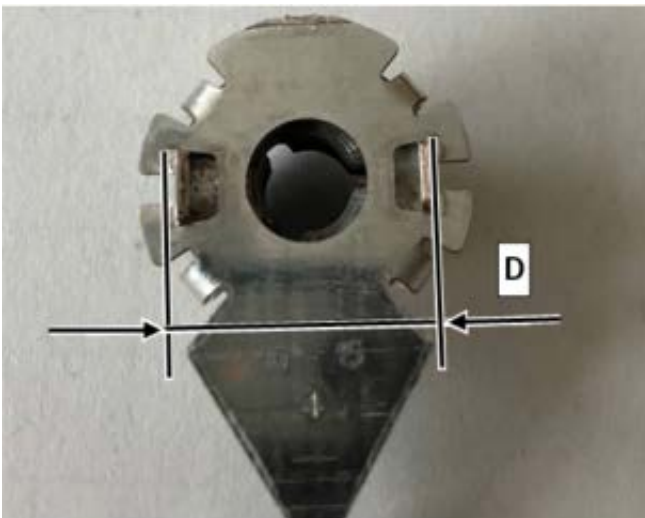
Figure 4

10. Measure outside dimension between anti-twist protection lugs (**D, figure 4**).
i Outside dimension between anti-twist protection lugs (**D, figure 4**) **min. 13.6 mm**.

- a. Anti-twist protection (**C, figure 3**) **straight** or **bent outwards**, i.e. outside dimension between anti-twist protection lugs (**D, figure 4**) **equal to or greater than 13.6 mm**: Perform operation step 11, then **end measure**.
- b. Anti-twist protection (**C, figure 3**) **bent inwards**, i.e. outside dimension between anti-twist protection lugs (**D, figure 4**) **less than 13.6 mm**: Create **PTSS case**.
