Product Safety Recall

N202312100 Seat Belt Cable Separation – US Only

Release Date: October 2020

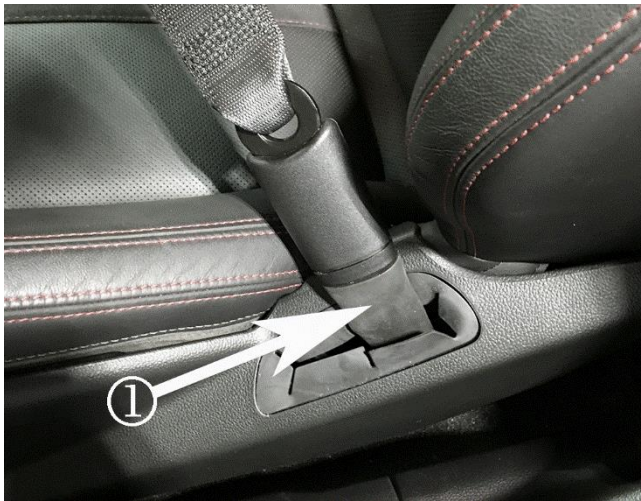
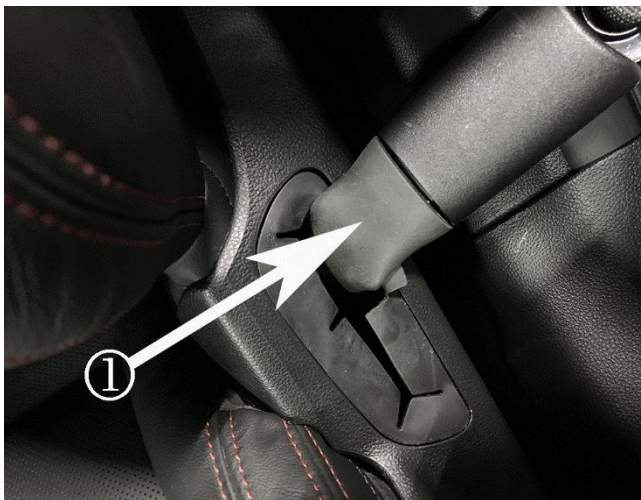
1. Using the seat adjustment switch, move the driver seat as far rearward and downward as possible. The front safety belt cable sleeve (hereinafter, “sleeve”) covers the flexible steel cable that connects the safety belt to the vehicle at the front outside seating position. The sleeve is covered by the seat trim and comes out of the slot on the side of the front seat.

2. Inspect the sleeve for any cuts or cracks. Bend the cable toward the inside and outside of the vehicle and inspect the area near arrows (1) above.

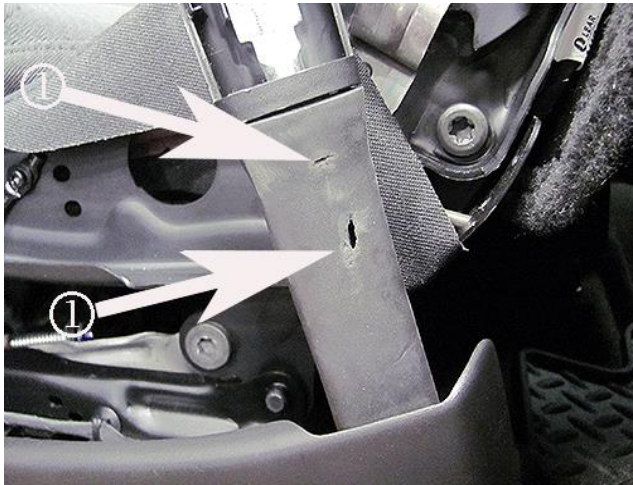
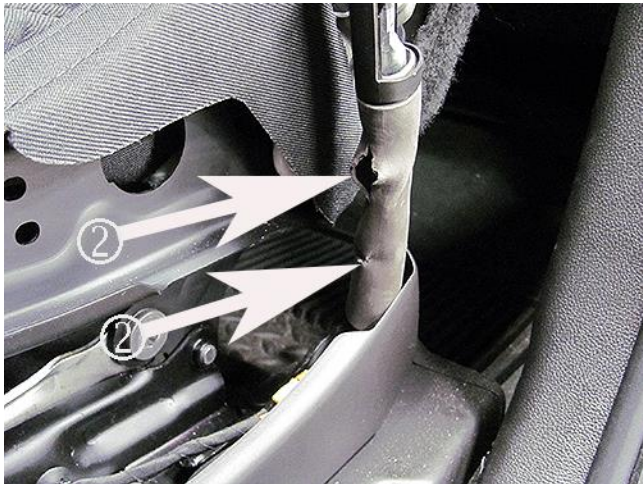
This damage will be in the form of holes (1) or splitting (2).

- If **any damage** is found, replace the tensioner and revised seat trim listed above. Refer to *Front Seat Belt Anchor Plate Tensioner Replacement* in SI.
- If no damage is found, only install the revised seat cushion outer finish cover.
