# Product Safety Recall

## N202312100 Seat Belt Cable Separation – US Only

**Release Date:** November 2020

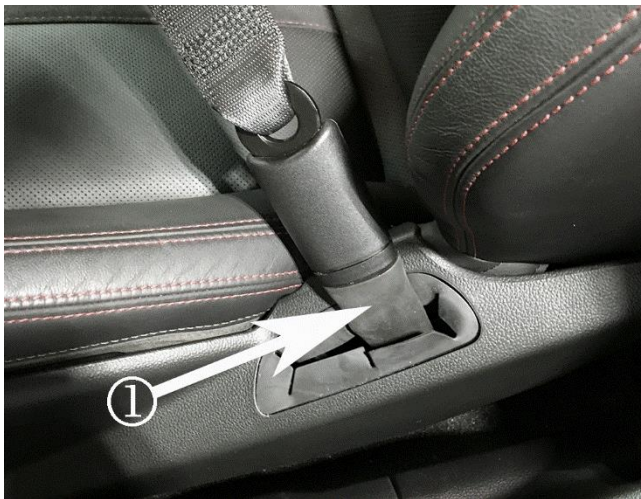
2. Inspect the sleeve for any cuts or cracks. Bend the cable toward the inside and outside of the vehicle and inspect the area near arrows (1) above.

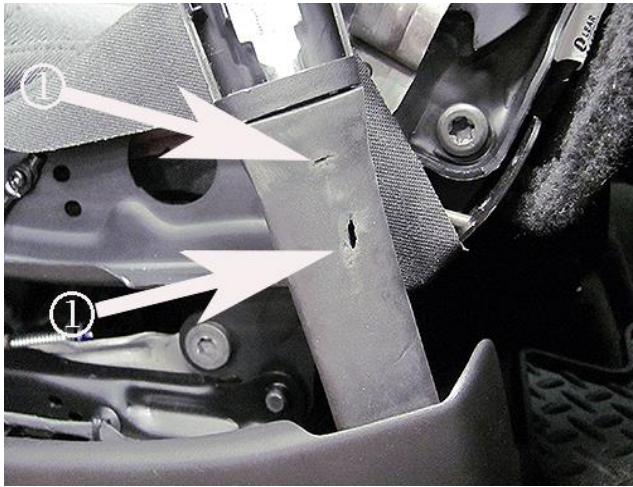
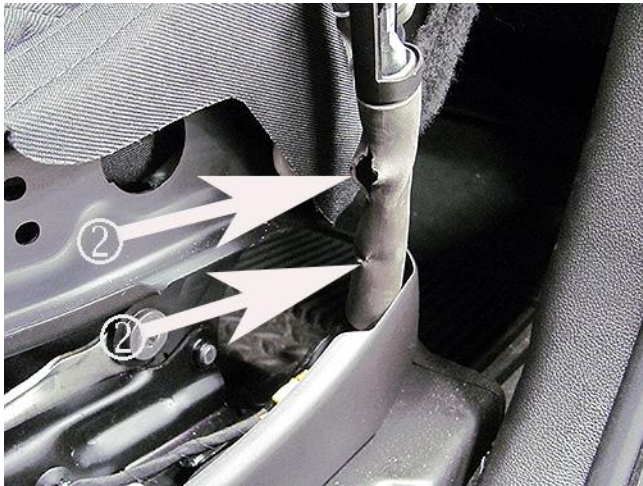
This damage will be in the form of holes (1) or splitting (2).

- If **any damage** is found, replace the tensioner and revised seat trim listed above. Refer to *Front Seat Belt Anchor Plate Tensioner Replacement* in SI.
- If no damage is found, only install the revised seat cushion outer finish cover.
